Macro-scale (1:50,000) Landslide Susceptibility Mapping in parts of Toposheets nos. 48O/2, O/6 Chikmangaluru, Shimoga, Dakshin Kannada districts, Karnataka.

टोपोशीट सं./ Toposheet Nos.: 48O/2, 48O/6

कार्य सत्र 2019-20 का अंतिम प्रतिवेदन  
Final Report for Field Season 2019-20

PROJECT: NLSM / परियोजना: एनएलएसएम

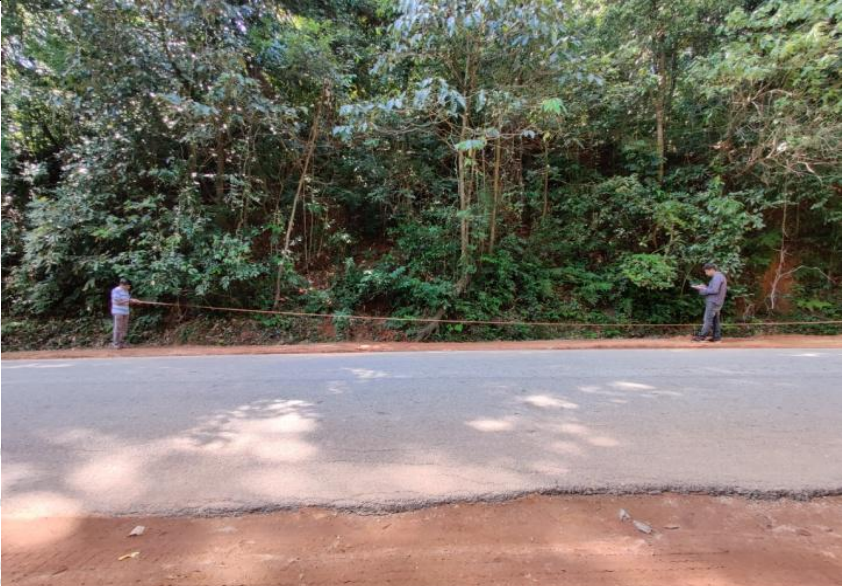
| 38 | Remarks, if any | : | The area is demarcated as unstable zone slumping zone susceptible to slope failure during rainfall. |
| 40 | Summary/Abstract | : | The road cut failure occurred due to intense weathering and erosional activity reduced the cohesion and shear strength of slope forming material. The lined drainage at toe part is required to avoid toe erosion. The slope forming material consists of in-situ soil and weathered rock. The overburden thickness is 5-10m. The area is slumping zone. The area is demarcated as unstable zone susceptible to slope failure during rainfall. |

| 37 | Remedial measures | : | The lined drainage at toe part is required to avoid toe erosion and toe support. |

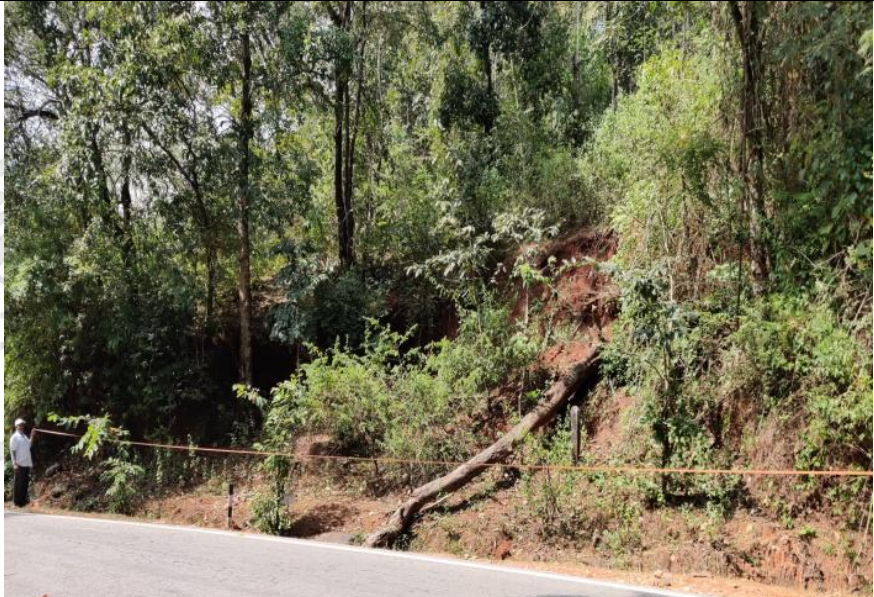
| 38 | Remarks, if any | | The area is demarcated as unstable zone susceptible to slope failure during rainfall. |
| 40 | Summary/Abstract | : | The vertical road cut failure occurred at concave curvature of road. The primary cause of slope failure is intense weathering and erosion and loss of cohesive strength of the soil. The area is slumping zone upto ~125m. The lined drainage at toe part is required to avoid toe erosion and culvert should be constructed at suitable location to drain excess water downslope to minimize slope seepage and saturation. The slope forming material consists of in-situ soil and weathered rock. The overburden thickness is 5-10m. The area is demarcated as unstable zone susceptible to slope failure during rainfall. |

| | | | downslope to minimize slope seepage and saturation. |

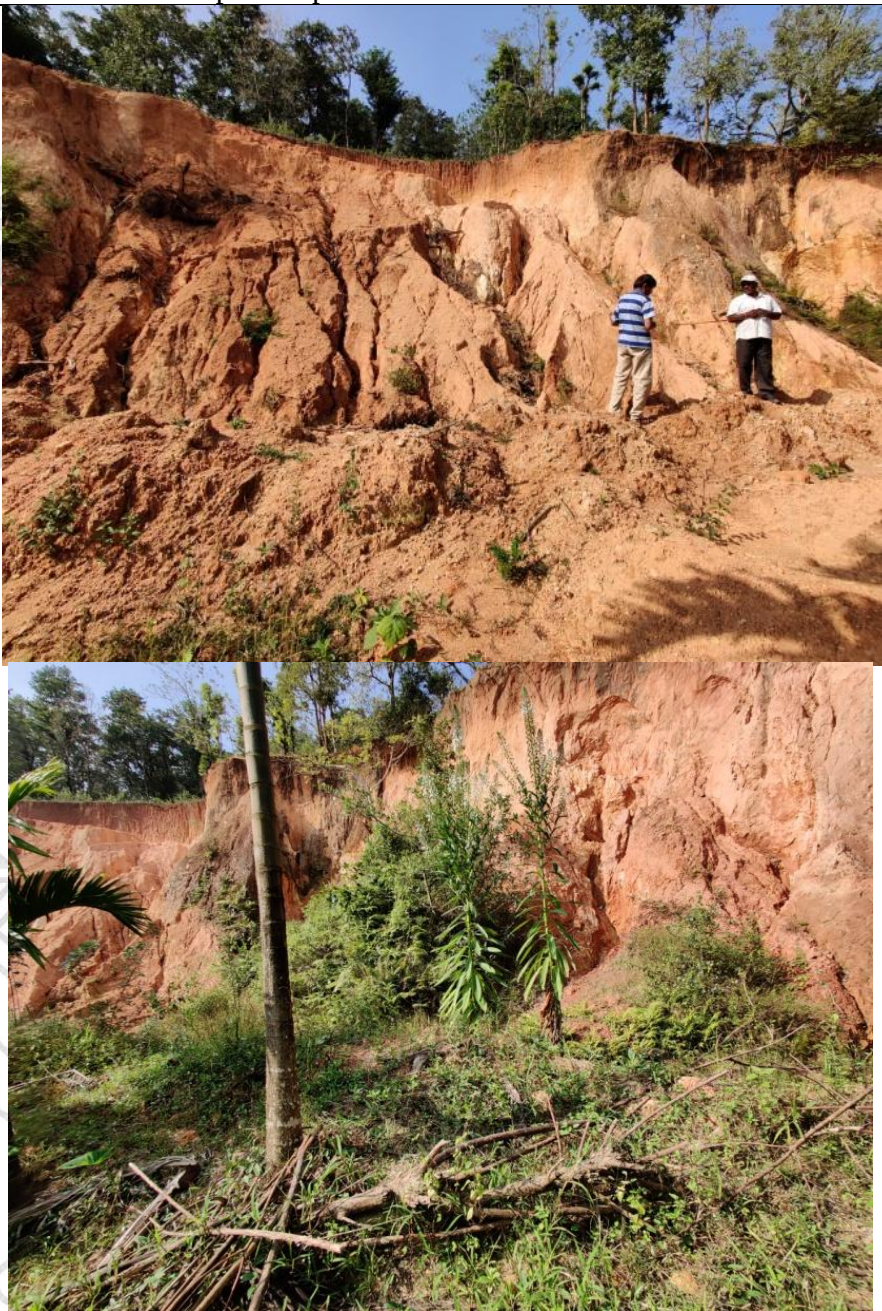
| 38 | Remarks, if any | | The area is demarcated as unstable zone. The settlements constructed on top of slope are at risk. |
| 40 | Summary/Abstract | : | Debris slide occurred on lowly dissected slope with moderate to sparse vegetation. In present scenario the landslide is active & retrogressive in nature. The vertical cut provided new pathway for water seepage and saturation during intense rainfall. The flowing stream at toe part contributed to toe erosion and removal of toe support. The debris flow may results in loss of crop (Paddy) & agriculture land. The construction lined drainage and retaining wall with weep holes should be provided at foot of hill slope as protective remedial measures. The area is demarcated as unstable zone. The settlements constructed on top of slope are at risk. |

| | | | and easing of slope should be done. |

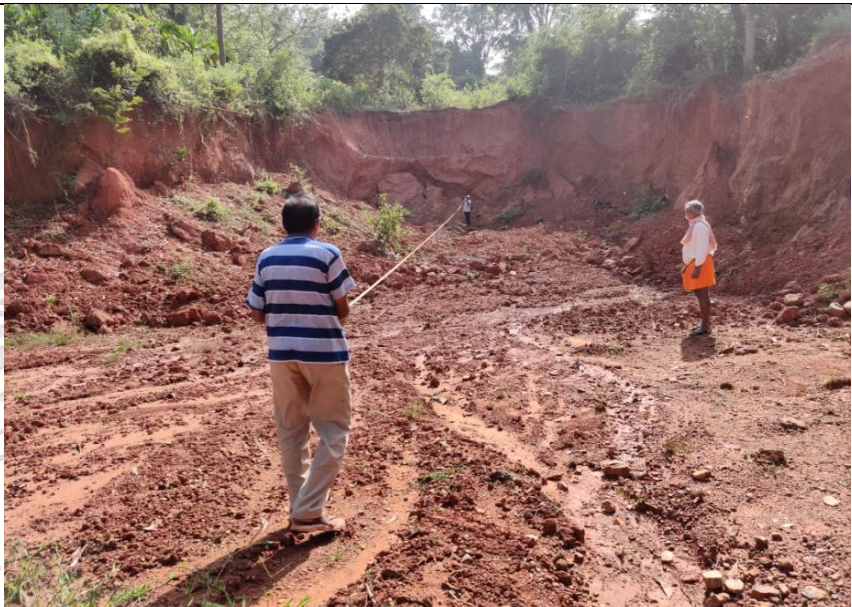
| No | Field | Description |
|---|---|---|
| 38 | Remarks, if any | : The area is demarcated as unstable zone susceptible to slope failure during rainfall. |

| 40 | Summary/Abstract | : | <p>The large dimension debris flow of ~100m run out distance recorded in Kanave village area on lowly dissected hillslope failed during heavy rainfall in August 2019. The water accumulated in trench made on top of hill under forest area resulted in water seepage and slope saturation. The over saturated slope failed during intense rainfall due to reduction in shear and cohesive strength of the slope forming material. The area is demarcated as unstable zone susceptible to slope failure during rainfall. The contact plane of ferruginous phyllite and quartz chlorite schist are prone to mass failure. The slope forming material consists of in-situ soil and highly weathered rock with overburden thickness is &gt;10m. The settlements in downslope direction are at high risk zone during rainfall.</p> |

| No | Field | Description |
|---|---|---|
| 37 | Remedial measures | : Trench dug at top slope must not be practised. Removal of soil from upslope for trench destabilised the slope and provided new path way for slope seepage and slope saturation. Easing of slope is required. |

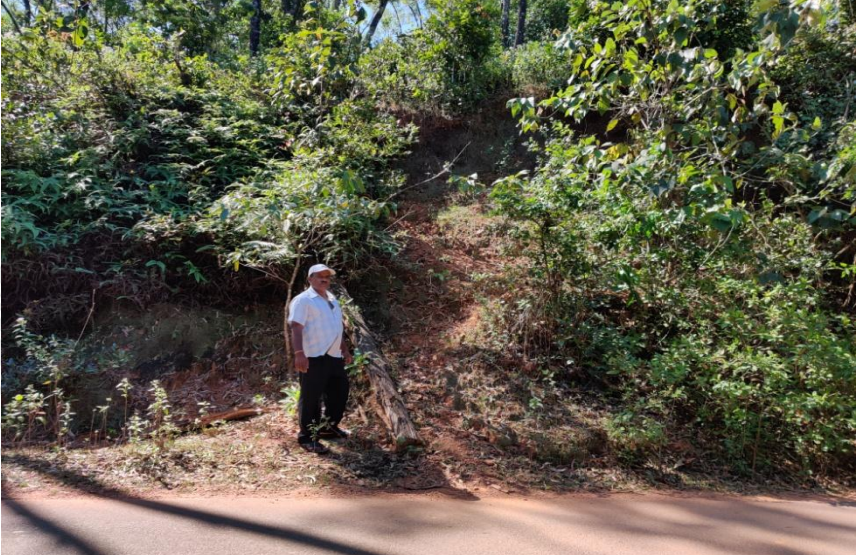
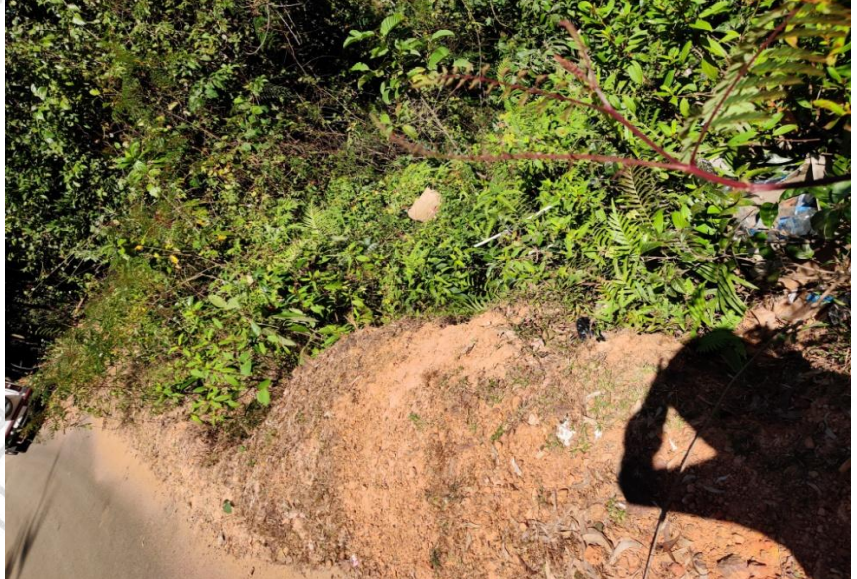
| No | Field | Description |
|---|---|---|
| 38 | Remarks, if any | : The area is demarcated as meta-stable zone susceptible to slope failure during rainfall. |

| 40 | Summary/Abstract | : | <p>The vertical road cut failure occurred at road bench level The primary cause of slope failure occurred due to intense weathering and erosion. The increased pore water pressure resulted in cohesive and shear strength failure of the soil. The lined drainage at toe part is required to avoid toe erosion and culvert should be constructed at suitable location to drain excess water downslope to minimize slope seepage and saturation. The slope forming material consists of in-situ soil and weathered rock. The overburden thickness is 5-10m. The area is demarcated as unstable zone susceptible to slope failure during rainfall.</p> |

| No | Field | Description |
|---|---|---|
| 37 | Remedial measures | : The lined drainage should be made at toe part and culvert should be designed at suitable locations to drain excess water. In current scenario retaining wall with weep holes should be constructed at footslope for toe support in order to avoid road subsidences during heavy rainfall. |

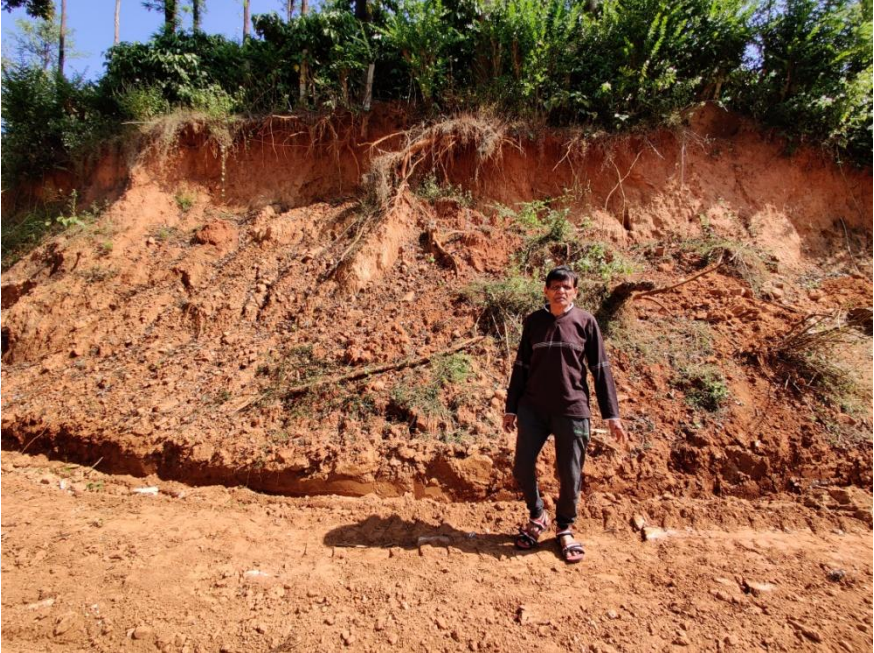
| No | Field | Description |
|---|---|---|
| 38 | Remarks, if any | : The area is demarcated as unstable zone susceptible to slope failure during rainfall. |

| 40 | Summary/Abstract | : | The vertical road cut failure is at concave curvature at road bench level caused due to intense weathering and erosion and loss of cohesive strength of the soil. The slope forming material consists of in-situ soil and weathered rock. The overburden thickness is 5-10m. The lined drainage at toe part is required to avoid toe erosion and culvert should be constructed at suitable location to drain excess water downslope to minimize slope seepage and saturation. Slope gradation is required. The area is demarcated as unstable zone susceptible to slope failure during rainfall. |

| No | Field | Description |
|---|---|---|
| 37 | Remedial measures | : The lined drainage at toe part is required to avoid toe erosion and culvert should be constructed at suitable location to drain excess water downslope to minimize slope seepage and saturation. Slope gradation is required. |

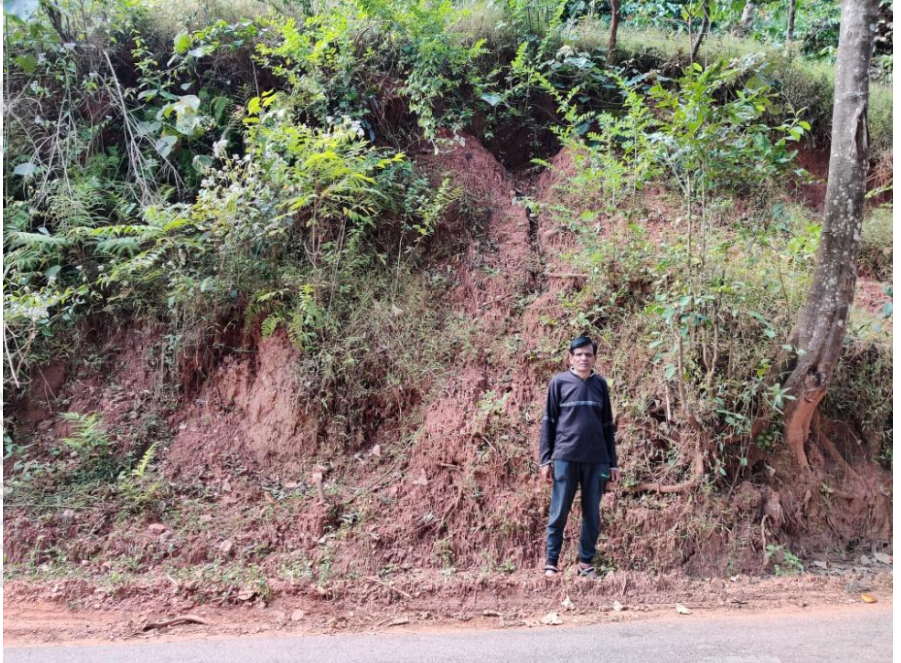
| 38 | Remarks, if any | : | The cracks were developed and area is demarcated as unstable zone susceptible to slope failure during rainfall. |
| 40 | Summary/Abstract | : | The vertical road cut failure is at concave curvature at road bench level. The primary cause of slope failure is due to intense weathering and erosion and loss of cohesive strength of the soil. The lined drainage at toe part is required to avoid toe erosion and culvert should be constructed at suitable location to drain excess water downslope to |

| | | | minimize slope seepage and saturation. The slope forming material consists of in-situ soil and weathered rock. The overburden thickness is 5-10m. The area is demarcated as unstable zone susceptible to slope failure during rainfall. |

| 37 | Remedial measures | : | The lined drainage at toe part is required to avoid toe erosion and culvert should be constructed at suitable location to drain excess water downslope to minimize slope seepage and saturation. |

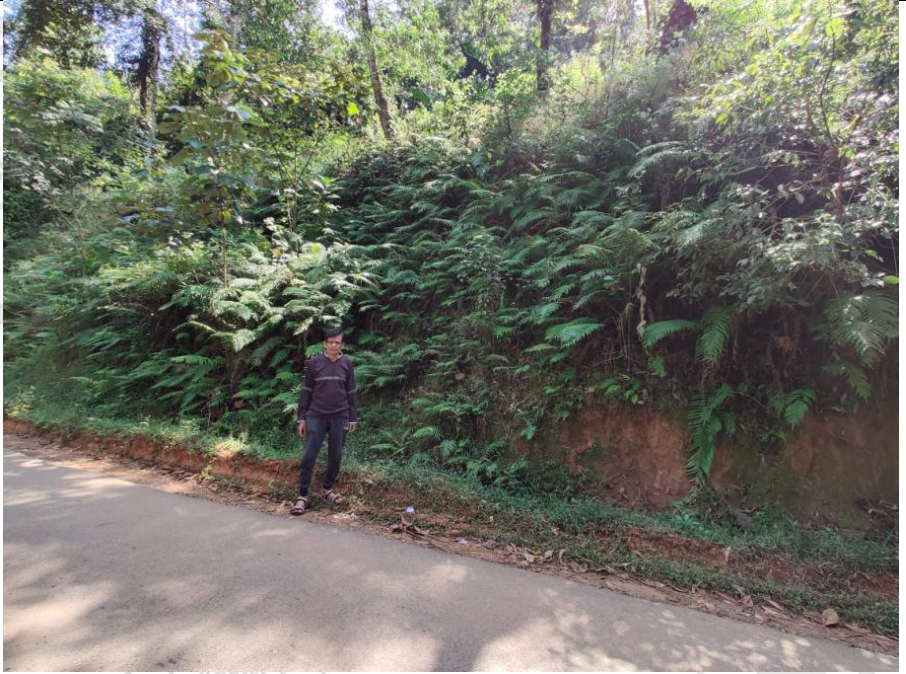
| 38 | Remarks, if any | | The area is demarcated as meta-stable zone susceptible to slope failure during rainfall. |
| 40 | Summary/Abstract | : | The shallow debris slide on lowly dissected hill slope with moderate vegetation cover. The vertical road cut open up new pathway for water seepage & slope saturation in weathered rock. Drainage at toe part saturated the slope and induced the toe erosion during heavy precipitation. The lined drainage at toe part should be provided and culvert should be designed at suitable location at road bench level to channelize or discharge excess water downslope are the effective drainage measures to avoid toe erosion and slope failure. The area is demarcated as meta-stable zone susceptible to slope failure during rainfall. The slope forming material consists of in-situ soil and weathered rock. The overburden thickness varies between 5-10m. |

| 37 | Remedial measures | : | The lined drainage at toe part should be provided and culvert should be designed at suitable location at road bench level to channelize or discharge excess water downslope are effective drainage measures to avoid toe erosion and slope failure. |

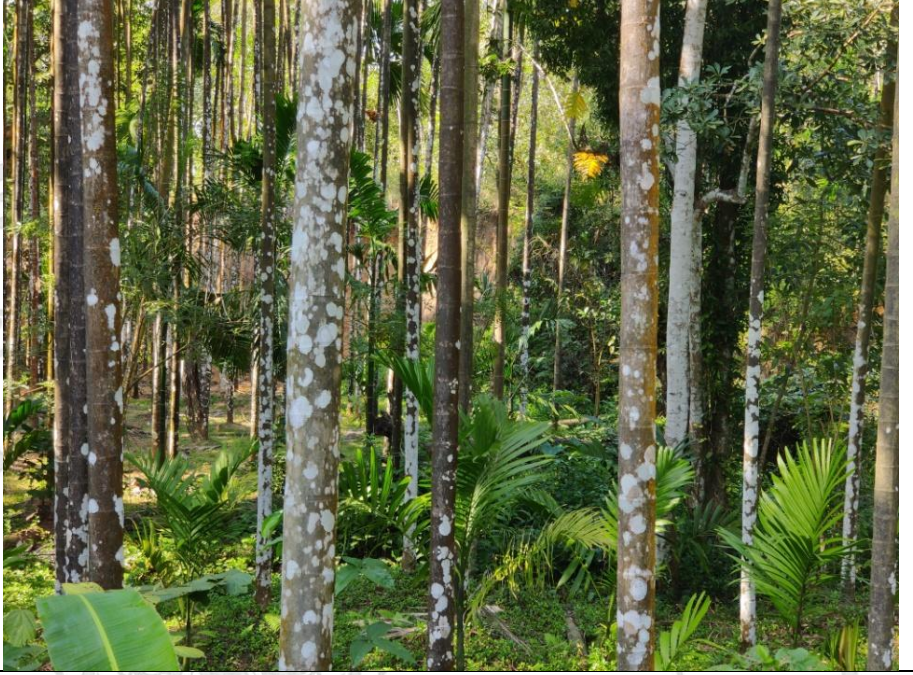
| 38 | Remarks, if any | | The area is demarcated as unstable zone. |
| 40 | Summary/Abstract | : | Debris slide occurred on lowly dissected slope with moderate to sparse vegetation. In present scenario the landslide is active & retrogressive in nature. The vertical cut provides new pathway for water seepage and saturation during intense rainfall. The flowing stream at toe part contributes to toe erosion and removal of toe support. The debris flow may results in loss of crop (Paddy) & agriculture land. The construction of gabion wall with wire mesh should be provided at foot of hill slope as protective remedial measures to restrict the soil slip. |

| | | | leading to mass movement. The plantation should be done on failed mass to stabilize the slope. |

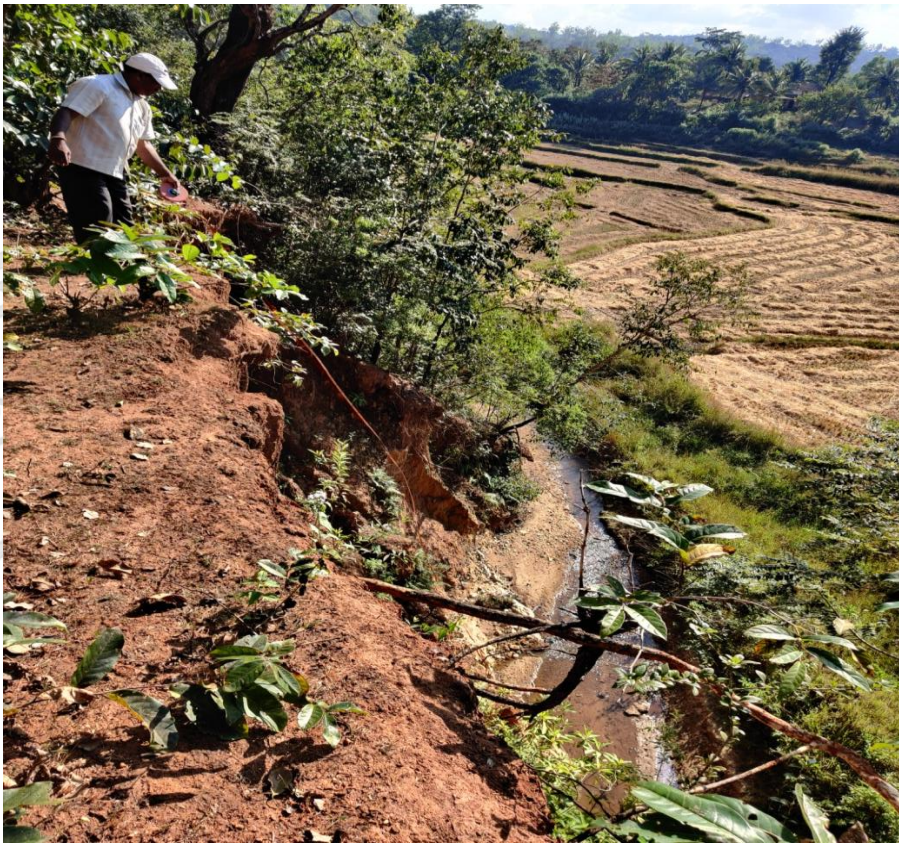
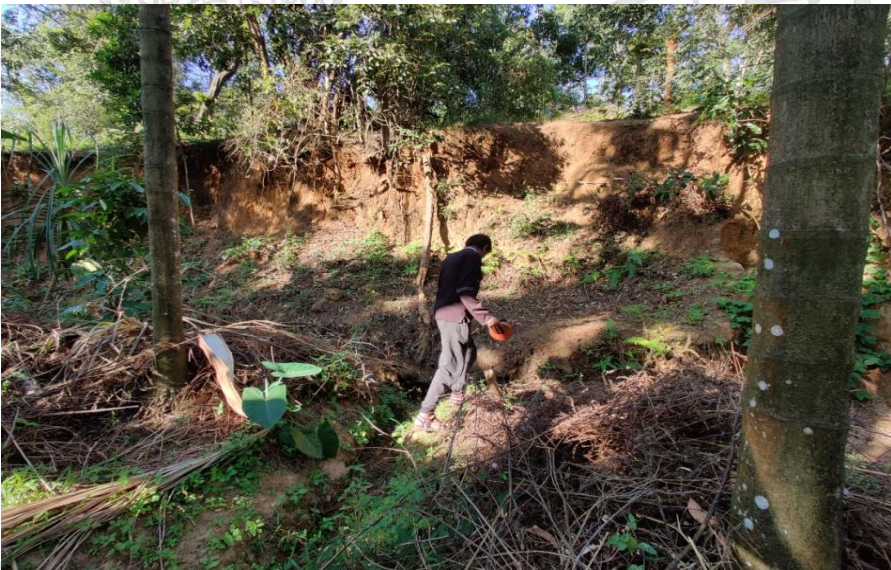
| 38 | Remarks, if any | : | The area is demarcated as unstable zone. |

| 40 | Summary/Abstract | : | Debris slide occurred on lowly dissected slope with moderate to sparse vegetation. In present scenario the landslide is active & retrogressive in nature. The stream channels get reactivated during intense rainfall that provides new pathway for water seepage and saturation. The flowing stream at toe part contributes to toe erosion and removal of toe support. The debris flow may results in loss of crop (Paddy) & Agriculture land. The construction of gabion wall with wire mesh should be provided at foot of hill slope as protective remedial measures. |

| 37 | Remedial measures | : | The construction of gabion wall with wire mesh should be provided at foot of hill slope adjoining the paddy field as protective remedial measures to minimize the chance of toe erosion and slope saturation leading to mass movement. The plantation should be done on failed mass to stabilize the slope. |

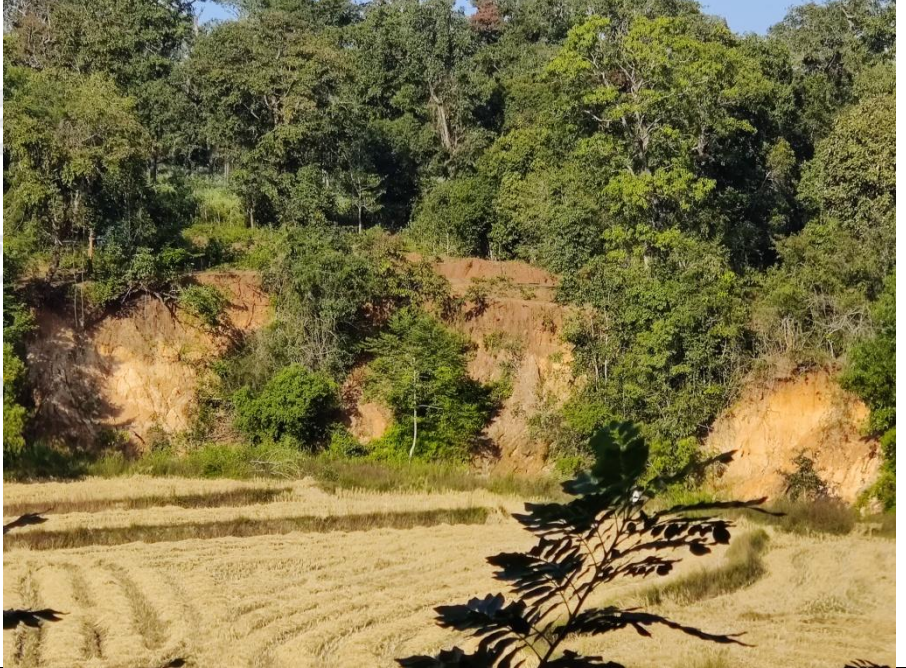
| 38 | Remarks, if any | | The area is demarcated as unstable zone. |
| 40 | Summary/Abstract | : | Debris slide occurred on lowly dissected slope with moderate to sparse vegetation. In present scenario the landslide is active & retrogressive in nature. The palaeo-stream channels get reactivated during intense rainfall that provides new pathway for water seepage and saturation. The flowing stream at toe part contributes to toe erosion and removal of toe support. The debris flow may result in loss of crop (Paddy) & Agriculture land if it get reactivated. The construction of gabion wall with wire mesh should be provided at foot of hill slope as protective remedial measures. |

| | | | foot of hill slope adjoining the paddy field as protective remedial measures to minimize the chance of toe erosion and slope saturation leading to mass movement. The plantation should be done on failed mass to stabilize the slope. |

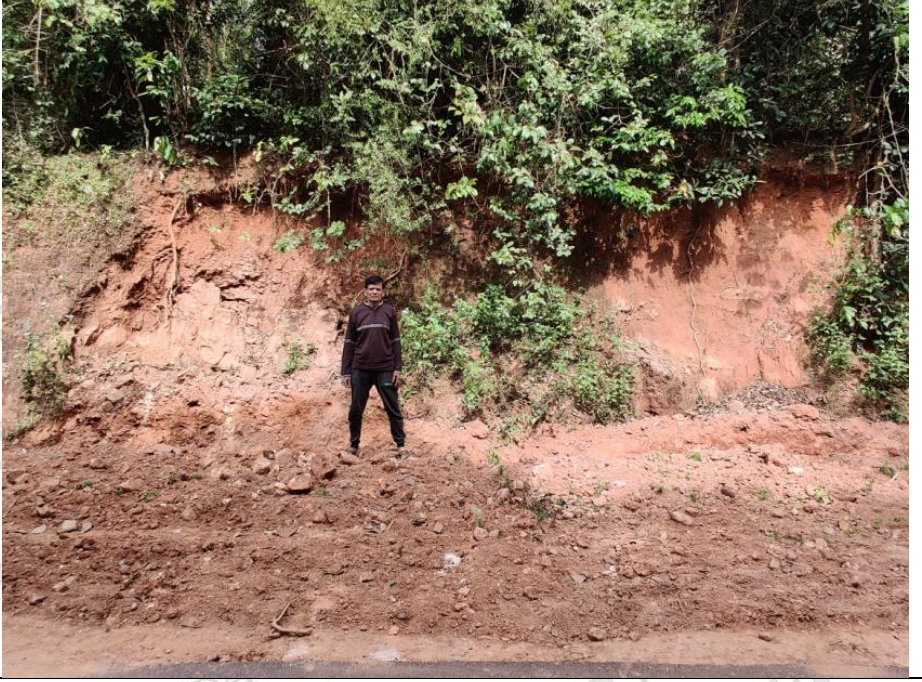
| 38 | Remarks, if any | : | The area is demarcated as meta-stable zone susceptible to slope failure during rainfall. |

| 40 | Summary/Abstract | : | The shallow debris slide is on lowly dissected hill slope with Moderate vegetation cover. The vertical cut opened up new way of water seepage & slope saturation in weathered rock. Drainage at toe part saturates the slope and induced toe erosion during heavy precipitation. The lined drainage at toe part and culvert should be designed at suitable location at road bench level to channelize or discharge excess water downslope as remedial measure for effective drainage and to avoid toe erosion and subsequent slope failure. The area is demarcated as meta-stable zone susceptible to slope failure during rainfall. The slope forming material consists of in-situ soil and weathered rock. The overburden thickness varies between 5-10m. |

| 37 | Remedial measures | : | The lined drainage at toe part and culvert should be designed at suitable location at road bench level to channelize or discharge excess water downslope as remedial measure for effective drainage and to avoid toe erosion and subsequent slope failure. |

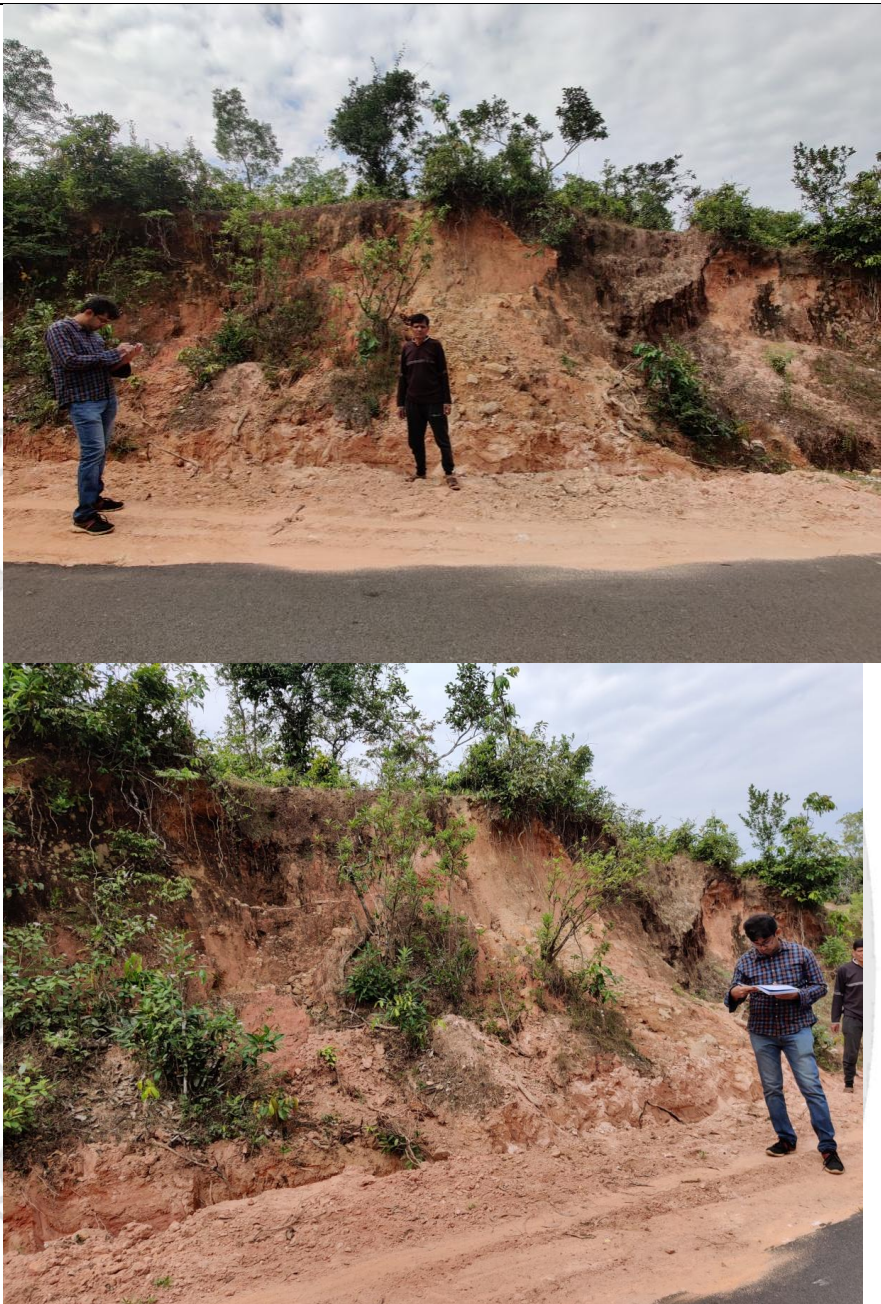
| 38 | Remarks, if any | : | The area is demarcated as meta-stable zone susceptible to slope failure during rainfall. |

| 40 | Summary/Abstract | : | <p>The shallow debris slide on lowly dissected hill slope with moderate vegetation cover. The vertical cut opened up new way of water seepage &amp; slope saturation in weathered rock. Drainage at toe part saturated the slope and induced toe erosion during heavy precipitation. The lined drainage at toe part and culvert should be designed at suitable location at road bench level to channelize or discharge excess water downslope is effective drainage measures to avoid toe erosion and slope failure. The area is demarcated as meta-stable zone susceptible to slope failure during rainfall. The slope forming material consists of in-situ soil and weathered rock. The overburden thickness varies between 5-10m.</p> |

| 37 | Remedial measures | : | The lined drainage at toe part and culvert should be designed at suitable location at road bench level to channelize or discharge excess water downslope as remedial measure for effective drainage and to avoid toe erosion and slope failure. |

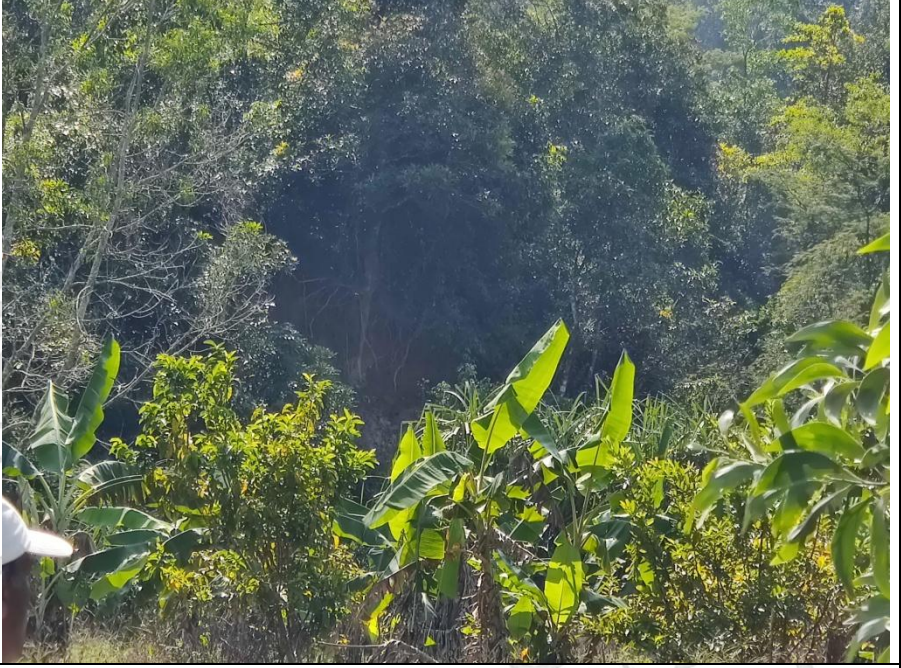
| No | Field | | Description |
|---|---|---|---|
| 36 | Geo-scientific Causes | : | Toe erosion by flowing nala, intense weathering and erosion reduced the cohesive and shear strength of the slope forming material. |
| 38 | Remarks, if any | : | The area is demarcated as unstable. |

| 40 | Summary/Abstract | : | The shallow debris slide occurred on lowly dissected hillslope caused due to toe erosion by flowing nala adjoining agricultural land. Gabion wall with wire mesh at toe part of hillslope should be provided to minimize toe erosion. |

| No | Field | | Description |
|---|---|---|---|
| 37 | Remedial measures | : | Gabion wall with wire mesh at toe part of hillslope should be provided. |

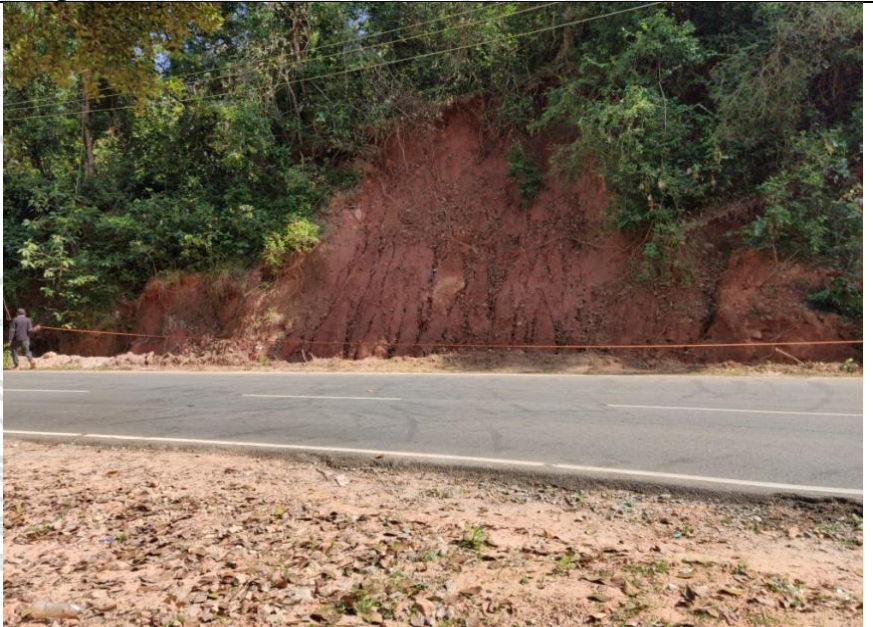
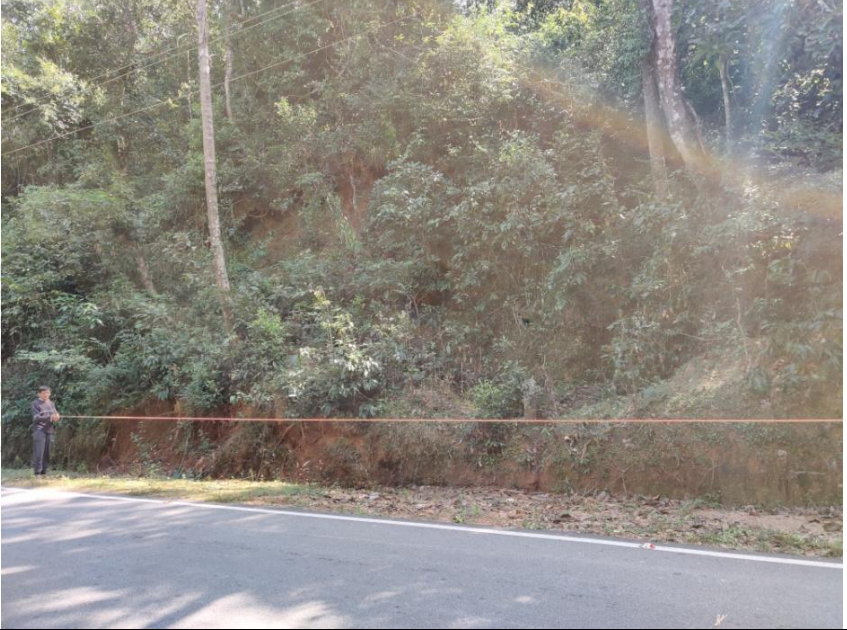
| 36 | Geo-scientific Causes | : | The slope disturbance is observed due to unscientific way of modification of slope and removal of soil for road development. The vertical road cut and toe cutting of hillslope lead to slope transformation that opened up new pathway for water seepage & slope saturation. Thus increased infiltration increased the pore water pressure and reduced the cohesive strength of the slope forming material during heavy rainfall. Drainage at toe part saturated the slope and induced toe erosion during heavy precipitation. |
| 38 | Remarks, if any | : | The area is demarcated as unstable zone susceptible to slope failure during rainfall. |

| 40 | Summary/Abstract | : | The shallow translational debris slide occurred on extensive road cut on lowly dissected slope with moderate vegetation cover. In present scenario the landslide zone is active, retrogressive, widening and enlarging in nature. The landslide zone is ~90m wide and slope failure is observed in downslope slope direction at road bench level. The slope forming material consists of in-situ soil and weathered rock with average overburden thickness of ~8m. The rock exposed is granite gneiss and is highly weathered. The lined drainage should be made at toe part and culvert should be designed at suitable locations to drain excess water. In current scenario retaining wall with weep holes should be constructed at footslope for toe support in order to avoid road subsidences during heavy rainfall. The area is demarcated as unstable zone susceptible to slope failure during rainfall. |

| 37 | Remedial measures | : | The Lined drainage should be made at toe part and culvert should be designed at suitable locations to drain excess water. In current scenario retaining wall with weep holes should be constructed at footslope for toe support in order to avoid road subsidences during heavy rainfall. |

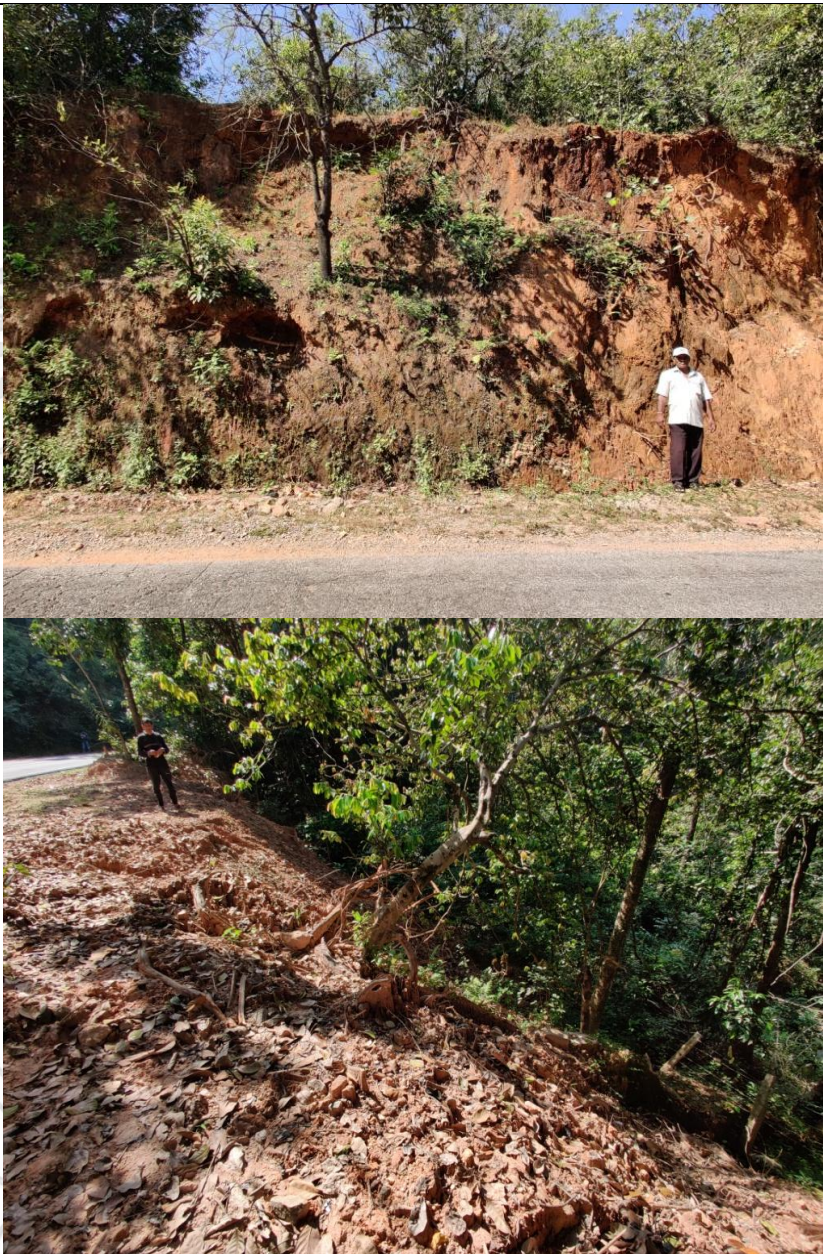
| 36 | Geo-scientific Causes | : | The slope disturbance is observed due to unscientific way of modification of slope and removal of soil for road development. The vertical road cut and toe cutting of hillslope leads to slope transformation that opened up new pathway for water seepage & slope saturation. Thus increased infiltration increased the pore water pressure and reduced the cohesive strength of the slope forming material during heavy rainfall. Drainage at toe part saturated the slope and induced toe erosion during heavy precipitation. |
| 38 | Remarks, if any | : | The area is demarcated as unstable zone susceptible to slope failure during rainfall. |

| 40 | Summary/Abstract | : | <p>The shallow debris slide occurred on lowly dissected hill slope with moderate vegetation cover. The vertical cut opened up new way of water seepage &amp; slope saturation in weathered rock. Drainage at toe part saturates the slope and induced toe erosion during heavy precipitation. The lined drainage should be made at toe part and culvert should be designed at suitable location at road bench level to channelize or discharge excess water downslope as effective drainage measures to avoid toe erosion and slope failure. The area is demarcated as meta-stable zone susceptible to slope failure during rainfall. The slope forming material consists of in-situ soil and weathered rock. The overburden thickness varies between 5-10m.</p> |

| 37 | Remedial measures | : | The lined drainage should be provided at toe part and culvert should be designed at suitable location at road bench level to channelize or discharge excess water downslope as remedial measure for effective drainage to prevent toe erosion and slope failure. |

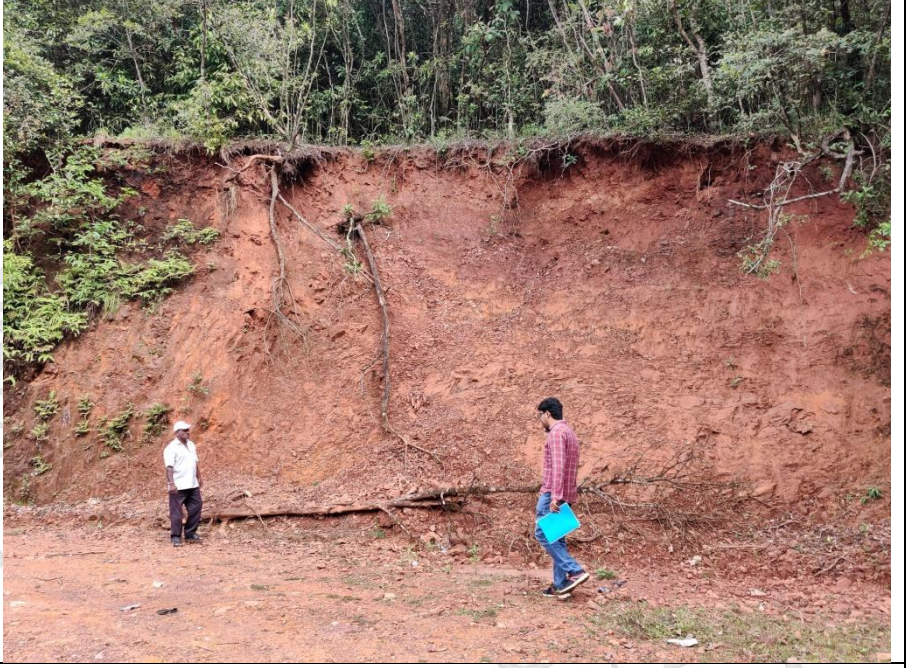
| No | Field | | Description |
|---|---|---|---|
| 36 | Geo-scientific Causes | : | The slope disturbance is observed due to unscientific way of modification of slope and removal of soil for road development. The vertical road cut and toe cutting of hillslope leads to slope transformation that opened up new pathway for water seepage & slope saturation. Thus increased infiltration increased the pore water pressure and reduced the cohesive strength of the slope forming material during heavy rainfall. |
| 38 | Remarks, if any | : | The area is demarcated as meta-stable zone susceptible to slope failure during rainfall. |

| 40 | Summary/Abstract | : | The shallow translational debris slide observed extensive road cut on Koppa-Agumbe road on lowly dissected slope with moderate vegetation cover. In present scenario the landslide zone is active, retrogressive, widening and enlarging in nature. The landslide zone is ~22m wide on convex curves of road section. The slope forming material consists of in-situ soil and weathered rock with average overburden thickness of 10m. The rock is highly weathered and fractured. Taking into consideration the risk factor, the lined drainage should be provided at toe part at road bench level to prevent water seepage and slope saturation. |

| No | Field | | Description |
|---|---|---|---|
| 37 | Remedial measures | : | Easing of slope is required and lined drainage is required so that excess water get drained through the existing culvert at road bench level. |

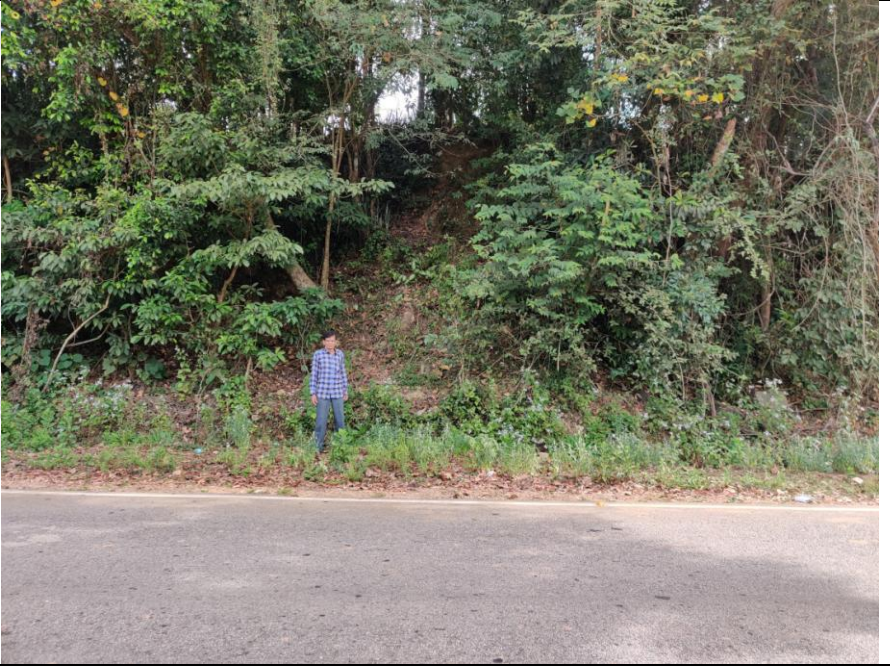
| 36 | Geo-scientific Causes | : | The slope disturbance is observed due to unscientific way of modification of slope and removal of soil for road development. The vertical road cut and toe cutting of hillslope lead to slope transformation that opened up new pathway for water seepage & slope saturation. Thus increased infiltration increased the pore water pressure and reduced the cohesive strength of the slope forming material during heavy rainfall. |
| 38 | Remarks, if any | : | The area is demarcated as meta-stable zone susceptible to slope failure during rainfall. The area is identified as slumping zone. The settlement at top slope at risk. |
| 40 | Summary/Abstract | : | The slope disturbance is observed due to unscientific way of |

| | | | modification of slope and removal of soil for road development. The vertical road cut and toe cutting of hillslope leads to slope transformation that opened up new pathway for water seepage & slope saturation. Thus increased infiltration increased the pore water pressure and reduced the cohesive strength of the slope forming material during heavy rainfall. Lined drainage at foot slope is required and excess water should be drained through culvert to minimize toe erosion and slope saturation. The area is demarcated as meta-stable zone susceptible to slope failure during rainfall. The area is identified as slumping zone. The settlement at top slope is having risk. |

| 37 | Remedial measures | : | Lined drainage at foot slope is required and excess water should be drained through culvert to minimize toe erosion and slope saturation. |

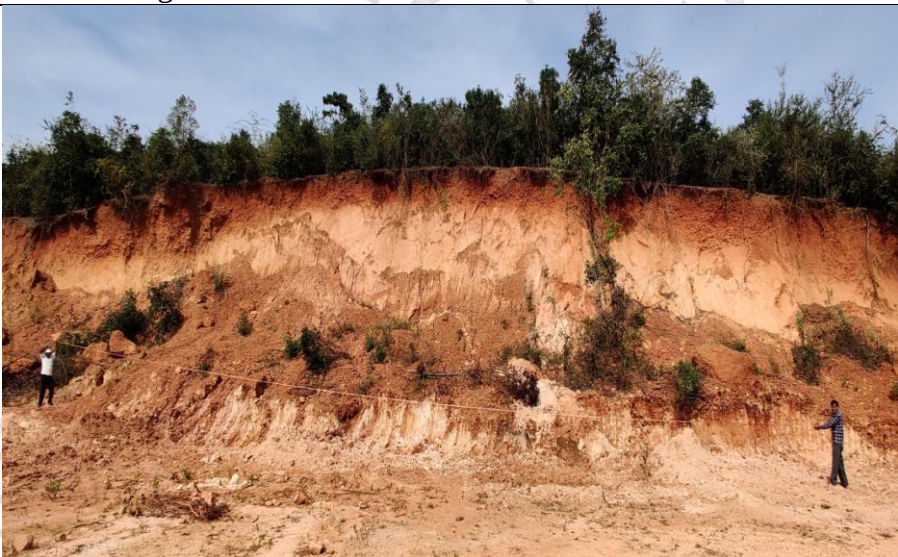
| 36 | Geo-scientific Causes | : | The slope disturbance is observed due to unscientific way of modification of slope and removal of soil for road development. The vertical road cut and toe cutting of hillslope lead to slope transformation that opened up new pathway for water seepage & slope saturation. Thus increased infiltration increased the pore water pressure and reduced the cohesive strength of the slope forming material during heavy rainfall. The rock is highly weathered and kaolinised. |
| 38 | Remarks, if any | : | The area is demarcated as meta-stable zone susceptible to slope failure during rainfall. |
| 40 | Summary/Abstract | : | The slope disturbance is observed due to unscientific way of modification of slope & removal of soil. The vertical cut and toe cutting of hillslope lead to slope transformation that opened up new way of water seepage & slope saturation. Thus increased infiltration destabilized the slope due to over water saturation and weathering during heavy rainfall. The rock is highly weathered and kaolinised. The slope gradation or easing of slope is required. The slope forming material consists of in-situ soil and weathered rock with average overburden thickness of >10m. The area is demarcated as meta-stable zone susceptible to slope failure during rainfall. |

| 37 | Remedial measures | : | Slope gradation or easing of slope required. |

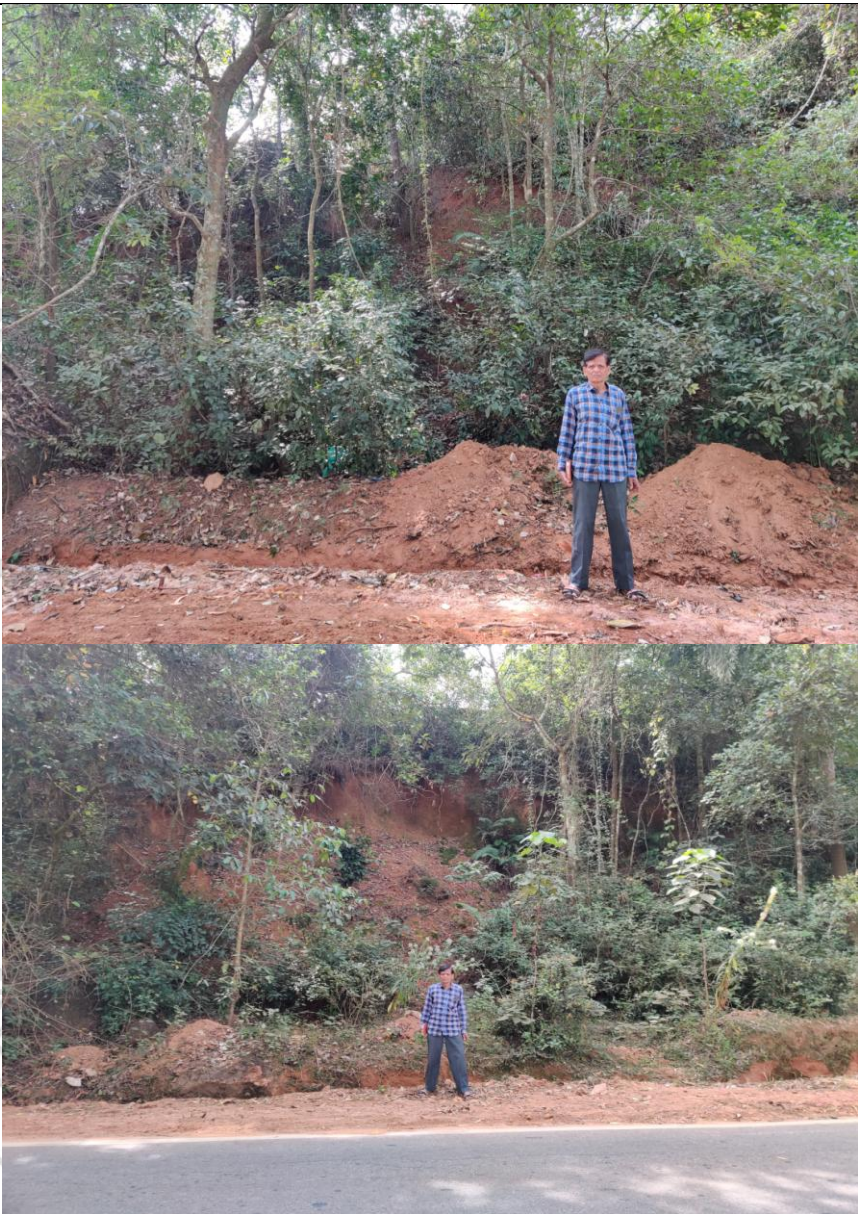
| No | Field | Description |
|---|---|---|
| 36 | Geo-scientific Causes | : The slope disturbance is observed due to unscientific way of modification of slope and removal of soil for road development. The vertical road cut and toe cutting of hillslope lead to slope transformation that opened up new pathway for water seepage & slope saturation. Thus increased infiltration increased the pore water pressure and reduced the cohesive strength of the slope forming material during heavy rainfall. |
| 38 | Remarks, if any | : The area is demarcated as meta-stable zone susceptible to slope failure during rainfall. |

| 40 | Summary/Abstract | : | <p>The slope disturbance is observed due to unscientific way of modification of slope and removal of soil for road development. The vertical road cut and toe cutting of hillslope lead to slope transformation that opened up new pathway for water seepage &amp; slope saturation. Thus increased infiltration increased the pore water pressure and reduced the cohesive strength of the slope forming material during heavy rainfall. Easing of slope and lined drainage is required. The slope forming material consists of in-situ soil with average overburden thickness of &gt;10m. The area is demarcated as meta-stable zone susceptible to slope failure during rainfall.</p> |

| No | Field | Description |
|---|---|---|
| 37 | Remedial measures | : Easing of slope and lined drainage is required. |
