Macro-scale (1:50,000) Landslide Susceptibility Mapping in parts of Toposheets nos. 48O/2, O/6 Chikmangaluru, Shimoga, Dakshin Kannada districts, Karnataka.

टोपोशीट सं./ Toposheet Nos.: 48O/2, 48O/6

कार्य सत्र 2019-20 का अंतिम प्रतिवेदन  
Final Report for Field Season 2019-20

PROJECT: NLSM / परियोजना: एनएलएसएम

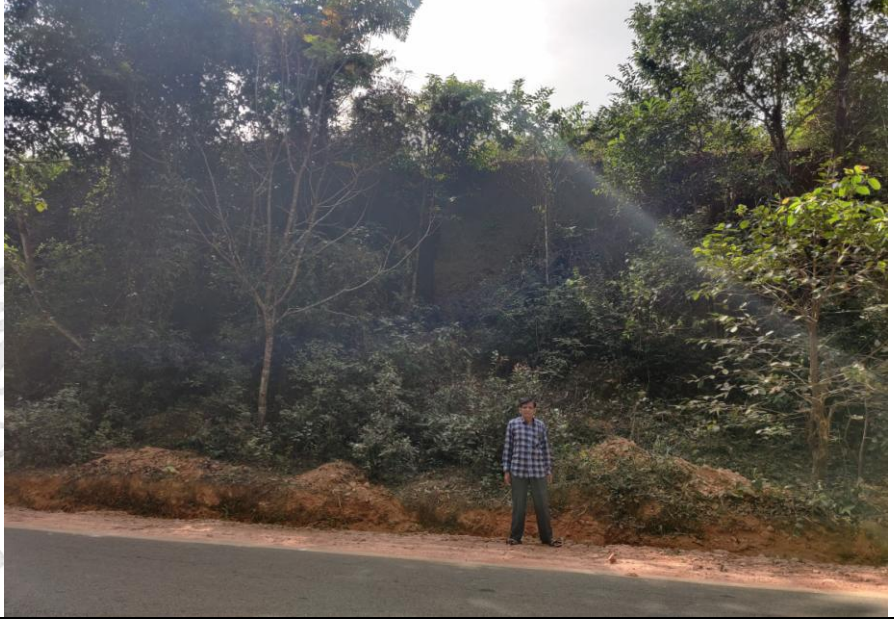
| No | Field | Description |
|---|---|---|
| 36 | Geo-scientific Causes | : The slope disturbance is observed due to unscientific way of modification of slope and removal of soil for road development. The vertical road cut and toe cutting of hillslope leads to slope transformation that opens up new pathway for water seepage & slope saturation. Thus increased infiltration increased the pore water pressure and reduced the cohesive strength of the slope forming material during heavy rainfall. |
| 38 | Remarks, if any | : The area is demarcated as meta-stable zone susceptible to slope failure during rainfall. |

| 40 | Summary/Abstract | : | The slope disturbance is observed due to unscientific way of modification of slope and removal of soil for road development. The vertical road cut and toe cutting of hillslope leads to slope transformation that opened up new pathway for water seepage & slope saturation. Thus increased infiltration increased the pore water pressure and reduced the cohesive strength of the slope forming material during heavy rainfall. Easing of slope and lined drainage is required. The slope forming material consists of in-situ soil with average overburden thickness of >10m. The area is demarcated as meta-stable zone susceptible to slope failure during rainfall. |

| No | Field | Description |
|---|---|---|
| 37 | Remedial measures | : Easing of slope and lined drainage is required. |

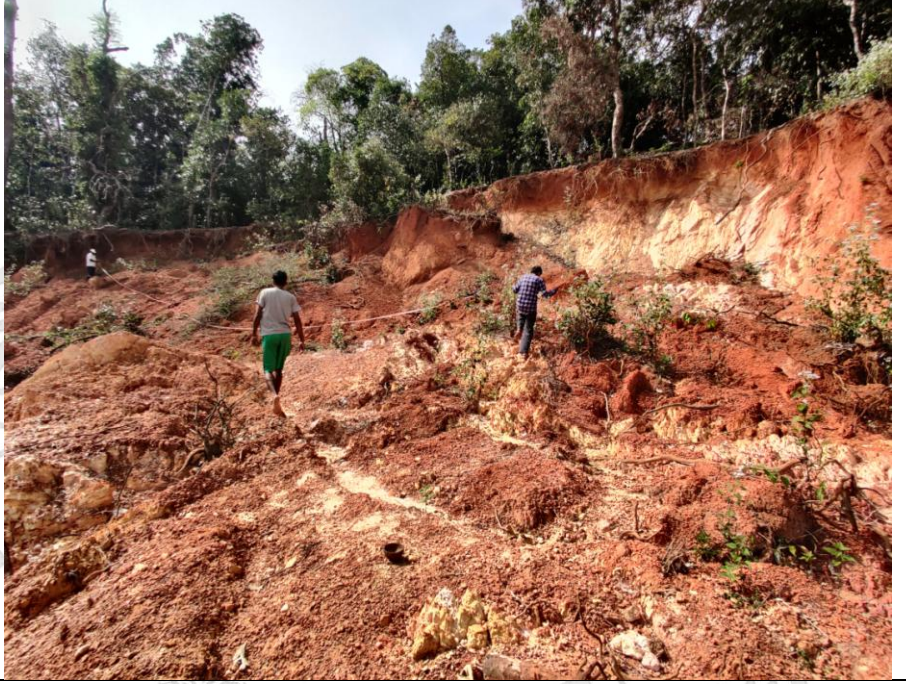
| 36 | Geo-scientific Causes | : | The slope disturbance is observed due to unscientific way of modification of slope & removal of soil for settlement purposes. The vertical cut and toe cutting of hillslope lead to slope transformation that opened up new pathway of water seepage & slope saturation. Thus increased infiltration and increased pore water pressure reduced the shear strength of slope forming material during heavy rainfall. The quartz vein and enclaves of quartz sericite schist within highly weathered Granite gneiss were observed on disturbed failed mass in landslide zone. The differential weathering and kaolinization of rock were also observed. |
| 38 | Remarks, if any | : | The area is demarcated as unstable zone susceptible to slope failure during rainfall. Taking into consideration the risk factor the settlement in flow direction of debris is at high risk. |

| 40 | Summary/Abstract | : | The shallow translational debris flow observed at Mathevani village area on lowly dissected slope with Moderate vegetation. In present scenario the landslide zone is active, retrogressive, widening and enlarging in nature. The landslide zone is ~75m wide with overburden thickness of ~14m. The slope disturbance is observed due to unscientific way of modification of slope & removal of soil for settlement purposes. The vertical cut and toe cutting of hillslope lead to slope transformation that opened up new way of water seepage & slope saturation. Thus increased infiltration destabilized the slope due to over water saturation during heavy rainfall. The quartz vein and enclaves of quartz sericite schist within highly weathered granite gneiss at failure zone were observed. The differential weathering and kaolinization of rock were also observed. Easing of slope is required and retaining wall with weep holes should be constructed to provide toe support. The slope should be monitored during heavy rainfall in monsoon. The area is demarcated as unstable zone susceptible to slope failure during rainfall. Taking into consideration the risk factor the settlement in flow direction of debris is at high risk. |

| 37 | Remedial measures | : | Easing of slope is required and retaining wall with weep holes should be constructed to provide toe support. The slope should be monitored during heavy rainfall in monsoon. |

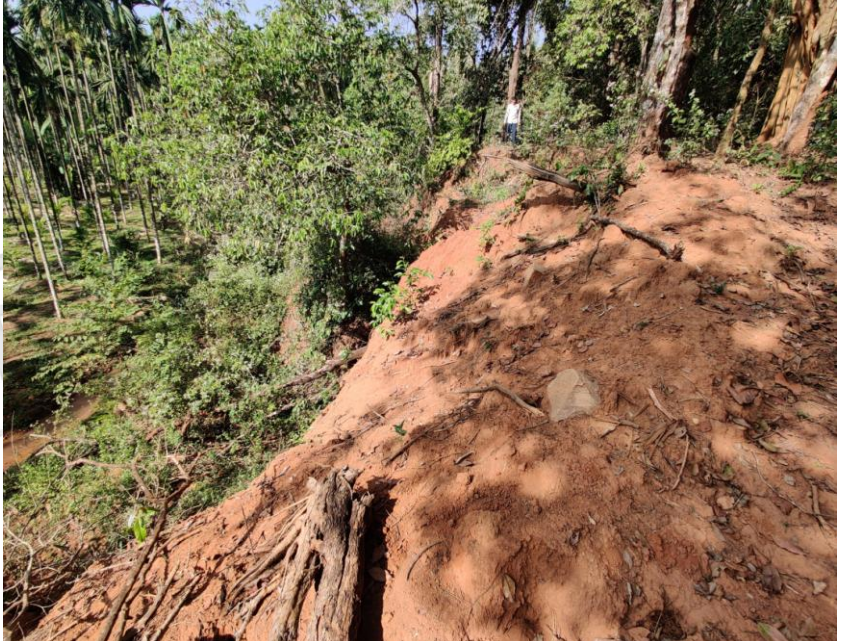
| 36 | Geo-scientific Causes | : | The slope disturbance is observed due to unscientific way of modification of slope & removal of soil for settlement purposes. The vertical cut and toe cutting of hillslope lead to slope transformation that opened up new pathway for water seepage & slope saturation. Thus increased water infiltration increased the pore water pressure and reduced the shear strength of slope forming material during heavy rainfall. |
| 38 | Remarks, if any | : | The area is demarcated as unstable zone susceptible to slope failure during rainfall. The road subsidence and slope failure is prone in downslope direction. |

| 40 | Summary/Abstract | : | The slope disturbance is observed due to unscientific way of modification of slope & removal of soil for settlement purposes. The vertical cut and toe cutting of hillslope leads to slope transformation that opened up new pathway for water seepage & slope saturation. Thus increased infiltration increased the pore water pressure and reduced the shear strength of slope forming material during heavy rainfall. Lined drainage and retaining wall with weep holes at footslope is required for toe support and to minimize toe erosion. The culvert should be constructed at road bench level to drain excess water downslope at suitable location. The area is demarcated as unstable zone susceptible to slope failure during rainfall. The road subsidence and slope failure is prone in downslope direction. |

| 37 | Remedial measures | : | Lined drainage and retaining wall with weep holes at footslope is required for toe support and to minimize toe erosion. The suitable designed culvert should be constructed at road bench level to drain excess water downslope at suitable location. |

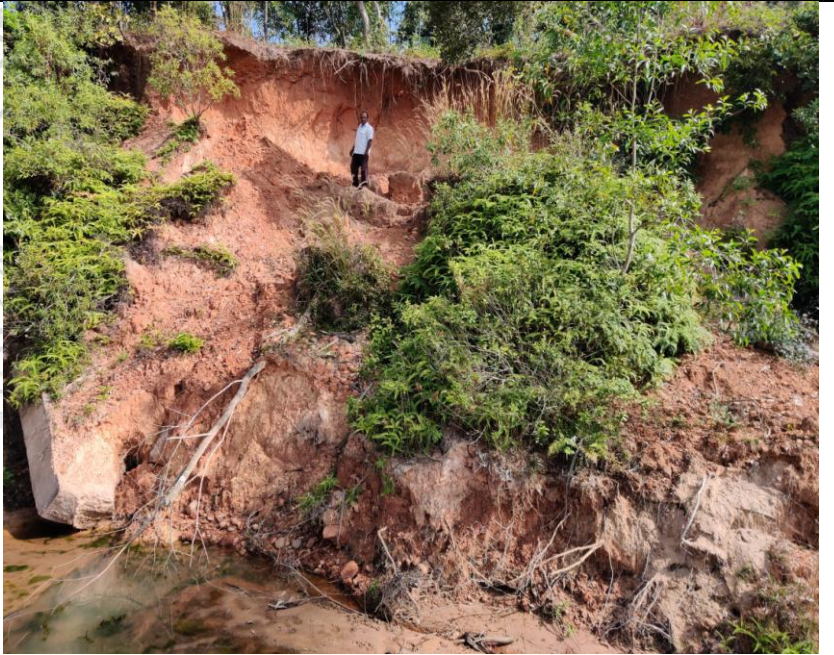
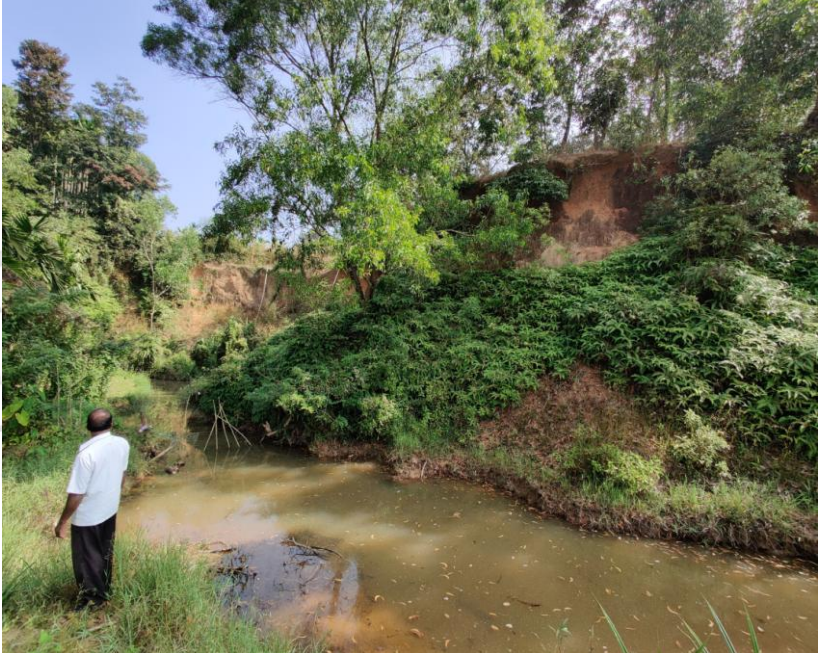
| 36 | Geo-scientific Causes | : | The scouring toe erosion by 1 <sup>st</sup> order drainage due to excess discharge of rainwater in stream channel that lead to slope failure. The exposed slope opened up new pathway for surface runoff, water seepage & slope saturation. Thus increased infiltration increased the pore water pressure and reduced the shear strength of slope forming material during heavy rainfall. |
| 38 | Remarks, if any | : | The area is demarcated as meta-stable zone susceptible to slope failure during rainfall. |

| 40 | Summary/Abstract | : | The slope failure resulted due to toe erosion and undercutting or scouring of footslope by flowing stream that lead to slope transformation that opened up new way of water seepage & slope saturation. Thus increased infiltration destabilized the slope due to over water saturation during heavy rainfall. Lined drainage at footslope is required to avoid toe erosion and slope saturation. The area is demarcated as meta-stable zone susceptible to slope failure during rainfall. |

| 37 | Remedial measures | : | Easing of slope required. Lined drainage at foot slope is required to avoid toe erosion and slope saturation. |

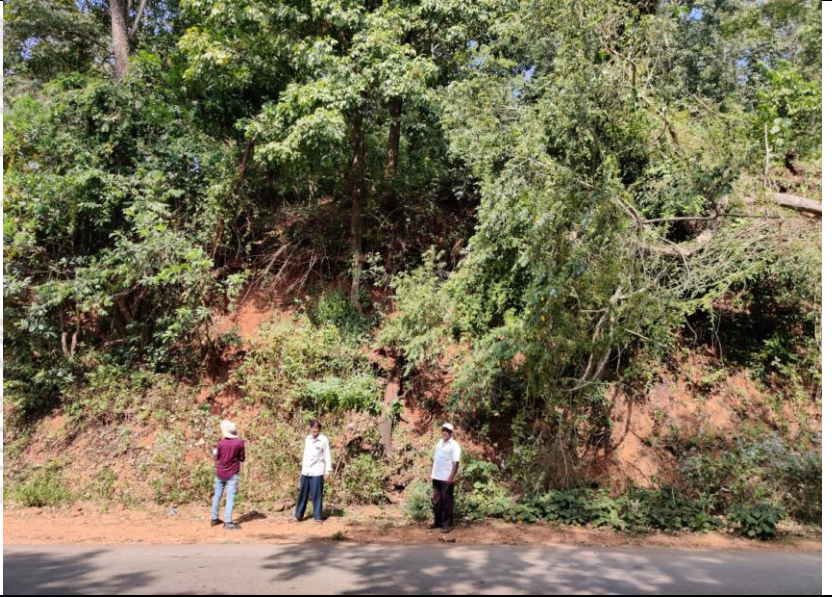
| 36 | Geo-scientific Causes | : | The slope disturbance is observed due to unscientific way of modification of slope and removal of soil for road development. The vertical road cut and toe cutting of hillslope lead to slope transformation that opened up new pathway for water seepage & slope saturation. Thus increased infiltration increased the pore water pressure and reduced the cohesive strength of the slope forming material during heavy rainfall. |
| 38 | Remarks, if any | : | The area is demarcated as meta-stable zone susceptible to slope failure during rainfall. |
| 40 | Summary/Abstract | : | The slope disturbance is observed due to unscientific way of modification of slope and removal of soil for road development. The vertical road cut and toe cutting of hillslope lead to slope transformation that opened up new pathway for water seepage & |

| | | | slope saturation. Thus increased infiltration increased the pore water pressure and reduced the cohesive strength of the slope forming material during heavy rainfall. Easing of slope and lined drainage is required. The culvert should be designed at proper location to discharge excess water downslope to avoid toe erosion and slope saturation. The area is demarcated as meta-stable zone susceptible to slope failure during rainfall. |

| 37 | Remedial measures | : | Lined drainage is required. The culvert should be designed at proper location to discharge excess water downslope to avoid toe erosion and slope saturation. |

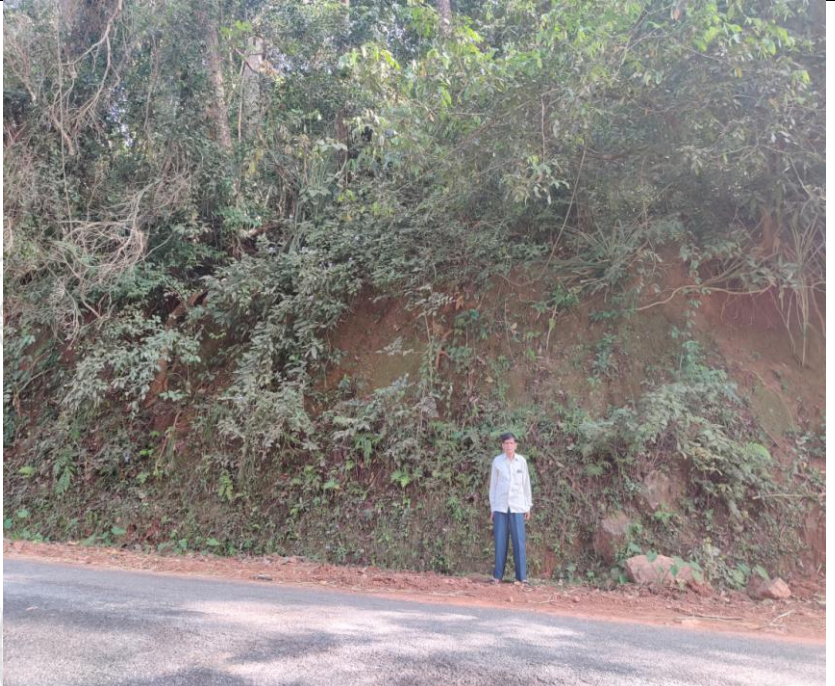
| 36 | Geo-scientific Causes | : | The slope disturbance is observed due to unscientific way of modification of slope and removal of soil for road development. The vertical road cut and toe cutting of hillslope lead to slope transformation that opened up new pathway for water seepage & slope saturation. Thus increased infiltration increased the pore water pressure and reduced the cohesive strength of the slope forming material during heavy rainfall. |
| 38 | Remarks, if any | : | The area is demarcated as meta-stable zone susceptible to slope failure during rainfall. |
| 40 | Summary/Abstract | : | The slope disturbance is observed due to unscientific way of modification of slope and removal of soil for road development. The vertical road cut and toe cutting of hillslope lead to slope transformation that opens up new pathway for water seepage & slope saturation. Thus increased infiltration increased the pore water pressure and reduced the cohesive strength of the slope forming material during heavy rainfall. Easing of slope and lined drainage is required. The culvert should be designed at proper location to discharge excess water downslope to avoid toe erosion and slope saturation. The area is demarcated as meta-stable zone susceptible to slope failure during rainfall. |

| 37 | Remedial measures | : | Lined drainage is required. The culvert should be designed at proper location to discharge excess water downslope to avoid toe erosion and slope saturation. |

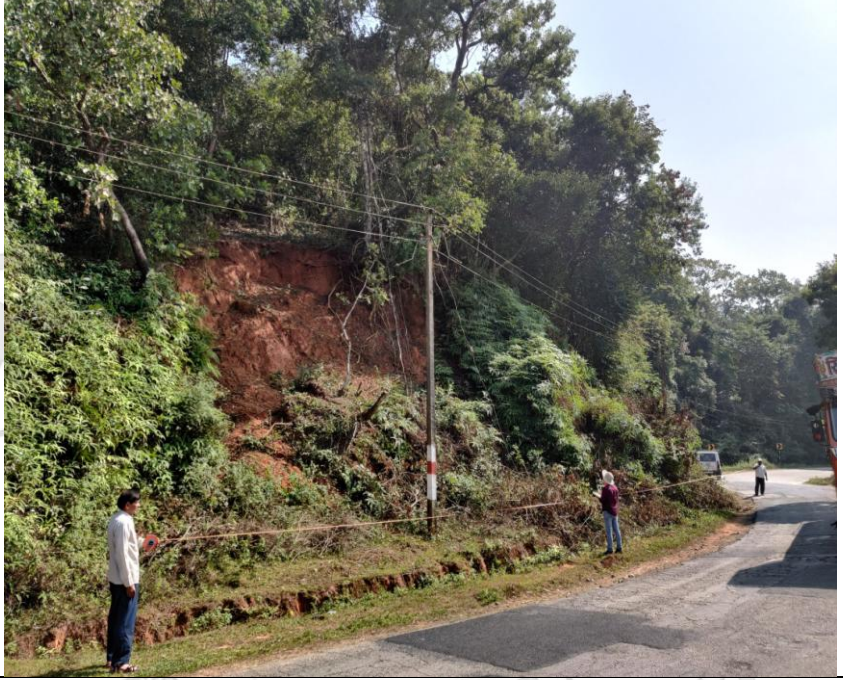
| No | Field | | Description |
|---|---|---|---|
| 36 | Geo-scientific Causes | : | The slope disturbance is observed due to unscientific way of modification of slope and removal of soil for road development. The vertical road cut and toe cutting of hillslope lead to slope transformation that open up new pathway for water seepage & slope saturation. Thus increased infiltration increased the pore water pressure and reduced the cohesive strength of the slope forming material during heavy rainfall. |
| 38 | Remarks, if any | | The area is demarcated as unstable zone susceptible to slope failure during rainfall. |

| 40 | Summary/Abstract | : | The slope disturbance is observed due to unscientific way of modification of slope and removal of soil for road development. The vertical road cut and toe cutting of hillslope lead to slope transformation that opened up new pathway for water seepage & slope saturation. Thus increased infiltration increased the pore water pressure and reduced the cohesive strength of the slope forming material during heavy rainfall. Easing of slope and lined drainage is required. The culvert should be designed at proper location to discharge excess water downslope to avoid toe erosion and slope saturation. The area is demarcated as meta-stable zone susceptible to slope failure during rainfall. |

| No | Field | | Description |
|---|---|---|---|
| 37 | Remedial measures | : | Lined drainage is required. The culvert should be designed at proper location to discharge excess water downslope to avoid toe erosion and slope saturation. |

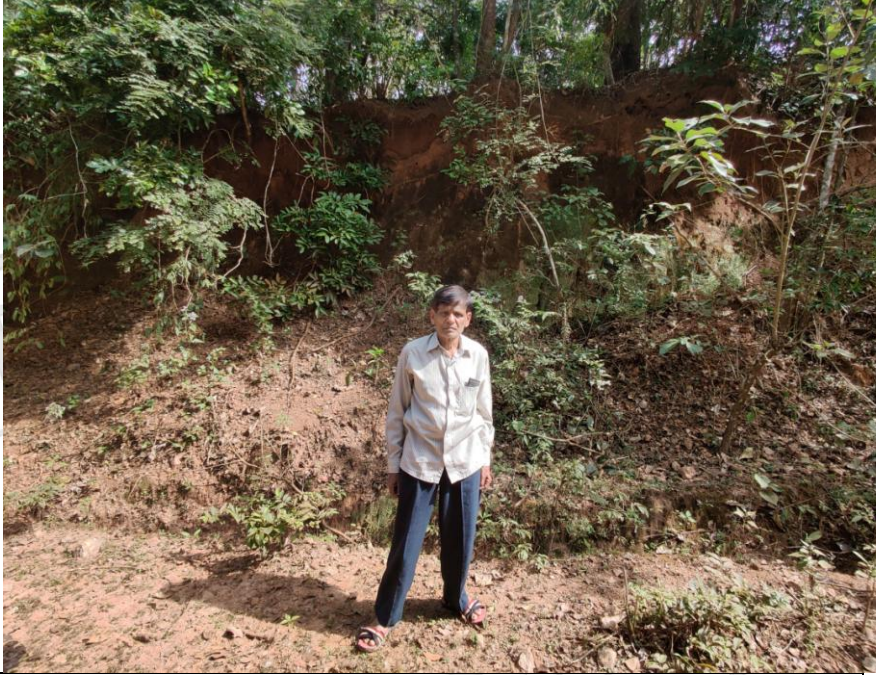
| 38 | Remarks, if any | : | The area is demarcated as unstable zone susceptible to slope failure during rainfall. |

| 40 | Summary/Abstract | : | The slope disturbance is observed due to unscientific way of modification of slope and removal of soil for road development. The vertical road cut and toe cutting of hillslope leads to slope transformation that opened up new pathway for water seepage & slope saturation. Thus increased infiltration increased the pore water pressure and reduced the cohesive strength of the slope forming material during heavy rainfall. Easing of slope and lined drainage is required. The culvert should be designed at proper location to discharge excess water downslope to avoid toe erosion and slope saturation. The area is demarcated as meta-stable zone susceptible to slope failure during rainfall. |

| 37 | Remedial measures | : | Lined drainage is required. The culvert should be designed at proper location to discharge excess water downslope to avoid toe erosion and slope saturation. |

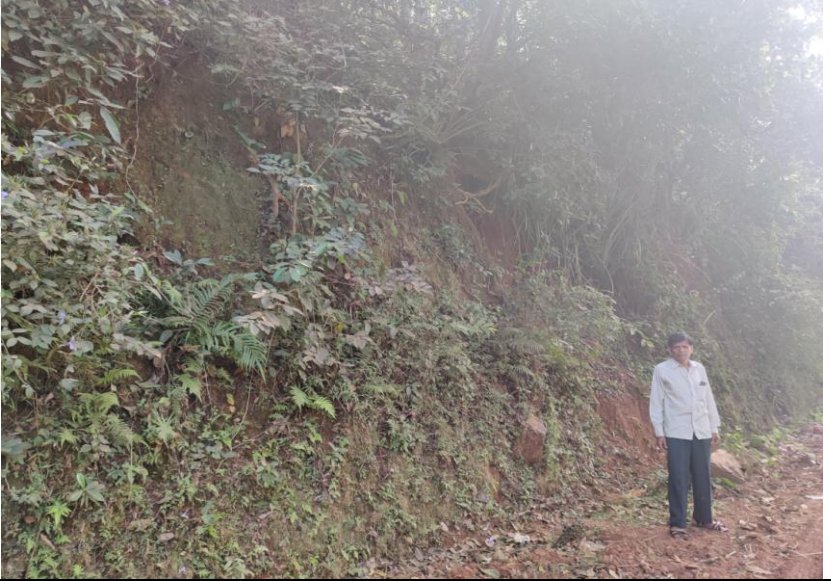
| 38 | Remarks, if any | : | The area is demarcated as unstable zone susceptible to slope failure during rainfall. |
| 40 | Summary/Abstract | : | The slope disturbance is observed due to unscientific way of modification of slope and removal of soil for road development. |

| | | | The vertical road cut and toe cutting of hillslope leads to slope transformation that opened up new pathway for water seepage & slope saturation. Thus increased infiltration increased the pore water pressure and reduced the cohesive strength of the slope forming material during heavy rainfall. Easing of slope and lined drainage is required. The culvert should be designed at proper location to discharge excess water downslope to avoid toe erosion and slope saturation. The area is demarcated as meta-stable zone susceptible to slope failure during rainfall. |

| 37 | Remedial measures | : | Lined drainage is required. The culvert should be designed at proper location to discharge excess water downslope to avoid toe erosion and slope saturation. |

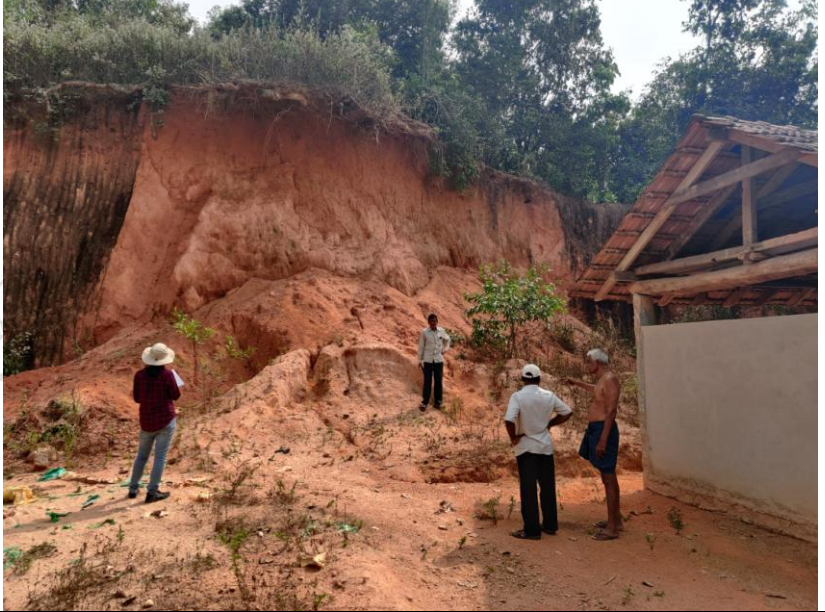
| 36 | Geo-scientific Causes | : | The slope disturbance is observed due to unscientific way of modification of slope & removal of soil for settlement purposes. The vertical toe cutting of hillslope lead to slope transformation that opened up new pathway for water seepage & slope saturation. Thus increased infiltration increased the pore water pressure and reduced the cohesive strength of the slope forming material during heavy rainfall. |
| 38 | Remarks, if any | : | The area is demarcated as meta-stable zone susceptible to slope failure during rainfall. The settlement in vicinity is at risk. |
| 40 | Summary/Abstract | : | The slope disturbance is observed due to unscientific way of modification of slope & removal of soil for settlement purposes. The vertical toe cutting of hillslope leads to slope transformation that opened up new pathway for water seepage & slope saturation. Thus increased infiltration increased the pore water pressure and reduced the cohesive strength of the slope forming material during heavy rainfall. The slope forming material consists of in-situ soil and weathered rock with average overburden thickness of 10m. The settlement in vicinity is at risk. Easing of slope is required. The area is demarcated as meta-stable zone susceptible to slope failure during rainfall. The area is identified as slumping zone. |

| 37 | Remedial measures | : | Easing and gradation of slope required. |

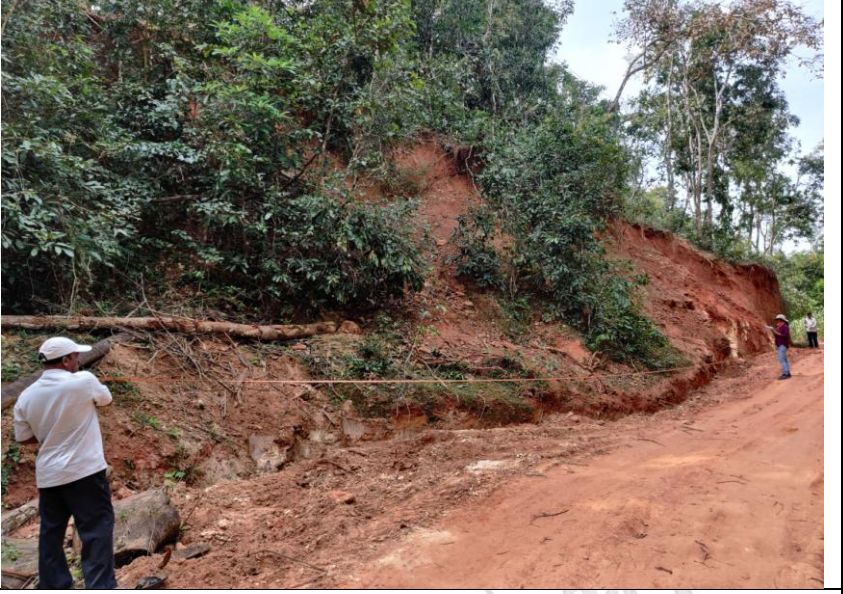
| No | Field | | Description |
|---|---|---|---|
| 36 | Geo-scientific Causes | : | The slope disturbance is observed due to unscientific way of modification of slope & removal of soil for road development. The vertical cut and toe cutting of hillslope lead to slope transformation that opened up new pathway for water seepage & slope saturation. Thus increased infiltration increased the pore water pressure and reduced the cohesive strength of the slope forming material during heavy rainfall. |
| 38 | Remarks, if any | : | The area is demarcated as meta-stable zone susceptible to slope failure during rainfall. The area is identified as slumping zone. |

| 40 | Summary/Abstract | : | The slope disturbance is observed due to unscientific way of modification of slope & removal of soil for road development. The vertical road cut and toe cutting of hillslope lead to slope transformation that opened up new pathway for water seepage & slope saturation. Thus increased infiltration increased the pore water pressure and reduced the cohesive strength of the slope forming material during heavy rainfall. The lined drainage at footslope is required and provision of water diversion or discharge through culvert should be made to avoid toe erosion and slope saturation. The area is demarcated as meta-stable zone susceptible to slope failure during rainfall. |

| No | Field | | Description |
|---|---|---|---|
| 37 | Remedial measures | : | Lined drainage at footslope is required and provision of water diversion or discharge through culvert should be made to avoid toe erosion and slope saturation. |

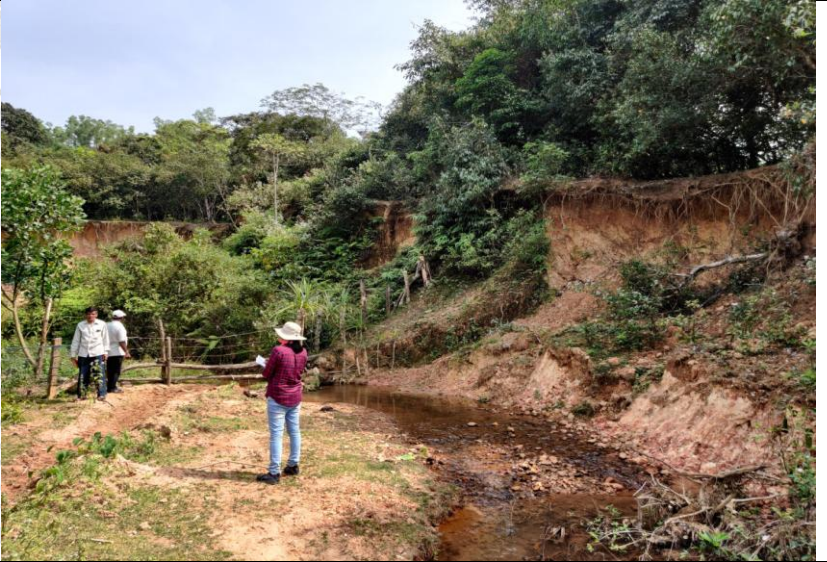
| 36 | Geo-scientific Causes | : | The toe erosion by 1 <sup>st</sup> order drainage and undercutting of foot slope by flowing stream leads to slope transformation that opened up new way of water seepage & slope saturation. Thus increased discharge of rainwater in stream channel and infiltration destabilized the slope due to over water saturation during heavy rainfall. |
| 38 | Remarks, if any | : | The area is demarcated as unstable zone susceptible to slope failure during rainfall. |

| 40 | Summary/Abstract | : | The debris slide that occurred due to unscientific way of removal of soil opened up new pathway for water seepage and saturation. The heavy discharge in flowing higher order stream during rainfall resulted in scouring and toe cutting of hillslope by nala erosion at toe part of hillslope that destabilized the slope due to over water saturation and reduced cohesive strength of the soil and highly weathered rock. The low height retaining wall with weep holes are required at footslope to minimise toe erosion by flowing nala. The area is demarcated as unstable zone susceptible to slope failure during rainfall. |

| 37 | Remedial measures | : | Lined drainage at footslope is required to avoid toe erosion and slope saturation. |

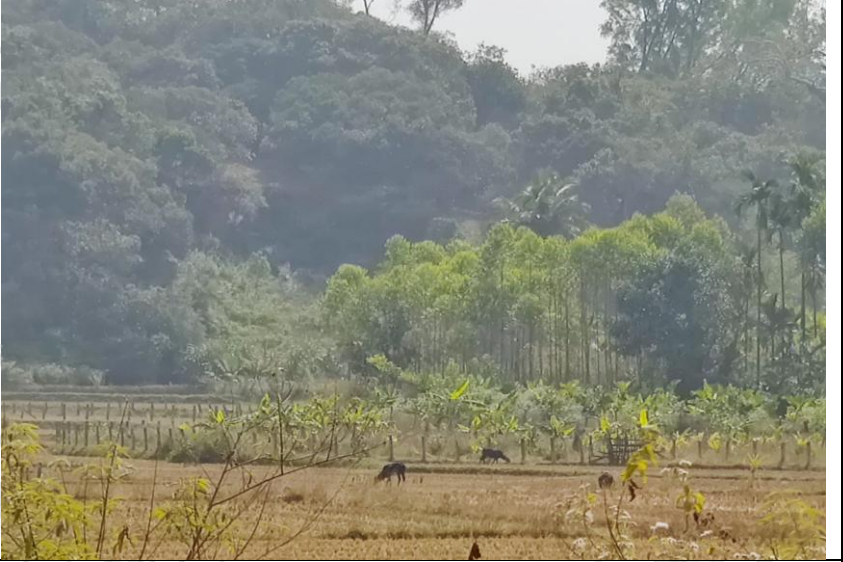
| 36 | Geo-scientific Causes | : | The slope failure occurred due to increased infiltration and nala erosion at toe part that destabilized the slope during heavy rainfall. |
| 38 | Remarks, if any | : | The area is demarcated as unstable zone susceptible to slope failure during rainfall. |
| 40 | Summary/Abstract | : | The debris slide occurred due to unscientific way of removal of soil opens up new pathway for water seepage and slope saturation. The heavy discharge in flowing higher order stream during rainfall resulted in scouring and toe cutting of hillslope by nala erosion at toe part of hillslope that destabilizes the slope due to over water saturation and reduction in cohesive strength of the soil and highly weathered rock. The slope forming material consists of in-situ soil and weathered rock with average overburden thickness of >10m. The area is demarcated as unstable zone susceptible to slope failure during rainfall. |

| 37 | Remedial measures | : | Lined drainage with weep holes are required at footslope to minimise toe erosion. |

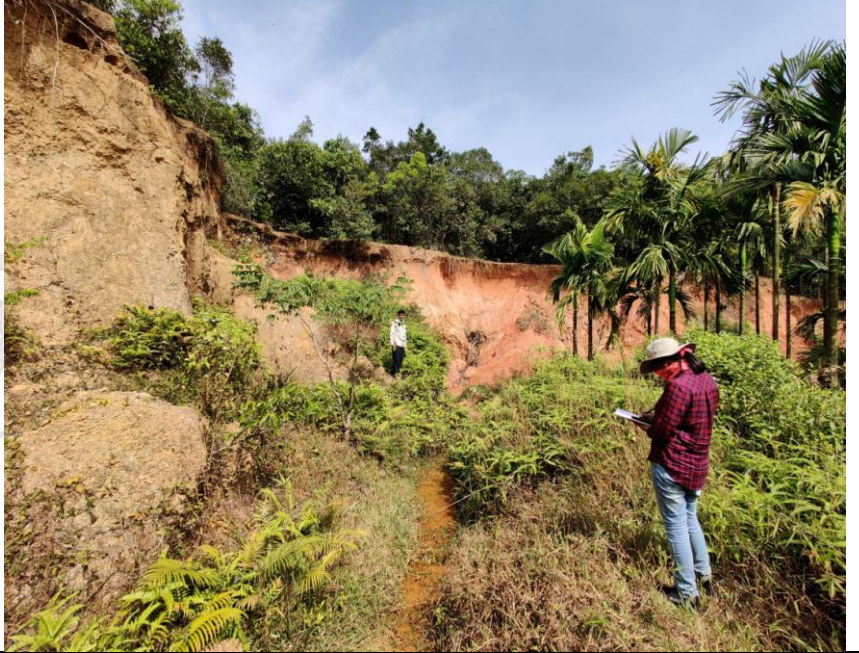
| No | Field | | Description |
|---|---|---|---|
| 36 | Geo-scientific Causes | : | The unscientific way of removal of soil for widening of agricultural land. The vertical cut opened up new pathway for water seepage and saturation. The heavy discharge in flowing higher order stream during rainfall resulted in scouring and toe cutting of hillslope by nala erosion at toe part of hillslope that destabilized the slope due to over water saturation and reduced cohesive strength of the soil and highly weathered rock. |
| 38 | Remarks, if any | | The area is demarcated as unstable zone susceptible to slope failure during rainfall. |

| 40 | Summary/Abstract | : | The debris slide occurred due to removal of soil for widening of agricultural land. The vertical cut opened up new pathway for water seepage and saturation. The heavy discharge in flowing higher order stream during rainfall resulted in scouring and toe cutting of hillslope by nala erosion at toe part of hillslope that destabilized the slope due to over water saturation and reduced the cohesive strength of the soil and highly weathered rock. Lined drainage and low height retaining wall with weep holes are required at footslope to minimise toe erosion by flowing nala. The area is demarcated as unstable zone susceptible to slope failure during rainfall. |

| No | Field | | Description |
|---|---|---|---|
| 37 | Remedial measures | : | Lined drainage and low height retaining wall with weep holes are required at footslope to minimise toe erosion by flowing nala. |

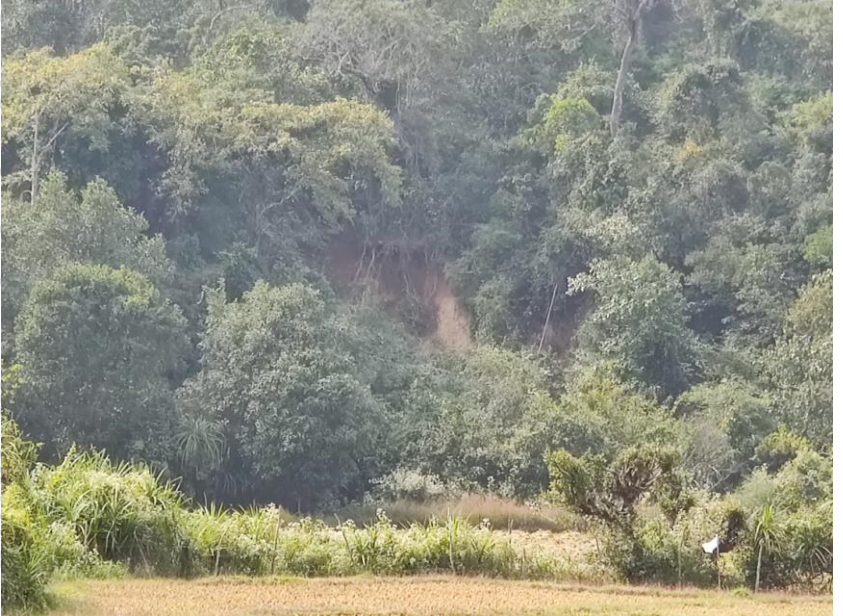
| 36 | Geo-scientific Causes | : | The heavy discharge in flowing higher order stream during rainfall resulted in scouring and toe cutting of hillslope by nala erosion at toe part of hillslope that destabilized the slope due to over water saturation and reduced cohesive strength of the soil. |
| 38 | Remarks, if any | : | The area is demarcated as unstable zone susceptible to slope failure during rainfall. |
| 40 | Summary/Abstract | : | The debris slide occurred on lowly dissected hillslope with thick vegetation cover. The heavy discharge in flowing higher order stream during rainfall resulted in scouring and toe cutting of hillslope by nala erosion at toe part of hillslope that destabilized the slope due to over water saturation and reduction in cohesive strength of the soil. Lined drainage is required at footslope to |

| | | | minimise toe erosion. The area is demarcated as unstable zone susceptible to slope failure during rainfall. |

| 37 | Remedial measures | : | Lined draiange are required at footslope to minimise toe erosion. |

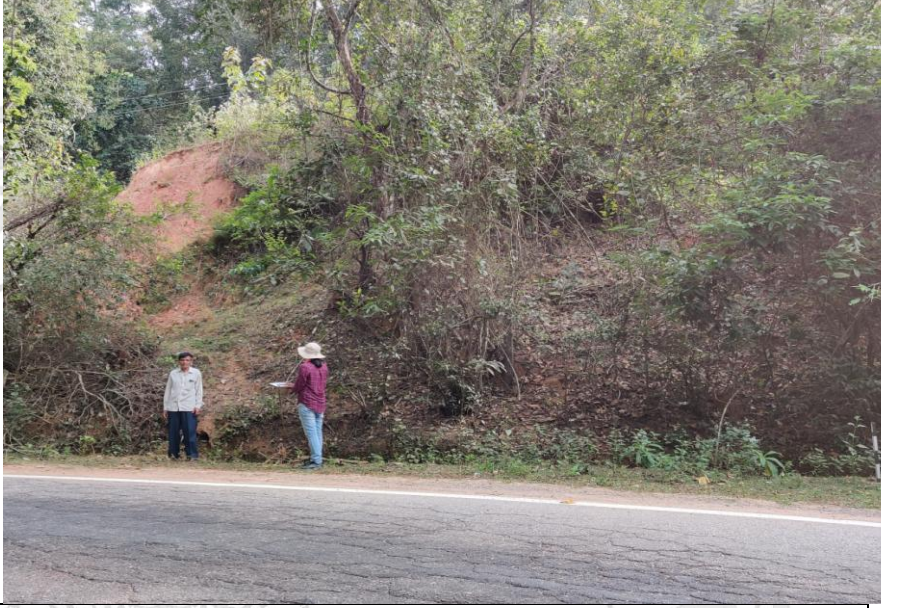
| No | Field | | Description |
|---|---|---|---|
| 36 | Geo-scientific Causes | : | The vertical road cut transformed the hillslope that paved the new pathway for water infiltration and saturation in highly weathered rock and soil leading to reduced cohesive and shear strength of the slope forming material. |

| 38 | Remarks, if any | : | The area is demarcated as unstable zone susceptible to slope failure during rainfall. |
| 40 | Summary/Abstract | : | The vertical road cut transformed the hillslope that paved the new pathway for water infiltration and saturation in highly weathered rock and soil lead to reduced cohesive and shear strength of the slope forming material. The low height retaining wall with weep holes and lined drainage are required at foot slope to minimise toe erosion. The slope forming material consists of in-situ soil and weathered rock with average overburden thickness of >10m. The cracks on convex curvature of the road are observed. The area is demarcated as unstable zone susceptible to slope failure during rainfall. |

| 37 | Remedial measures | : | The low height retaining wall with weep holes and lined drainage are required at foot slope to minimise toe erosion. |

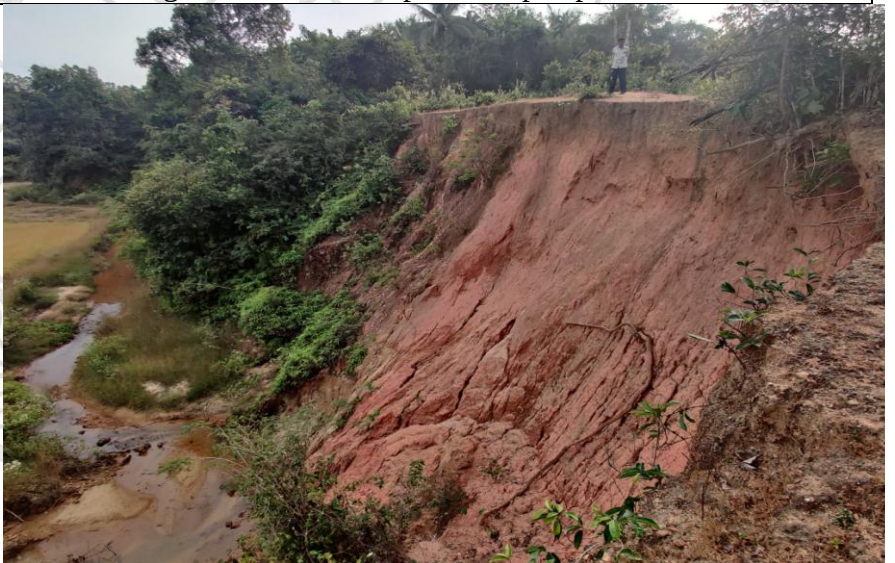
| 36 | Geo-scientific Causes | : | The stream/nala erosion and undercutting or scouring at toe part of hillslope destabilized the slope due to over water saturation that reduced the cohesive and shear strength of the slope forming material during heavy rainfall. |
| 38 | Remarks, if any | : | The area is demarcated as unstable zone susceptible to slope failure during rainfall. Electric pole on upslope is at risk. |
| 40 | Summary/Abstract | : | The shallow translational debris slide observed South of Kalgudge village area on lowly dissected slope with sparse vegetation/open scrub land in vicinity of agriculture land. In present scenario the landslide zone is active, widening and enlarging in nature. The |

| | | | landslide zone is ~95m wide with overburden thickness of ~16m. The crown cracks were also visible. The toe erosion by meandering concave curves of 2 <sup>nd</sup> order perennial stream resulted in slope failure due to increased pore water pressure and reduced cohesive and shear strength failure during heavy rainfall. Crown cracks are also visible. The low height retaining wall and lined drainage with weep holes are required at footslope to minimise toe erosion. The slope forming material consists of in-situ soil and weathered rock with average overburden thickness of >10m. The area is demarcated as unstable zone susceptible to slope failure during rainfall. |

| 37 | Remedial measures | : | The low height retaining wall and lined drainage with weep holes are required at footslope to minimise toe erosion. Easing of slope required. |

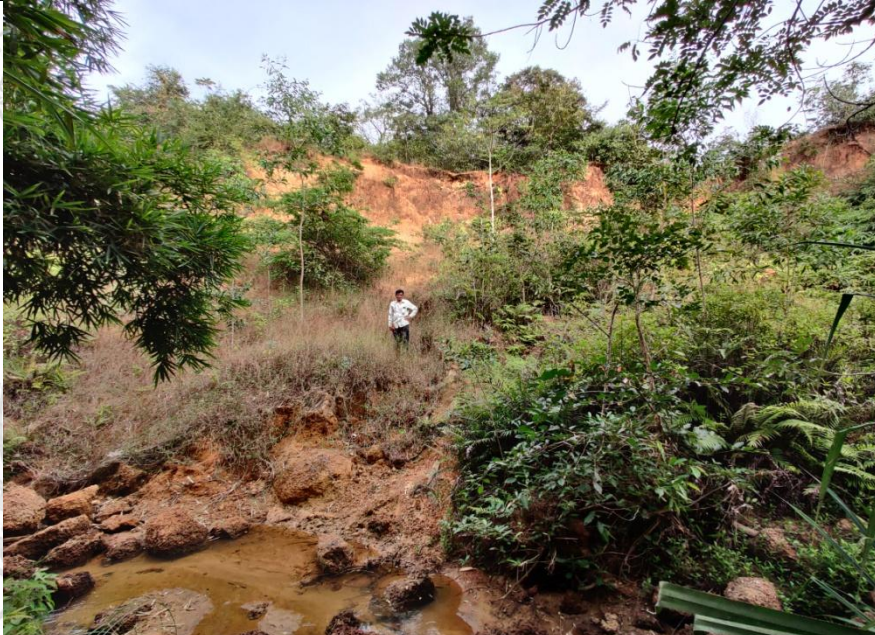
| 36 | Geo-scientific Causes | : | The water seepage and saturation at road bench level on upslope initiated the slope failure and further aggravated by toe erosion by higher order (2 <sup>nd</sup> order) stream channel flowing at footslope. The removal of soil for areacanut plantation further contributed in slope instability due to cohesive and shear strength failure during heavy rainfall. |
| 38 | Remarks, if any | : | The area is demarcated as unstable zone susceptible to slope failure during rainfall. Road is at high risk. |
| 40 | Summary/Abstract | : | The debris slide occurred on lowly dissected hillslope at road bench level in downslope direction. The water seepage and saturation at road bench level on upslope initiated the slope failure and further aggravated by toe erosion by higher order (2 <sup>nd</sup> order) stream channel flowing at footslope. The removal of soil for areacanut plantation further contributed in slope instability. The lined drainage with weep holes should be constructed at road bench level to avoid water seepage and saturation on slope. Culvert should be designed at road bench level at suitable location to drain the excess water downslope. In current scenario retaining wall with weep holes should be constructed at footslope for toe support in order to avoid road subsidences during heavy rainfall. |

| 37 | Remedial measures | : | The lined drainage with weep holes should be constructed at road bench level to avoid water seepage and saturation on slope. And culvert should be designed at road bench level at suitable location to drain the excess water downslope. In current scenario retaining wall with weep holes should be constructed at footslope for toe support in order to avoid road subsidences during heavy rainfall. |

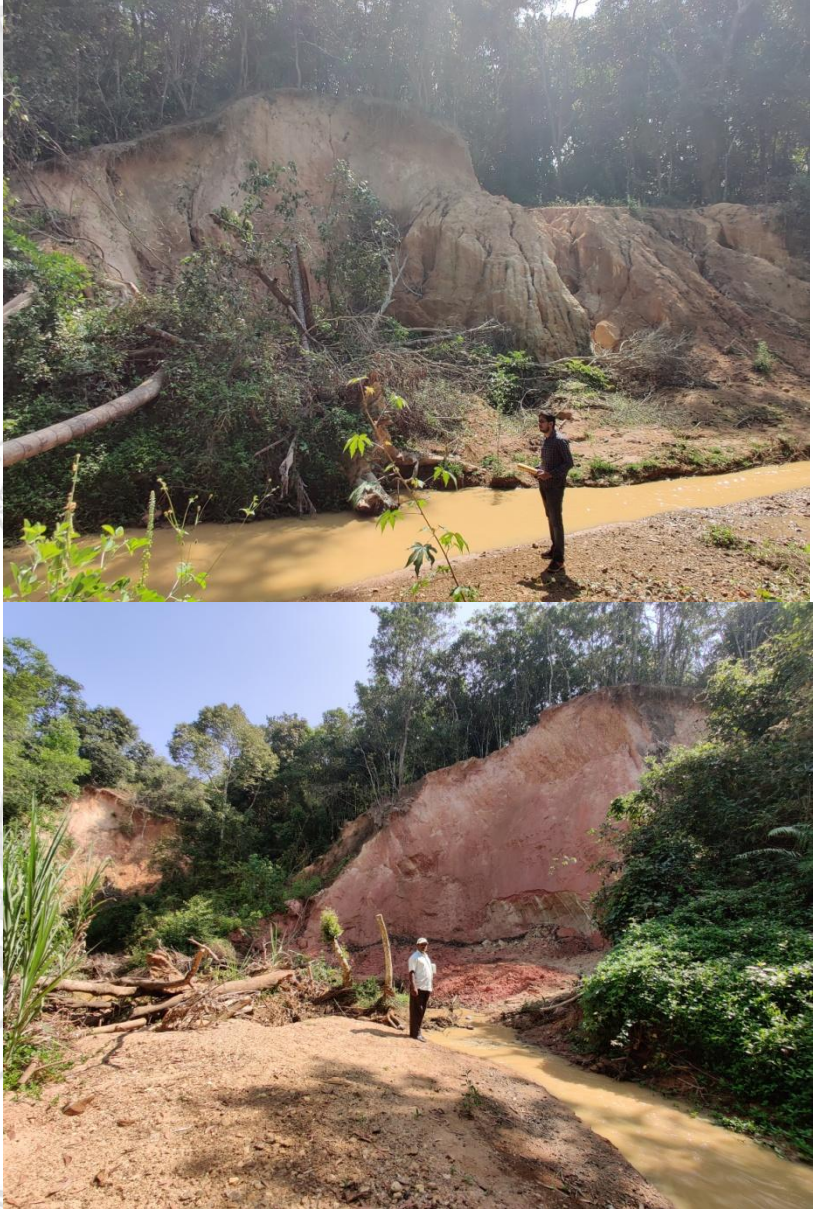
| No | Field | | Description |
|---|---|---|---|
| 36 | Geo-scientific Causes | : | The increased infiltration and nala erosion at toe part that |

| | | | destabilized the slope due to over water saturation that resulted in cohesive and shear strength failure triggered during heavy rainfall. |
| 38 | Remarks, if any | | The area is demarcated as unstable zone susceptible to slope failure during rainfall. |
| 40 | Summary/Abstract | : | The debris slide occurred on lowly dissected hillslope due to removal of soil for arecanut plantation that destabilised the slope. The stream/nala erosion and undercutting or scouring at toe part of hillslope further contributed in slope destabilization due to over water saturation resulted in cohesive and shear strength failure during heavy rainfall. The retaining wall and lined drainage with weep holes are required at footslope to minimise toe erosion. The area is demarcated as unstable zone susceptible to slope failure during rainfall. |

| 37 | Remedial measures | : | Easing of slope, lined drainage and breast wall with weep holes are required at footslope to minimise toe erosion and toe cutting by higher 3rd order stream. |

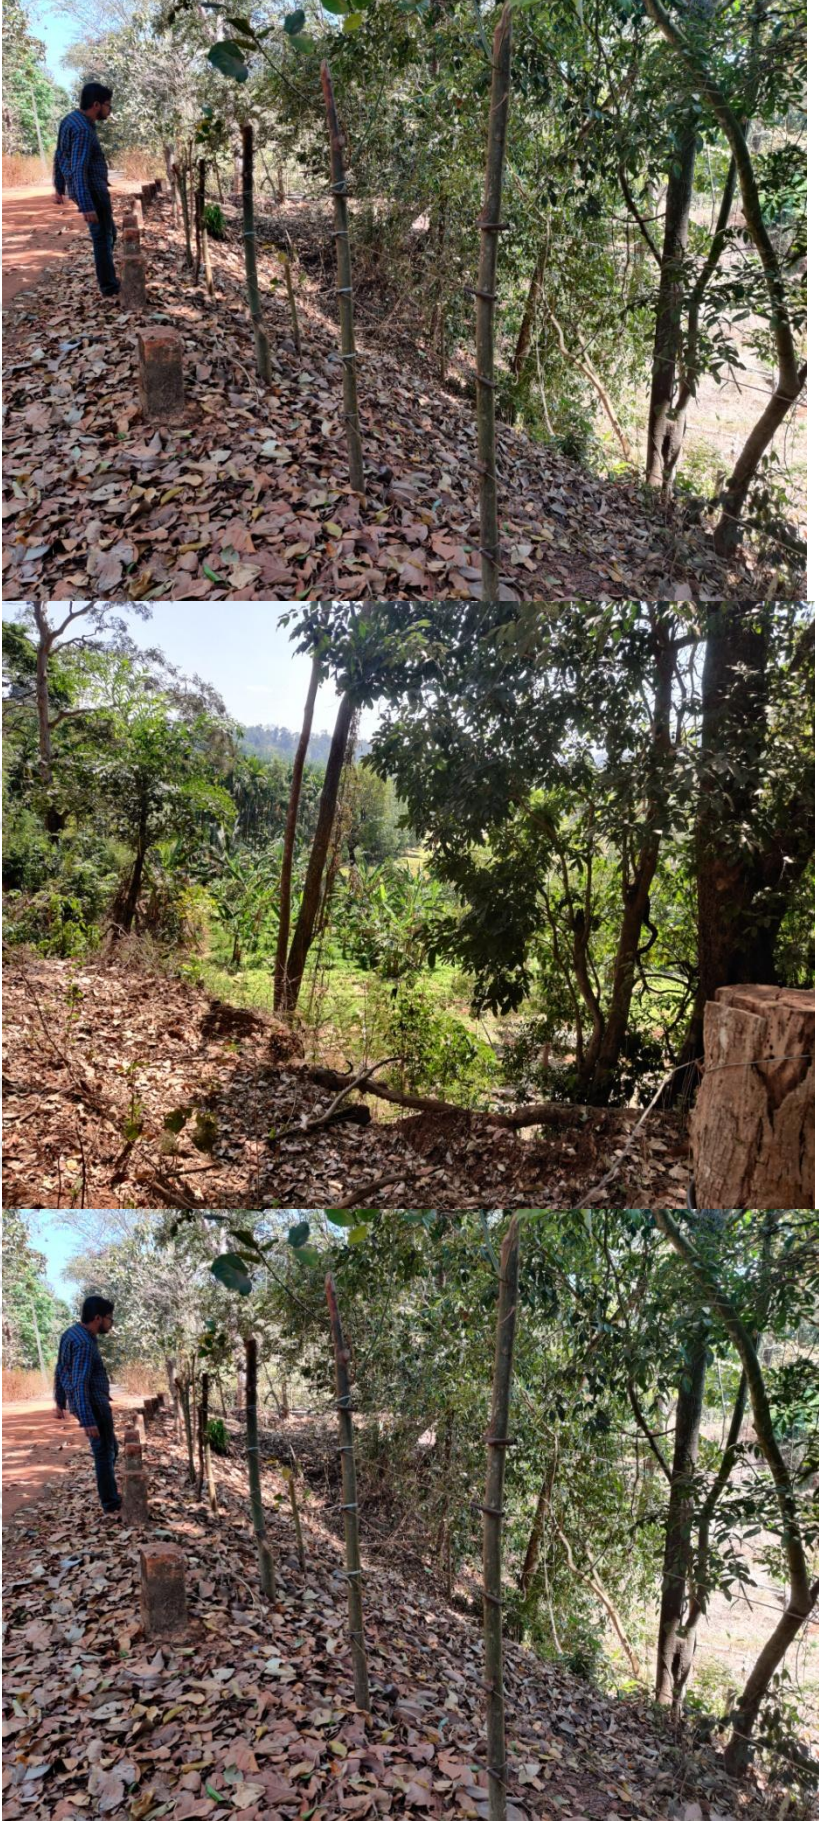
| No | Field | | Description |
|---|---|---|---|
| 36 | Geo-scientific Causes | : | The stream/nala erosion and undercutting or scouring at toe part of hillslope destabilized the slope due to over water saturation that resulted in cohesive and shear strength failure during heavy rainfall. |
| 38 | Remarks, if any | | The area is demarcated as unstable zone susceptible to slope failure during rainfall. |

| 40 | Summary/Abstract | : | <p>The debris slide occurred on lowly dissected hillslope at road bench level in downslope direction where removal of soil for areca nut plantation destabilised the slope. The stream/nala</p> |

| | | | erosion and undercutting or scouring at toe part of hillslope destabilized the slope due to over water saturation resulted in cohesive and shear strength failure of soil during heavy rainfall. The lined drainage and retaining wall with weep holes are required at footslope to minimise toe erosion and provide toe support. The area is demarcated as unstable zone susceptible to slope failure during rainfall. |

| No | Field | | Description |
|---|---|---|---|
| 37 | Remedial measures | : | The low height retaining wall and lined drainage with weep holes are required at footslope to minimise toe erosion. |

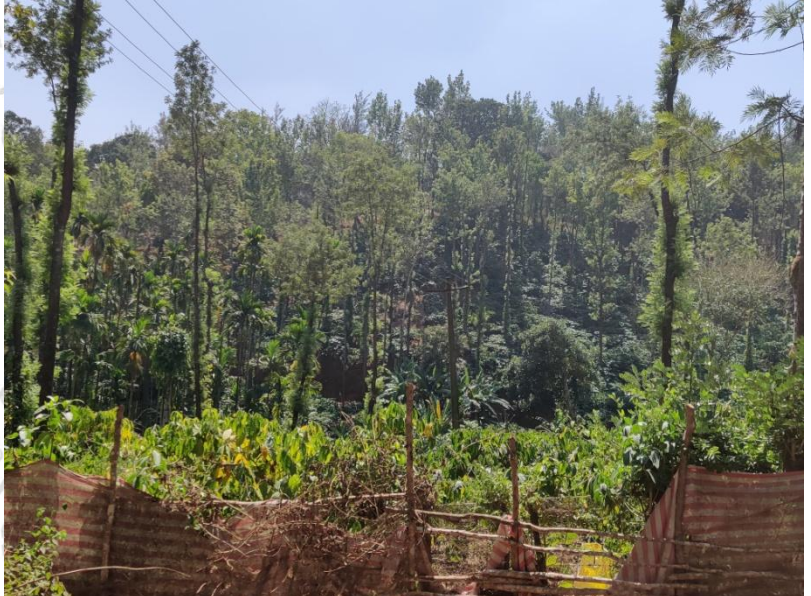
| 36 | Geo-scientific Causes | : | The unscientific way of slope modification for plantation purposes destabilized the slope gradient and provided new pathway for water seepage and saturation. The slope failure resulted due to reduced cohesive and shear strength of the slope forming material. |
| 38 | Remarks, if any | : | The area is demarcated as unstable zone susceptible to slope failure during rainfall. |
| 40 | Summary/Abstract | : | The debris slide occurred on lowly dissected hillslope. The unscientific way of slope modification for plantation purposes destabilized the slope gradient and provided new pathway for water seepage and saturation. The slope failure resulted due to reduced cohesive and shear strength of the slope forming material. Easing of slope is required. The area is demarcated as unstable zone susceptible to slope failure during rainfall. |

| 37 | Remedial measures | : | Easing of slope is required. |

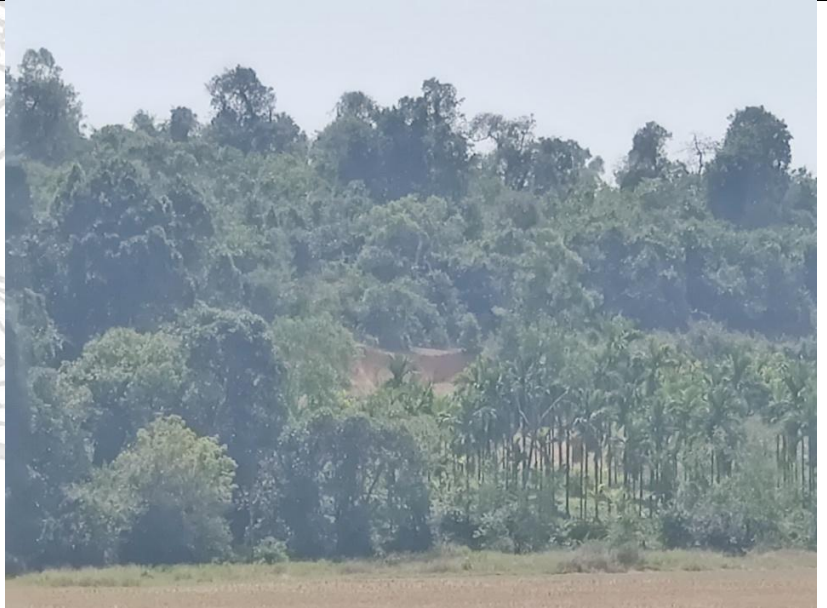
| 36 | Geo-scientific Causes | : | The increased infiltration and nala erosion at toe part destabilized the slope due to over water saturation and increased pore water pressure during intense rainfall. |
| 38 | Remarks, if any | : | The area is demarcated as unstable zone susceptible to slope failure during rainfall. |
| 40 | Summary/Abstract | : | The slope failure occurred on lowly dissected hillslope adjoining agricultural land due to increased infiltration and nala erosion at toe part of hillslope due to over water saturation |

| | | | and increased pore water pressure during heavy rainfall. The slope forming material consists of in-situ soil and weathered rock with average overburden thickness of >10m. Toe erosion along 3 <sup>rd</sup> order nala/stream. Gabbion wall and lined drainage with weep holes are required at footslope to minimise toe erosion and toe cutting by higher 3 <sup>rd</sup> order stream. |

| 37 | Remedial measures | : | Easing of slope and lined drainage are required at footslope to minimise toe erosion and toe cutting by higher 3 <sup>rd</sup> order stream. |
