Macro-scale (1:50,000) Landslide Susceptibility Mapping in parts of Toposheets nos. 48O/2, O/6 Chikmangaluru, Shimoga, Dakshin Kannada districts, Karnataka.

टोपोशीट सं./ Toposheet Nos.: 48O/2, 48O/6

कार्य सत्र 2019-20 का अंतिम प्रतिवेदन  
Final Report for Field Season 2019-20

PROJECT: NLSM / परियोजना: एनएलएसएम

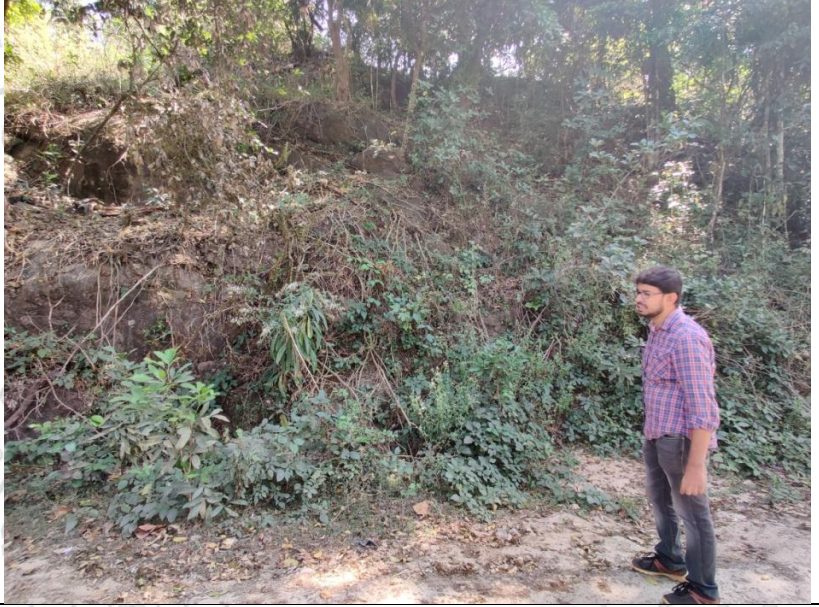
| 38 | Remarks, if any | : | The area is demarcated as unstable zone susceptible to slope failure during rainfall. |
| 40 | Summary/Abstract | : | The slope failure resulted due to weathering and erosion of rocks and increased pore water pressure and slope saturation during heavy rainfall. Lined drainage should be provided at toe part and excess water should be diverted through properly designed culvert at suitable location at road bench level. The area is demarcated as unstable zone susceptible to slope failure during rainfall. |

| 37 | Remedial measures | : | Lined drainage should be provided at toe part and excess water should be diverted through properly designed culvert at suitable location at road bench level. |

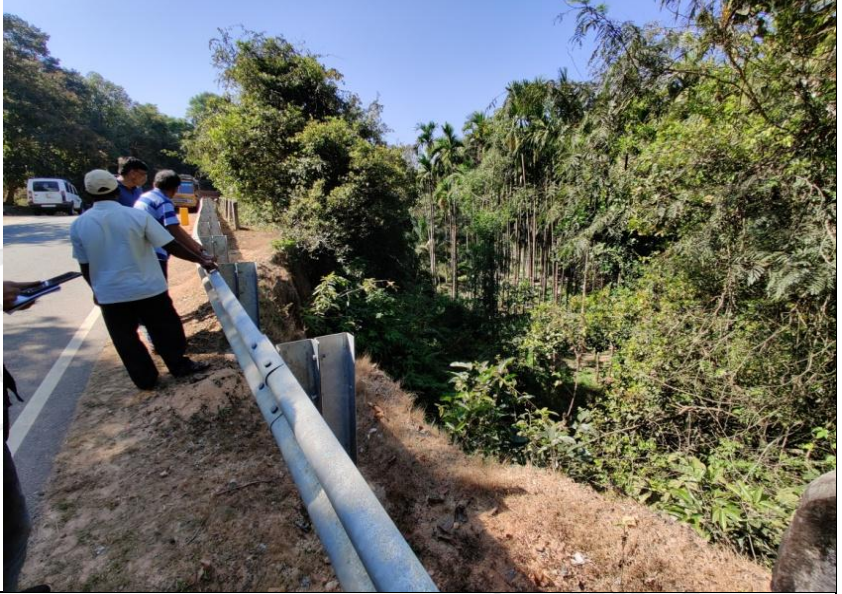
| 38 | Remarks, if any | : | The area is demarcated as unstable zone susceptible to slope failure during rainfall. |

| 40 | Summary/Abstract | : | Modification of slope for plantation provided new pathway for water infiltration and erosion. During heavy rainfall pore water pressure got increased and nala erosion at toe part destabilized the slope during heavy rainfall. Lined drainage and culvert should be designed at proper location to drain excess rain water to minimize the slope saturation downslope. So, retaining wall with weep holes and lined drainage are required at foot slope to minimise toe erosion and toe cutting by higher 3 <sup>rd</sup> order stream and provide toe support to reduce the risk of road collapse. The slope forming material consists of in-situ soil and weathered rock with average overburden thickness of >10m. The area is demarcated as unstable zone susceptible to slope failure during rainfall. |

| 37 | Remedial measures | : | Lined drainage and culvert should be designed at proper location to drain excess rain water to minimize the slope saturation downslope. So, retaining wall with weep holes and lined drainage are required at foot slope to minimise toe erosion and toe cutting by higher 3 <sup>rd</sup> order stream and provide toe support to reduce the risk of road collapse. |

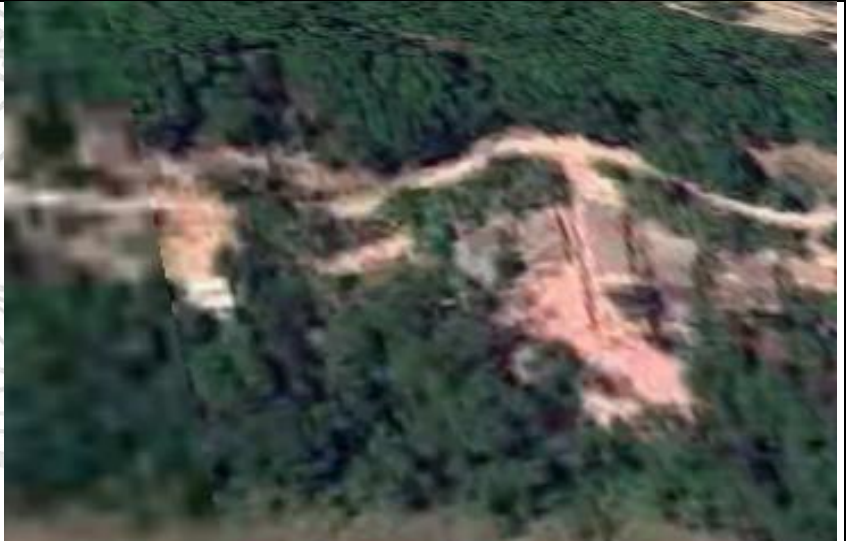
| 36 | Geo-scientific Causes | : | The increased infiltration by household discharge and nala erosion at toe part destabilized the slope due to over water saturation during heavy rainfall. The settlement at top slope add additional mass on the hillslope. Toe erosion along 3 <sup>rd</sup> order nala/stream further contributes in slope instability. |
| 40 | Summary/Abstract | : | At 13°34'19.16"N/75°19'59.73"E Kumbarakoppa village multiple active debris landslides with slope failures are recorded on lowly dissected hillslope. The slope forming material is in-situ soil with overburden thickness of >10m. The settlements on top of the hillslope are at risk. The landslides get triggered by |

| | | | heavy rainfall during monsoon. The drainage at toe part propagates the toe erosion. So, lined drainage at toe part of the slope should be provided to avoid seepage & slope saturation. The slope gradation should be done and appropriate drainage should be provided. |

| 37 | Remedial measures | : | Lined drainage and retaining wall with weep holes are required at footslope to minimise toe erosion and toe cutting by higher 3 <sup>rd</sup> order stream. Discharge of household waste water on the slope should not be done. |

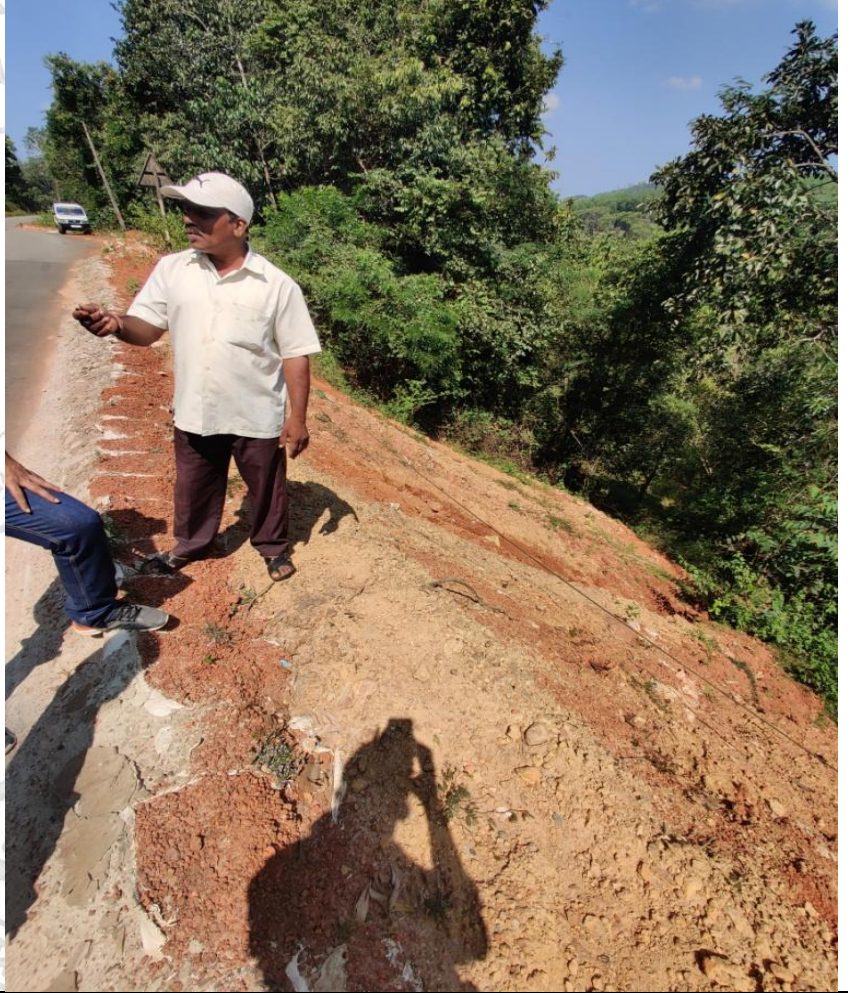
| No | Field | | Description |
|---|---|---|---|
| 36 | Geo-scientific Causes | : | The slope saturation leads to increased infiltration that reduced |

| | | | the shear and cohesive strength of the slope forming material leading to slope failure in downslope direction during heavy rainfall. |
| 40 | Summary/Abstract | : | Subsidence of road was observed due to debris slide at downslope direction at due to improper and ineffective drainage on upslope. The slope stabilization at road bench level is provided using sand bags at successive benches in downslope direction to prevent landslips and ground subsidences as short term remedial measures. The area is demarcated as unstable zone susceptible to slope failure during rainfall. The slope forming material consists of in-situ soil with average overburden thickness of >10m. |

| 37 | Remedial measures | : | Reinforced retaining wall with weep holes are required at road bench level at foot slope to avoid road subsidence and collapse. along important road corridor. |

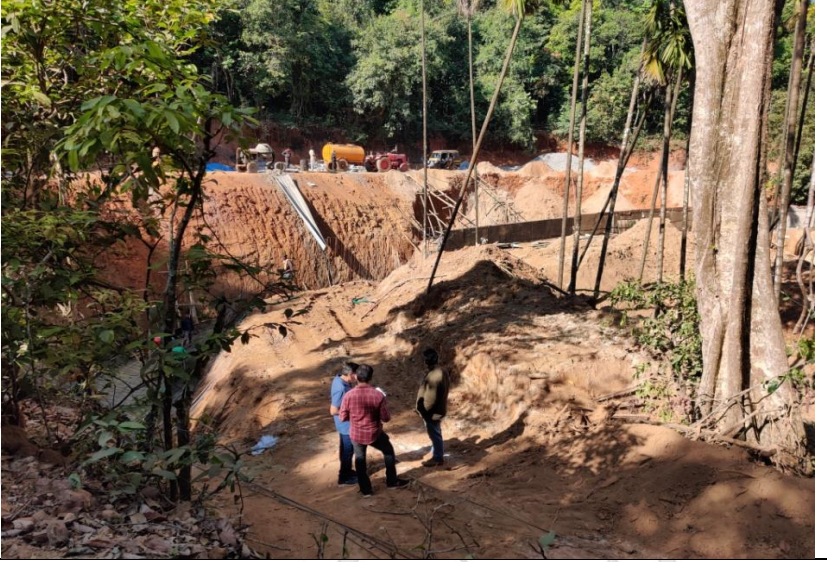
| No | Field | | Description |
|---|---|---|---|
| 36 | Geo-scientific Causes | : | The unscientific way of removal of soil for arecanut plantation destabilized the slope, exposed cut section provides new pathway for water seepage and saturation and 1 <sup>st</sup> order nala/streams further reduced the cohesive and shear strength of slope forming material during heavy rainfall. |

| 40 | Summary/Abstract | : | The shallow translational debris slide observed on lowly dissected slope in downslope direction at convex turn of the road beside arecanut plantation in Kestur village area. The overburden thickness of in-situ soil and weathered granite is >10m. The unscientific way of removal of soil for arecanut plantation destabilized the slope, exposed cut section provided new pathway for water seepage and saturation and 1 <sup>st</sup> order nala/streams further contributed in reduction of cohesive strength of slope forming material. In active landslide zone construction of 75m wide and 4m high with retaining wall with weep holes provided at 3ft interval is on progress to stabilize and restrict road subsidences. |

| No | Field | | Description |
|---|---|---|---|
| 37 | Remedial measures | : | The lined drainage and retaining wall with weep holes are required at footslope to provide toe support. |

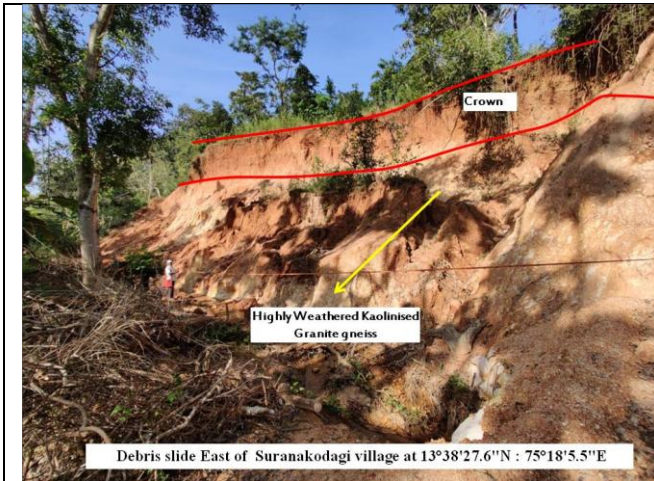
**Photo 1: Debris slide East of Suranakodagi village at  $13^{\circ}38'27.6''\text{N}$  :  $75^{\circ}18'5.5''\text{E}$**

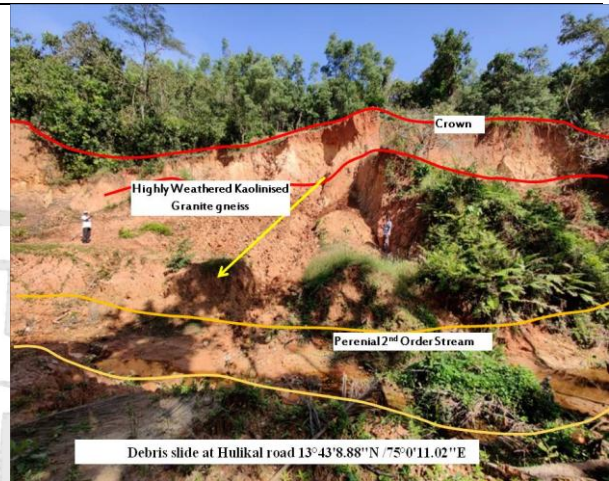
**Photo 2: Debris slide at Hulikal road  $13^{\circ}43'8.88''\text{N}$  /  $75^{\circ}0'11.02''\text{E}$**

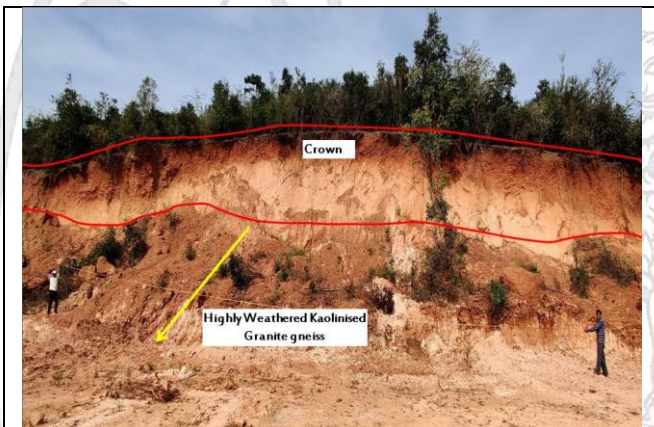
**Photo 3: Hariharpur on NH-169; Debris Slide at  $13^{\circ}41'58.1''\text{N}$ : $75^{\circ}24'11.7''\text{E}$**

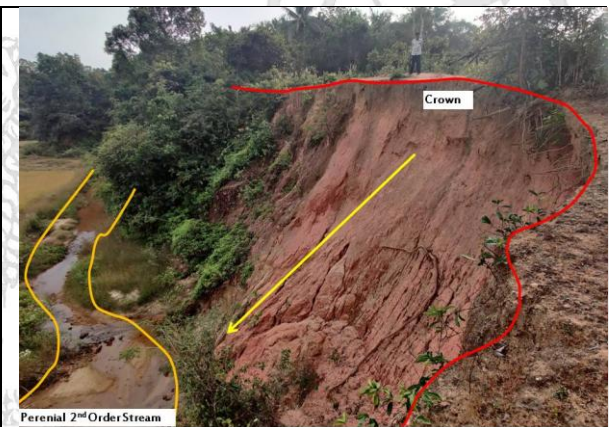
**Photo 4: Debris Slide South of Kalgudge Village/Koppa road at  $13^{\circ}35'48.4''\text{N}$ / $13^{\circ}35'48.4''\text{N}$**

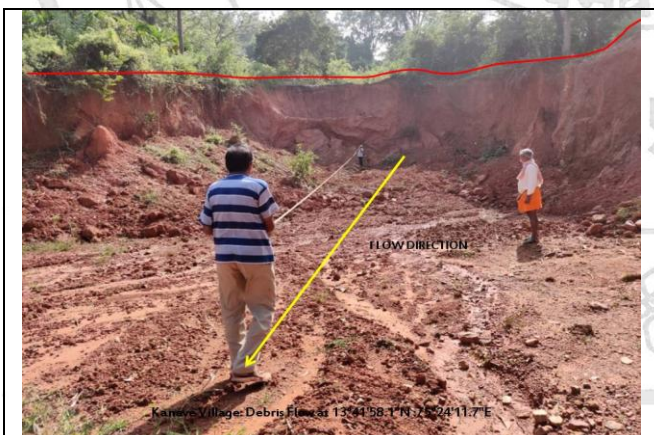
**Photo 5: Kanave Village: Debris Flow at  $13^{\circ}41'58.1''\text{N}$  :  $75^{\circ}24'11.7''\text{E}$**

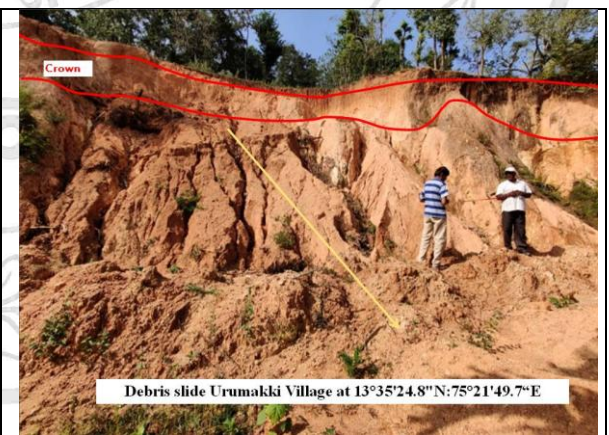
**Photo 6: Debris slide Urumakki Village at  $13^{\circ}35'24.8''\text{N}$ : $75^{\circ}21'49.7''\text{E}$**

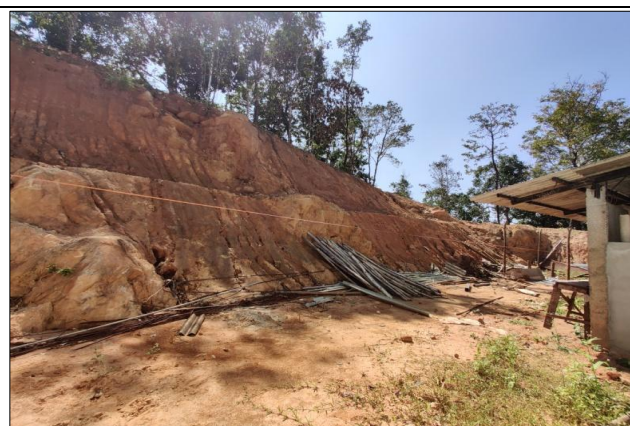
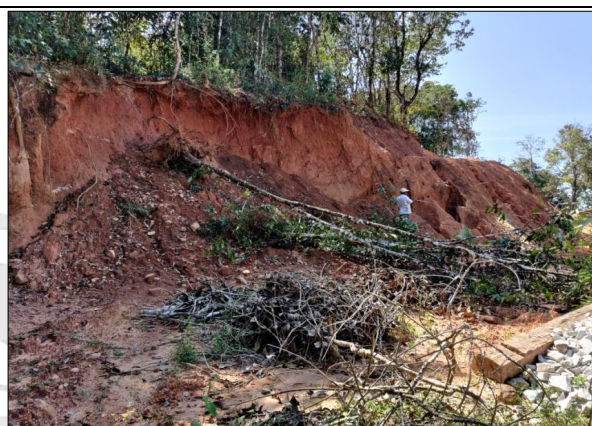
**Photo 7: Extensive Cut Slope failure on lowly dissected hillslope in Ganapatikatte Village of T.S. no. 480/6**

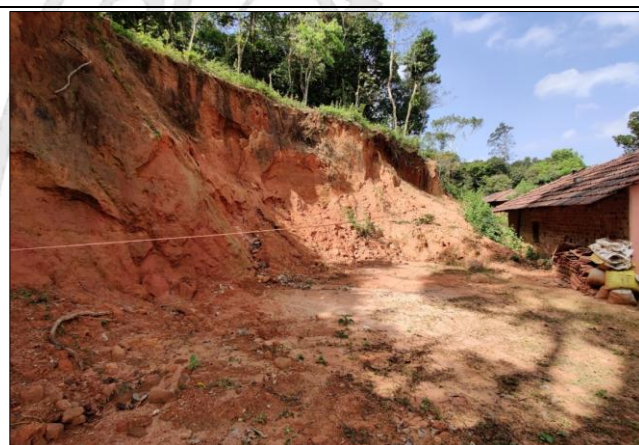
**Photo 8: Settlement on Modified Slope Madagere village of T.S. no. 480/6**

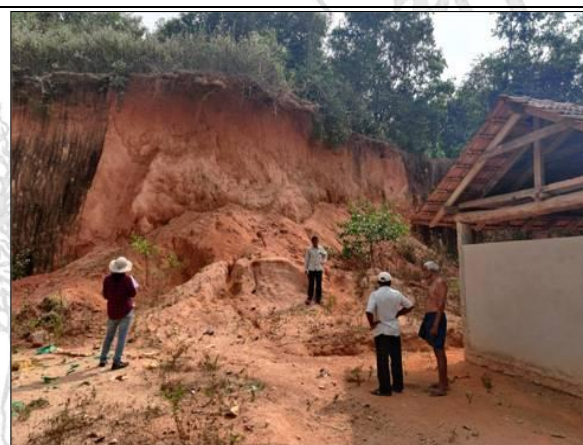
**Photo 9: Settlement on Modified Slope Nagalapur Village of T.S. no. 480/6**

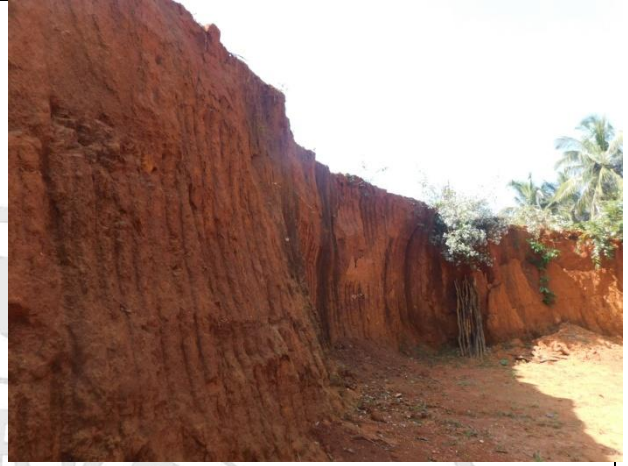
**Photo 13: Soil profile section of Vertical Slope Cut in the study area.**
