MESO-SCALE (1:10,000) LANDSLIDE SUSCEPTIBILITY MAPPING IN SUNKASALE  
AREA, CHIKMAGALUR DISTRICT, KARNATAKA.

Toposheet no. 48O/08

FSP CODE: M4LSSM/NC/SR/SU-KG/2022/42400

कार्य सत्र: 2022-23 का अंतिम प्रतिवेदन  
Final Report for Field Season 2022-2023

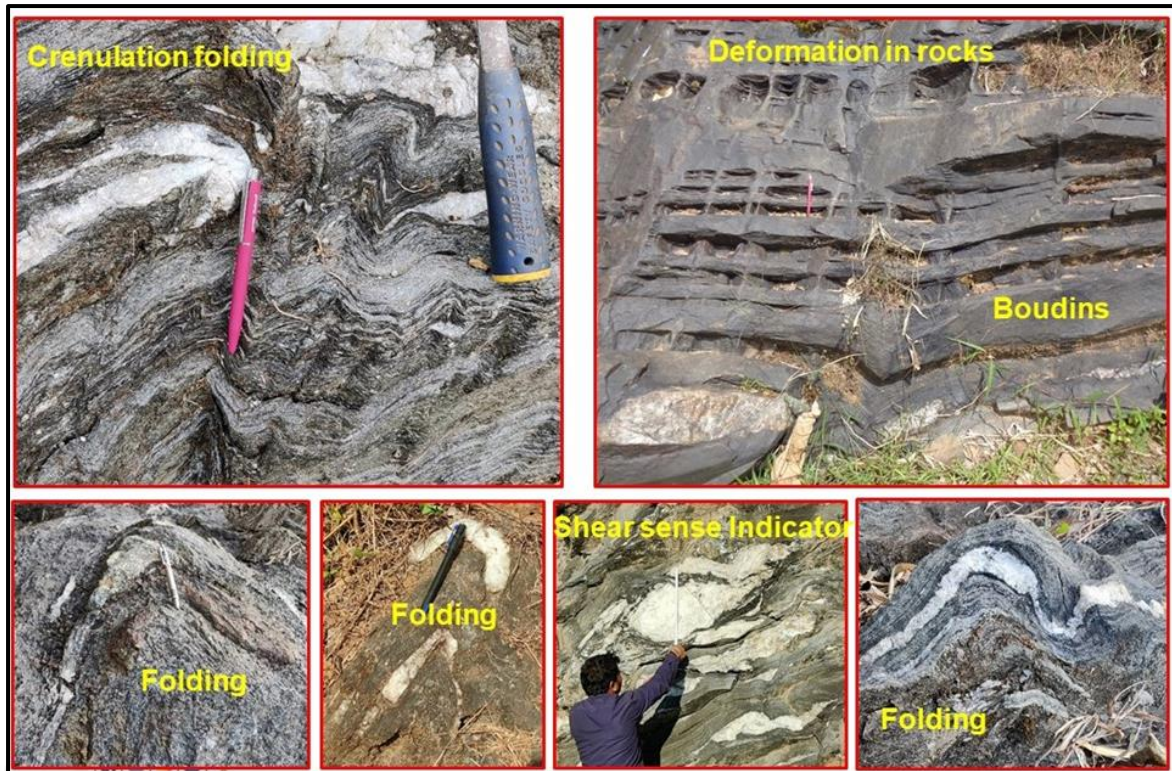
**Photo 1:** Sheared Boudin quartz in Gneissic rock near Balige.

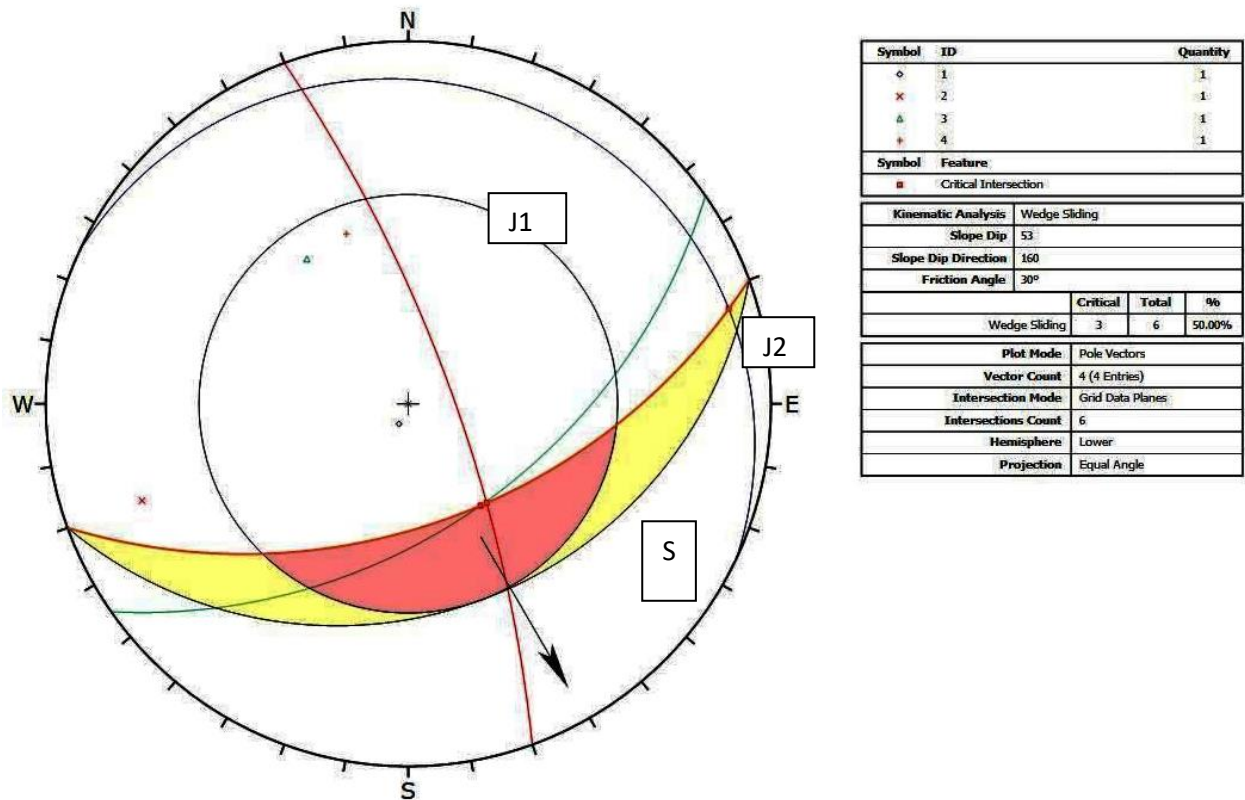
Figure 24: Kinematic analysis near Maidadi

Here the kinematic analysis of the joints with the bedding shows the wedge failure which fails along South East direction. The pink zone shows the critical zone, where failure may happen.

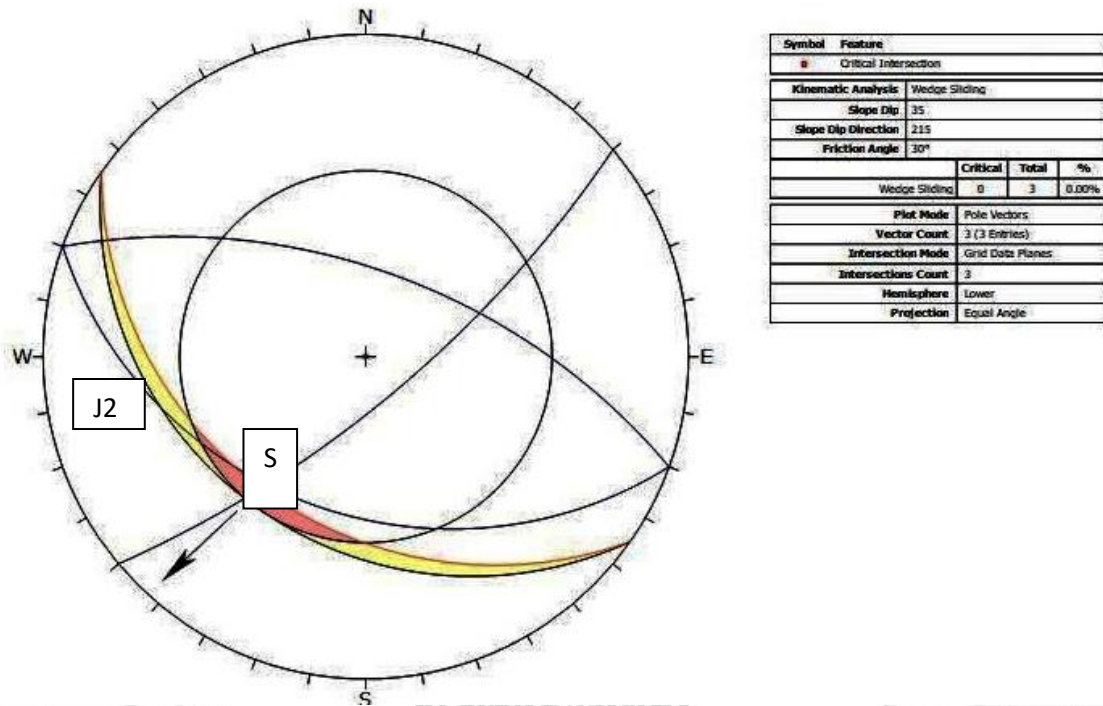
**Figure 25:** Kinematic analysis near Balige

The pink region shows the probable vulnerable zone. Here the kinematic analysis of these spot shows that only planar failure can take place towards SW directions, not a wedge; the plunge of the two joints are steeper than the slope.

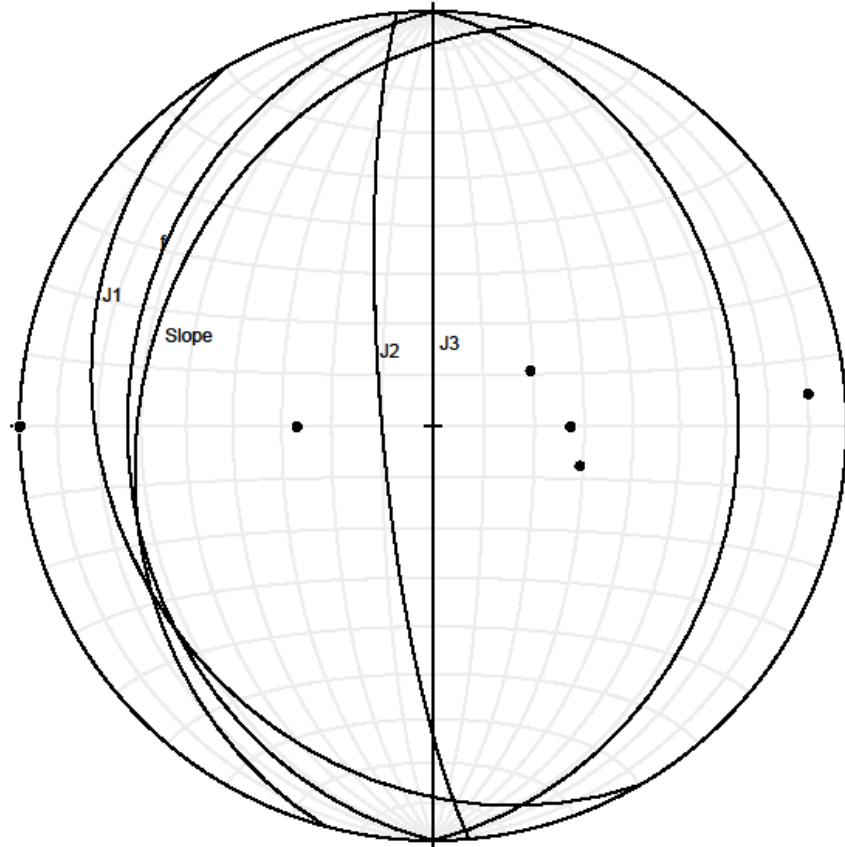
**Fig 26: Kinematic analysis along the NE sector**

The northeastern sector kinematic analysis shows planar failures than the Wedge and Topple failures.

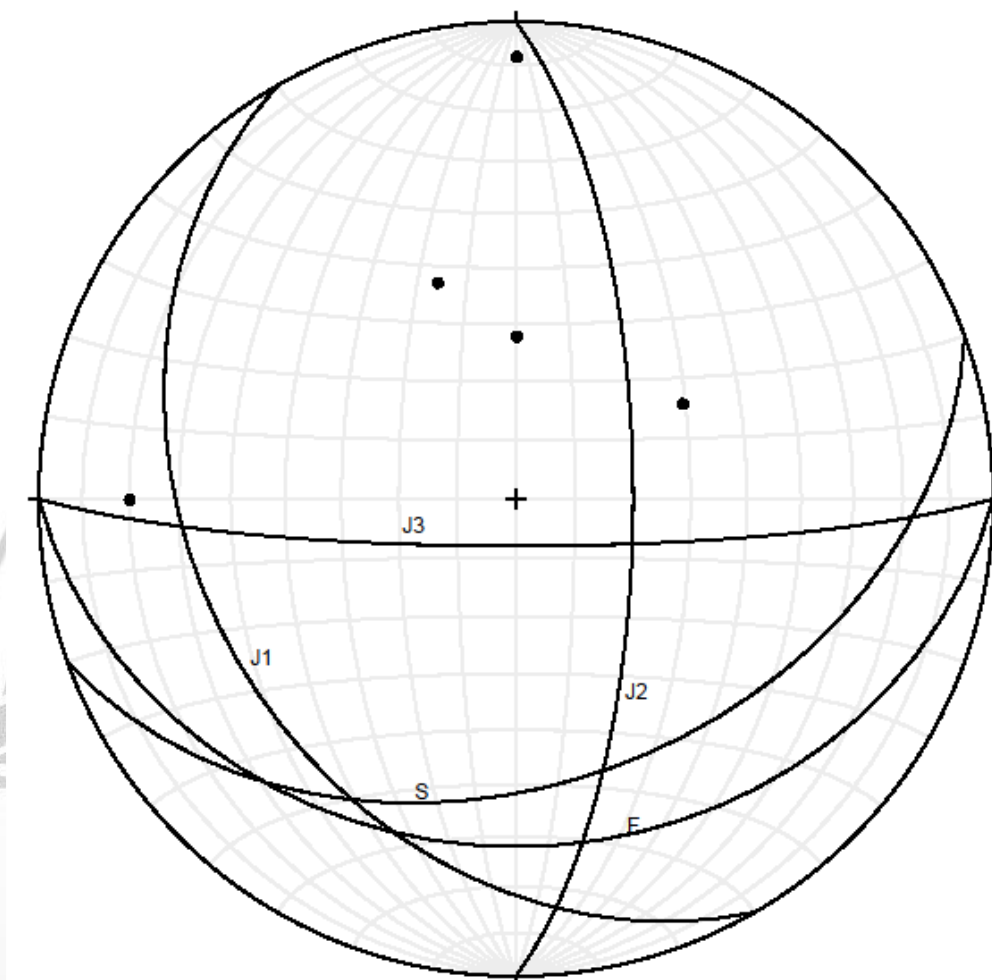
**Fig 27: Kinematic analysis along the Northern sector**

The northern sector also shows planar failures

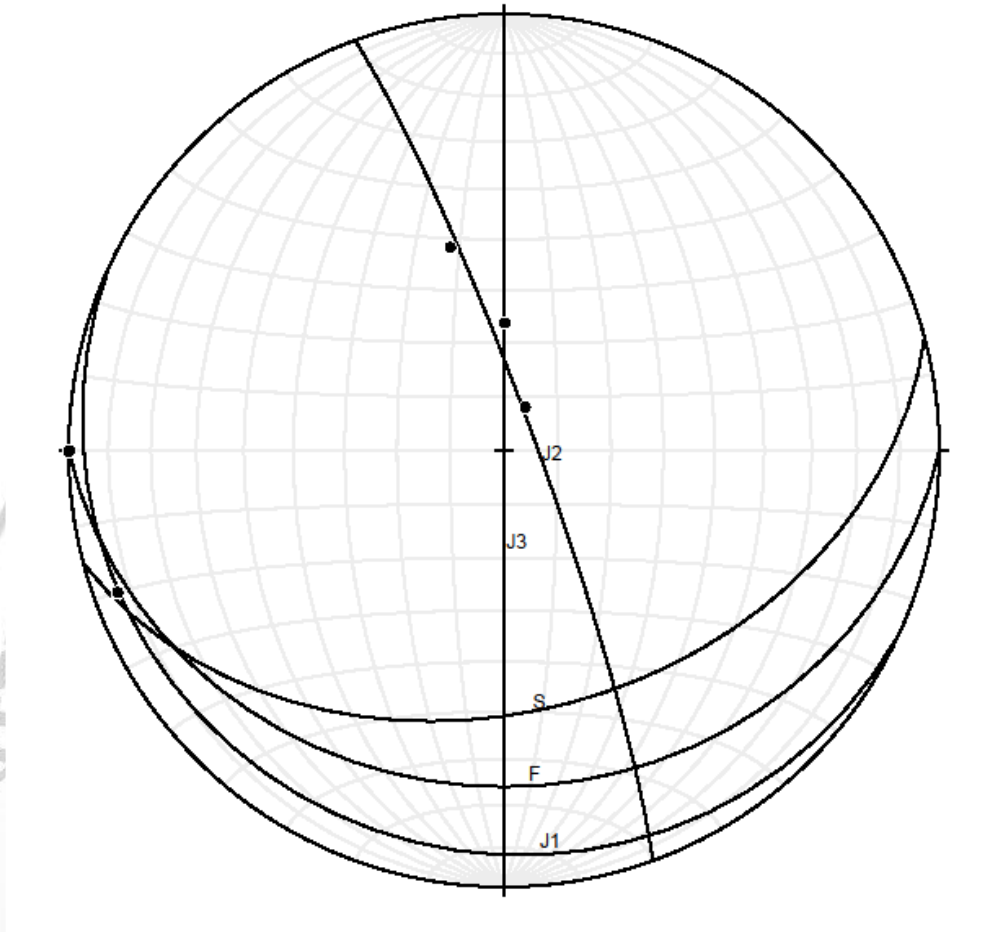
**Fig 28:** Kinematic analysis along the South eastern sector  
South eastern sector shows topple failures instead of planar failures.

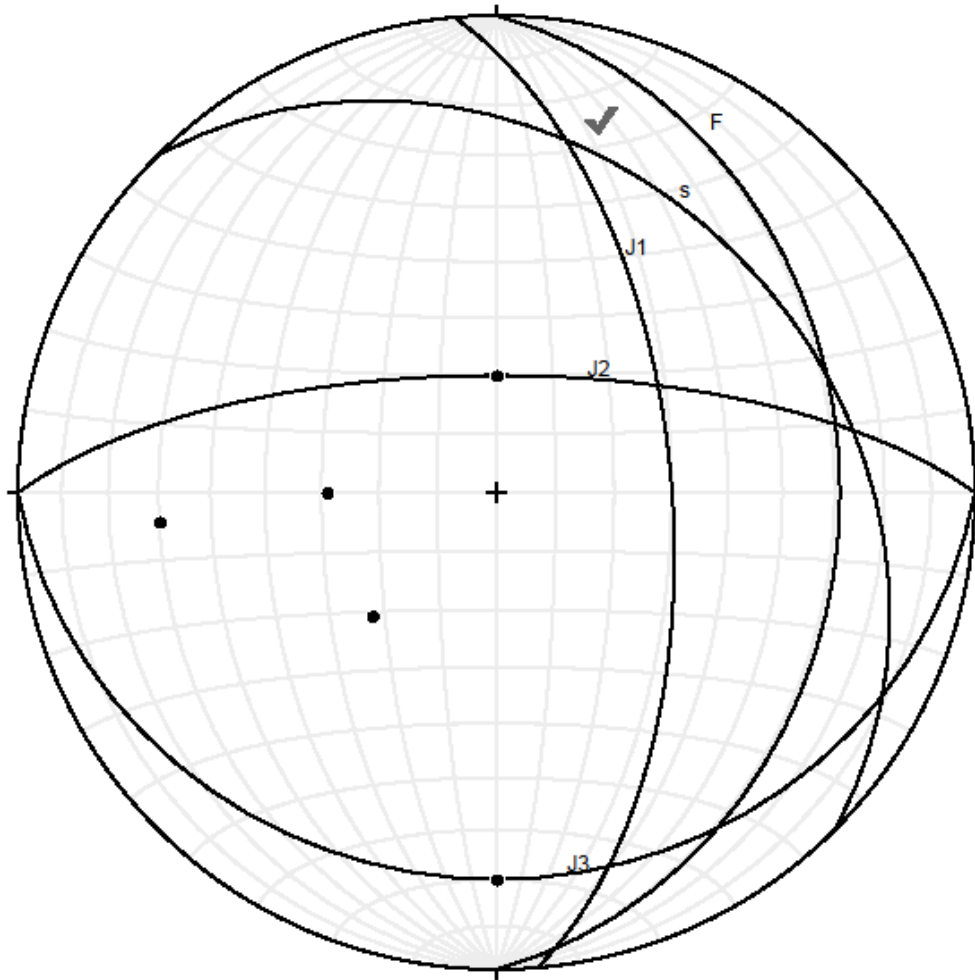
**Fig 29: Kinematic analysis along the Southern sector**

The southern sector displays planar failure

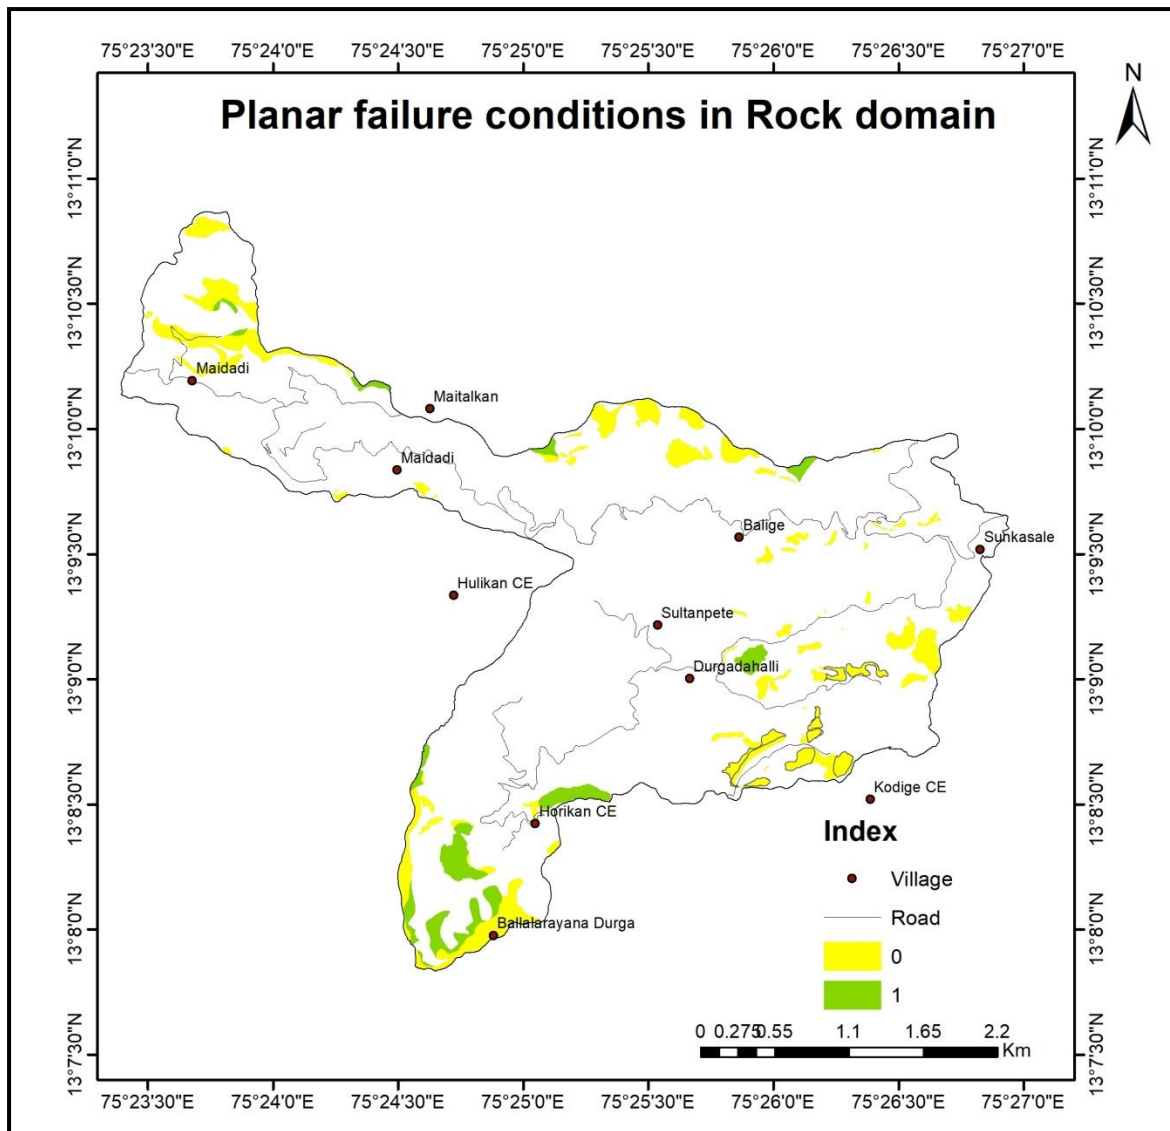
**Figure 30:** Planar failure conditions in the Rock Domain

As 0 in the index value indicates no failure and 1 indicates the above-said condition failure i.e. planar failure.

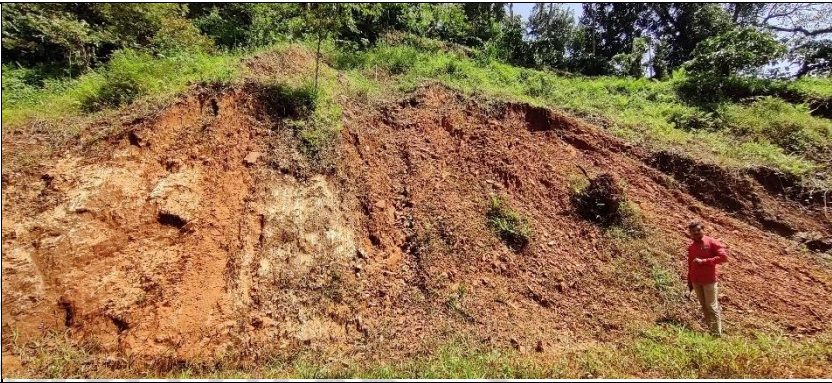
| No | Field | Description |
|---|---|---|
| 22 | Failure mechanism | Shallow planar failure |

| 40 | Summary/Abstract | Extensive cut slope has been made for road construction without proper remedy. Due to extensive rainfall as a triggering factor material moved towards downside. |

| No | Field | Description |
|---|---|---|
| 37 | Remedial measures | Slope easing & deep root plantation required, remove the debris materials from the slope. |

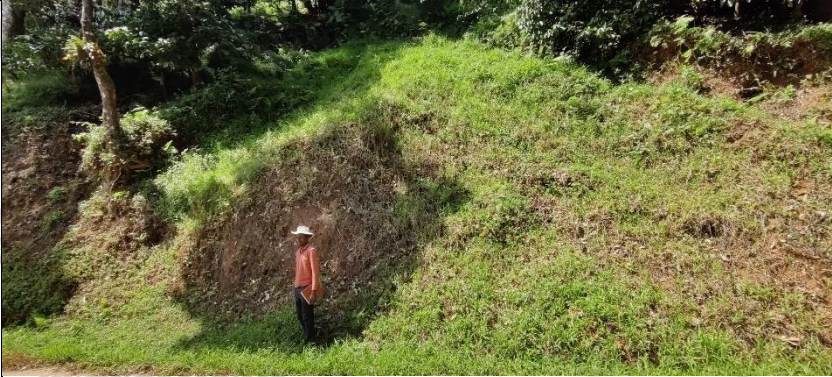
| No | Field | Description |
|---|---|---|
| 22 | Failure mechanism | Shallow planar failure |

| 38 | Remarks, if any | At down slope a retaining wall has constructed for toe support after 2019 landslide event in this area. |
| 40 | Summary/Abstract | Due to Anthropogenic activities like unplanned cutting of slope causes planar failure triggered by rain. Slope grading, at down slope deep root plantation are required and retaining structure are suggested. Soil piping have also observed. At down slope a retaining wall has already constructed for toe support after 2019 landslide event in this area. |

| 37 | Remedial measures | Slope grading, at down slope deep root plantation are required and retaining structure are suggested. |

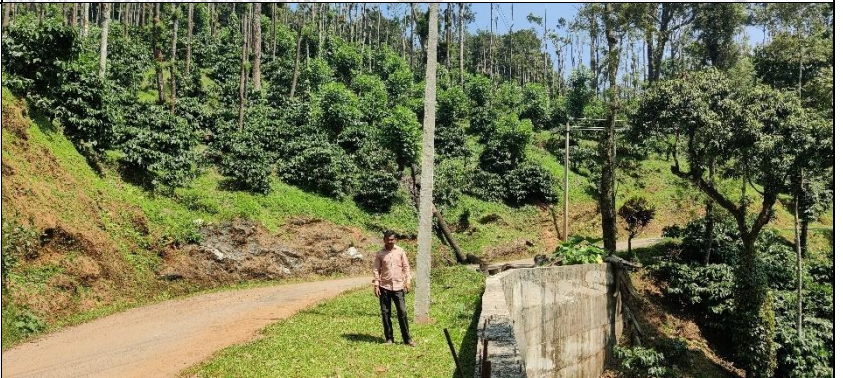
| 40 | Summary/Abstract | Retaining wall has already constructed for toe support after 2019 landslide event in this area. |

| 37 | Remedial measures | Retaining structure has suggested |

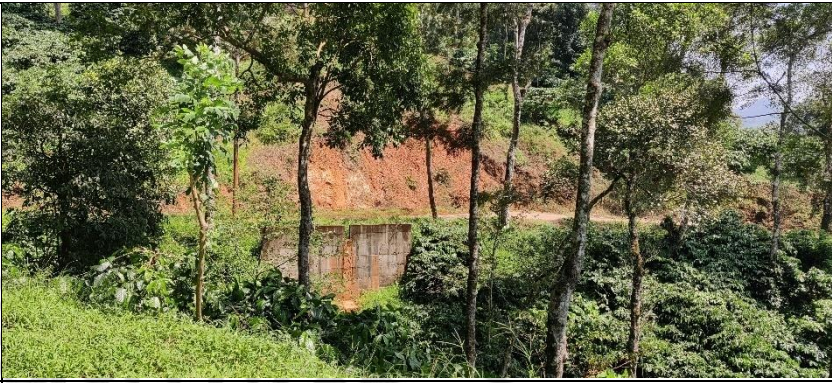
| 22 | Failure mechanism | Deep planar failure |
| 36 | Geo-scientific Causes | Increasing of Pore water pressure and reduction of strength on supersaturation, Anthropogenic activities which is unplanned cutting of slope. |

| 40 | Summary/Abstract | Due to increasing of Pore water pressure and reduction of strength on supersaturation, Anthropogenic activities which is unplanned cutting of slope. At upslope side slope easing & benching should be done and retaining structure are also required. A retaining wall (20 m length) has constructed after 2019 landslide incidence. |

| 37 | Remedial measures | At upslope side slope easing & benching should be done and retaining structure are also required. |

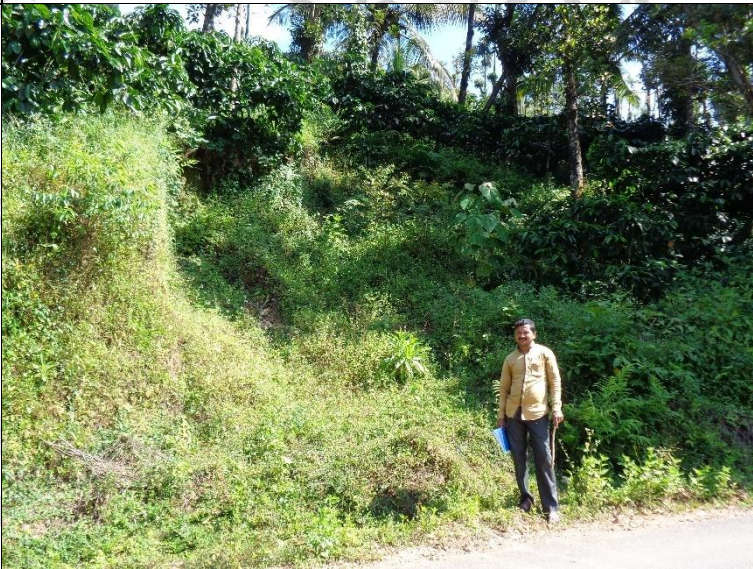
| No | Field | Description |
|---|---|---|
| 22 | Failure mechanism | Shallow planar failure |

| 36 | Geo-scientific Causes | Anthropogenic activities which is unplanned cutting of slope. |
| 40 | Summary/Abstract | Due to increasing of pore water pressure and reduction of strength on supersaturation, anthropogenic activities which is unplanned cutting of slope. |

| 37 | Remedial measures | Slope easing and deep root plantations are suggested |

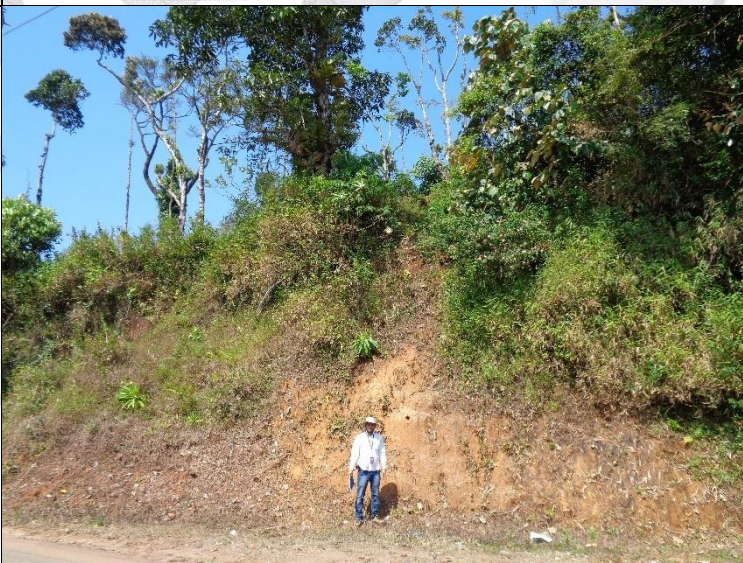
| 22 | Failure mechanism | Shallow planar |
| 36 | Geo-scientific Causes | Planar failure due to Anthropogenic activities which is unplanned cutting of slope. |
| 40 | Summary/Abstract | Planar failure due to anthropogenic activities which is unplanned cutting of slope. Slope grading and line drainage are required. |

| 37 | Remedial measures | Slope grading and line drainage are required. |

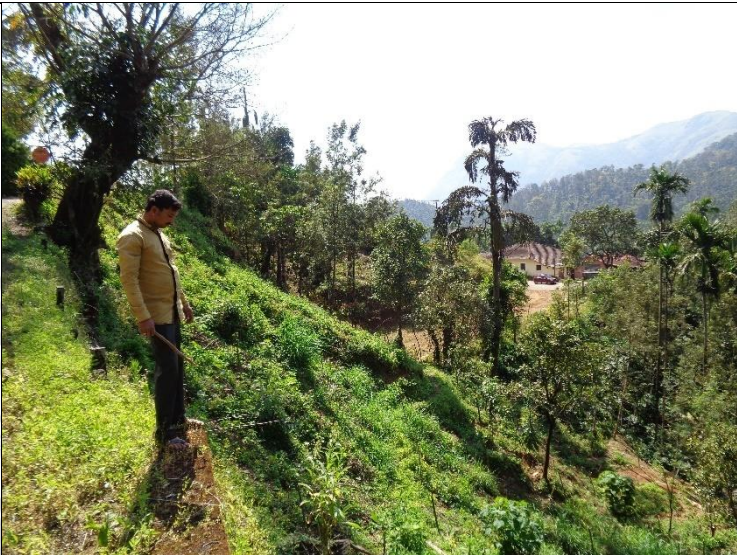
| No | Field | Description |
|---|---|---|
| 22 | Failure mechanism | Shallow rotational failure |
| 33 | Communication | Road connecting Balige was damaged. |
| 36 | Geo-scientific Causes | Increasing of Pore water pressure and reduction of strength on supersaturation, Anthropogenic activities which is unplanned cutting of slope. |

| 40 | Summary/Abstract | Increasing of Pore water pressure and reduction of strength on supersaturation, Anthropogenic activities which is unplanned cutting of slope. During 2019 event Retaining wall has constructed at down slope. At downside slope plantation is required. |

| No | Field | Description |
|---|---|---|
| 37 | Remedial measures | During 2019 event Retaining wall has constructed at down slope. |
| 38 | Remarks, if any | At downside slope plantation is required. |

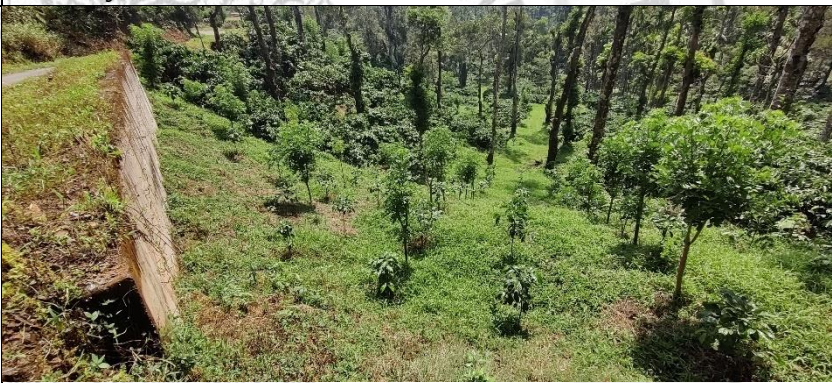
| No | Field | Description |
|---|---|---|
| 22 | Failure mechanism | Shallow Planar failure |

| 36 | Geo-scientific Causes | Planar failure, Anthropogenic activities which is unplanned cutting of slope. |
| 40 | Summary/Abstract | Planar failure, Anthropogenic activities which is unplanned cutting of slope. During 2019 event road was damaged and Retaining wall has constructed at down slope. Presently it is in stable condition. |

| 37 | Remedial measures | During 2019 event road was damaged and Retaining wall has constructed at down slope. |

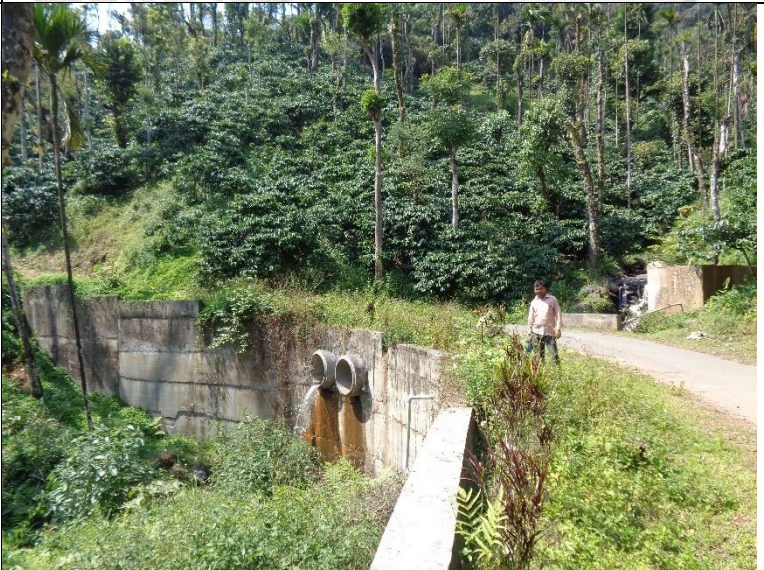
| 22 | Failure mechanism | Deep planar failure |
| 36 | Geo-scientific Causes | Due to intense rainfall in 2019 the entire area was badly affected by many landslides. Along flowing stream landslide occurred. |

| 40 | Summary/Abstract | Due to intense rainfall in 2019 the entire area was badly affected by many landslides. Along flowing stream landslide occurred. Remedial measures provided after 2019 landslide incidence. |

| 37 | Remedial measures | Retaining wall has constructed at down side of the slope which is 40-50 m in length and 7-8 m in height. |

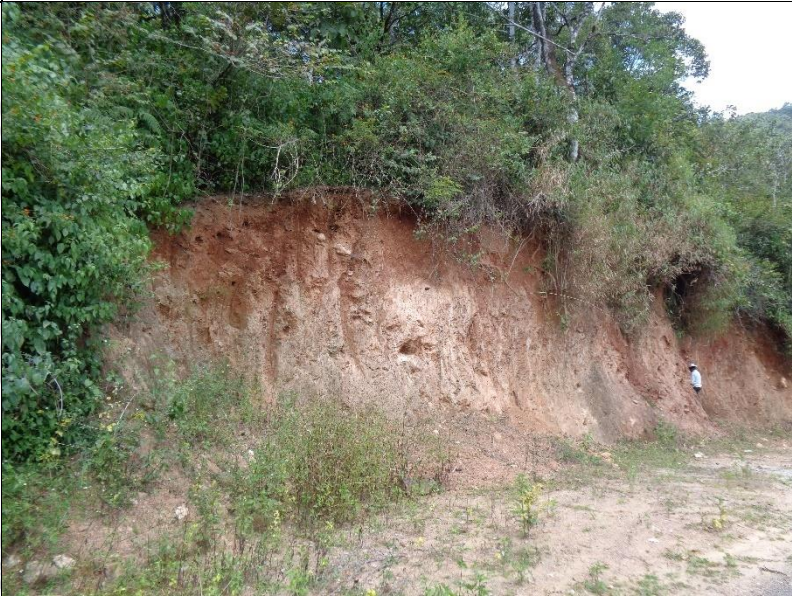
| No | Field | Description |
|---|---|---|
| 22 | Failure mechanism | Shallow rotational failure |
| 36 | Geo-scientific Causes | Increasing of Pore water pressure and reduction of strength on supersaturation, Anthropogenic activities which is unplanned |

| 38 | Remarks, if any | Adjacent to the landslide buffer one residential house is situated which is not safe to live during intense rainfall. |
| 40 | Summary/Abstract | Increasing of Pore water pressure and reduction of strength on supersaturation. Anthropogenic activities which is unplanned cutting of slope.<br>Slope grading and road drainage are required<br>Adjacent to the landslide buffer one residential house is situated which is not safe to live during intense rainfall. |

| 37 | Remedial measures | Slope grading and road drainage are required |

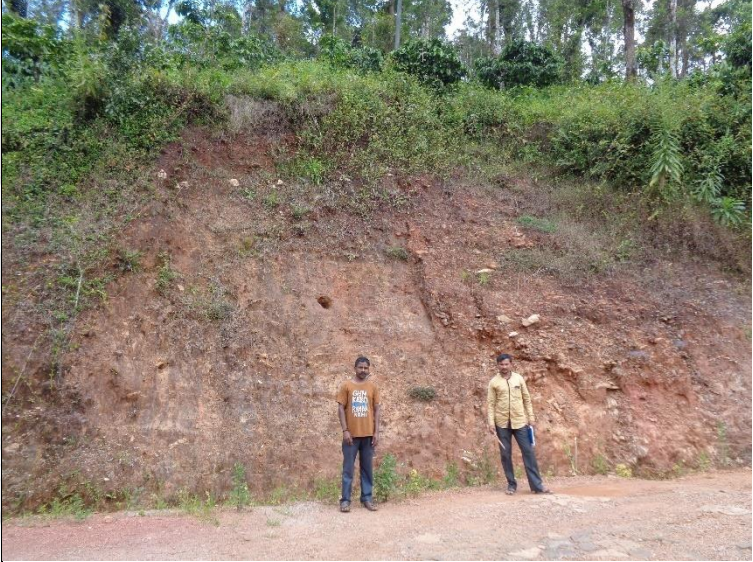
| 22 | Failure mechanism | Shallow rotational failure |
| 36 | Geo-scientific Causes | Increasing of Pore water pressure and reduction of strength on supersaturation, Anthropogenic activities which is unplanned cutting of slope. |
| 40 | Summary/Abstract | Extensive cut slope made for road construction. Downside of the nala few houses are present. During monsoon or heavy rain this place is not safe for stay. |

| 37 | Remedial measures | Benching should be done.<br>Relocate the settlements during intense rainfall. This place is not suitable for residential purpose during monsoon period. |

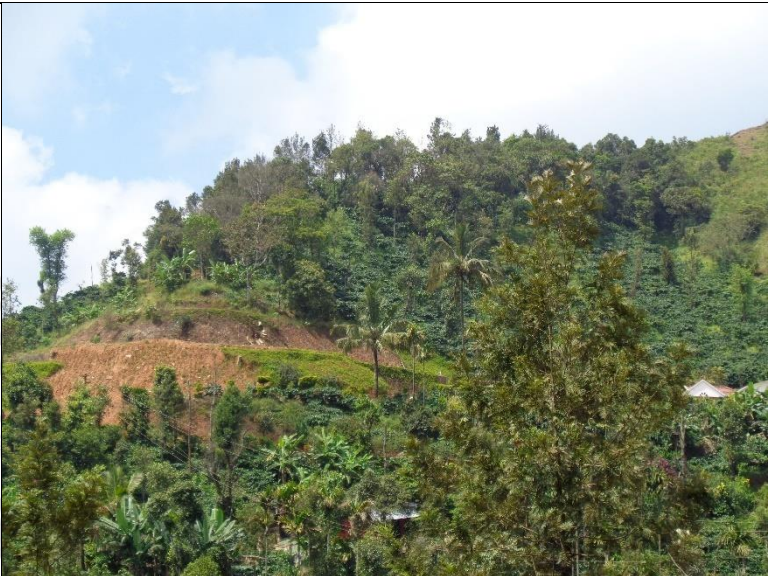
| No | Field | Description |
|---|---|---|
| 22 | Failure mechanism | Shallow planar failure |
| 36 | Geo-scientific Causes | Planar failure due to Increasing of Pore water pressure and reduction of strength on supersaturation. Anthropogenic activities which is unplanned cutting of slope. |

| 40 | Summary/Abstract | Extensive cut slope made for road construction. At downside slope few residential house is situated. Slope grading and deep root plantation are recommended. Proper drainage management are suggested at this site. |

| No | Field | Description |
|---|---|---|
| 37 | Remedial measures | Slope grading and deep root plantation are recommended. |

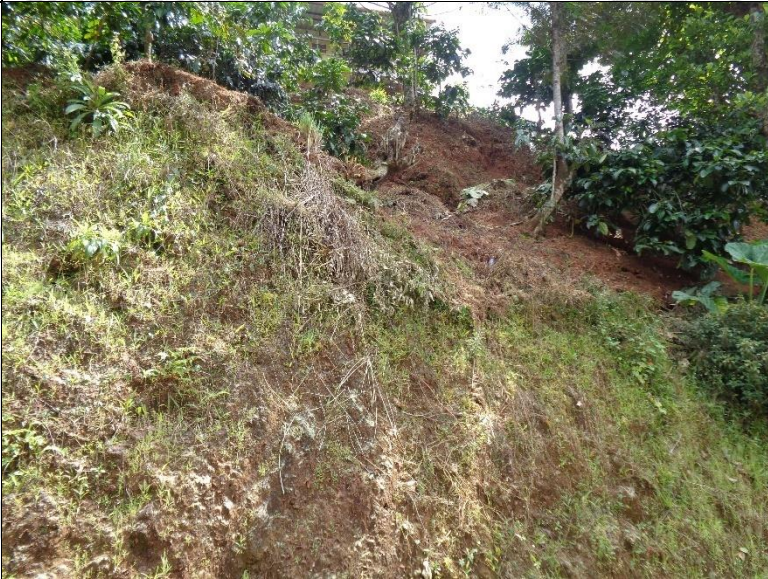
| No | Field | Description |
|---|---|---|
| 22 | Failure mechanism | Shallow Planar failure |

| 36 | Geo-scientific Causes | Planar failure due to Increasing of Pore water pressure and reduction of strength on supersaturation, Anthropogenic activities which is unplanned cutting of slope. |
| 38 | Remarks, if any | Retaining wall are present which is partially damaged, repairing should be done. At upslope side benching are required. |
| 40 | Summary/Abstract | Towards slope one homestay is present and one higher order stream is flowing adjacent to the landslide. Retaining wall are present which is partially damaged, repairing should be done. At upslope side benching are required. |

| 37 | Remedial measures | Slope easing and retaining wall are required at down side of the road. |

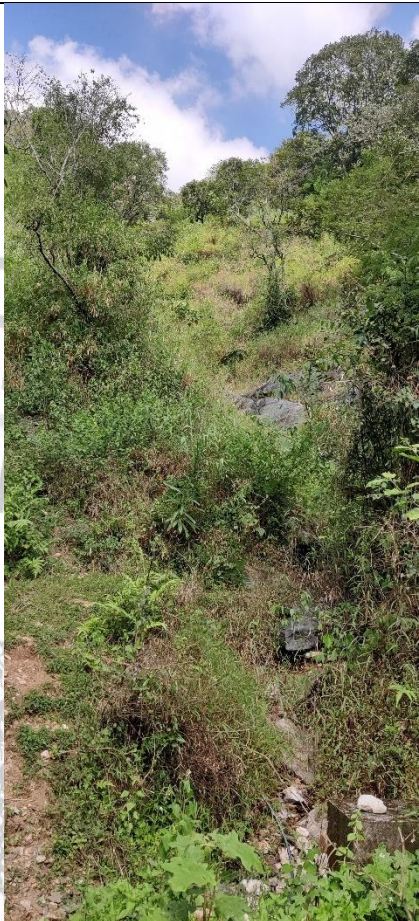
| 22 | Failure mechanism | Deep rotational failure |
| 36 | Geo-scientific Causes | Planar failure due to increasing of pore water pressure and reduction of strength on supersaturation. Anthropogenic activities which is unplanned cutting of slope. |

| 40 | Summary/Abstract | Planar failure due to increasing of pore water pressure and reduction of strength on supersaturation. Anthropogenic activities which is unplanned cutting of slope. After the 2019 landslide event remedial measures are already present. |

| 37 | Remedial measures | Retaining wall and drainage management have suggested. |

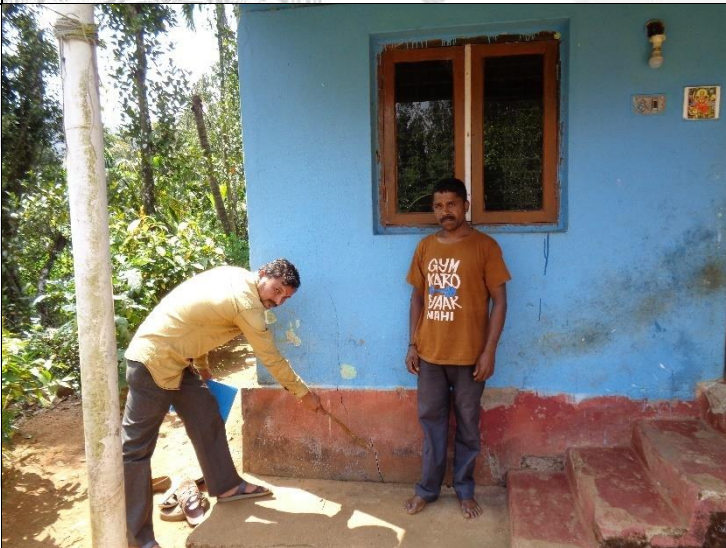
| 22 | Failure mechanism | Shallow planar failure |
| 36 | Geo-scientific Causes | Planar failure due to Increasing of Pore water pressure and reduction of strength on supersaturation, Anthropogenic activities which is unplanned cutting of slope. |
| 40 | Summary/Abstract | Near Giri Sri homestay one residential house is present which is at risk during intense rainfall. Cracks has already developed in house wall. Adjacent to this house 4 more residential houses are situated. These house should be relocate during rainy season. The house owner name is Mr. Rukumayya. |

| 37 | Remedial measures | Cracks should be filled and the house is not safe during monsoon. It is at risk. |

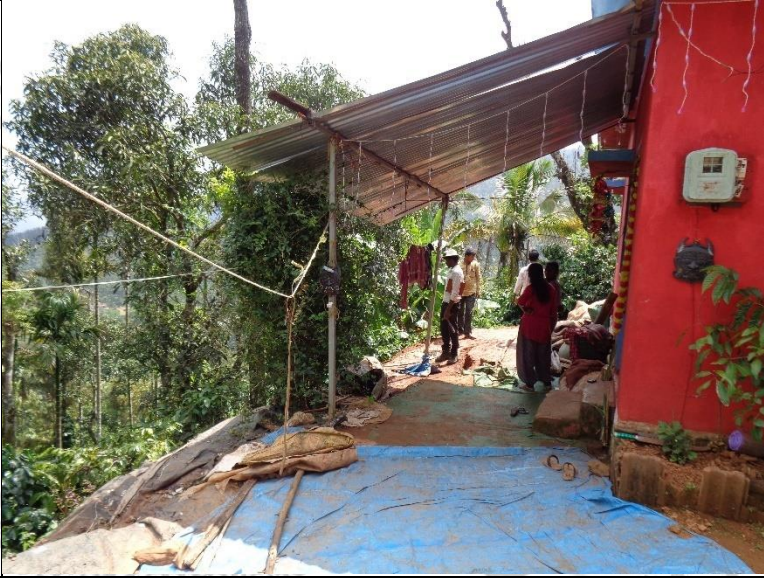
| No | Field | Description |
|---|---|---|
| 22 | Failure mechanism | Shallow planar failure |
| 36 | Geo-scientific Causes | Due to unplanned cutting and construction (homestay) without any proper remedies below one house is present. There is no proper drainage management, water is flowing from the downslope house and road which is increasing soil erosion. Towards flowing direction of rain water one house is situated which have cracks and land subsidence. That house is not |

| 40 | Summary/Abstract | Due to unplanned cutting and construction (homestay) without any proper remedies below one house is present. There is no proper drainage management, water is flowing from the downslope house and road which is increasing soil erosion. Towards flowing direction of rain water one house is situated which have cracks and land subsidence. That house is not suitable for living during rainy season. |

| 37 | Remedial measures | Residential house is present which is at risk during intense rainfall. Cracks has already developed in house wall. This house should be relocate as it is at risk. |

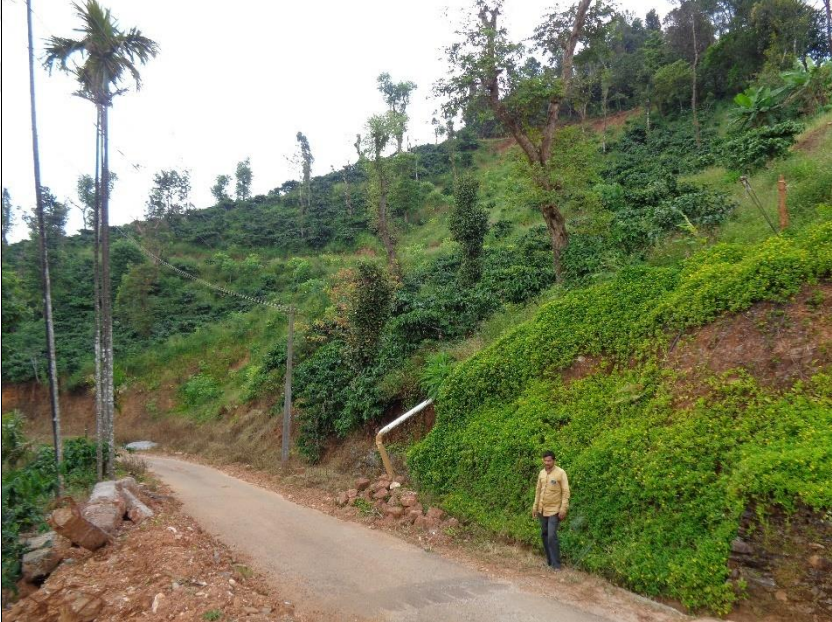
| 22 | Failure mechanism | Shallow planar failure |
| 36 | Geo-scientific Causes | Planar failure due to increasing of pore water pressure and reduction of strength on supersaturation. Anthropogenic activities which is unplanned cutting of slope. |
| 40 | Summary/Abstract | At this site stream is present. Landslide occurred along the stream towards downside of the slope. Debris material is weathered rock. After 2019 landslide event remedial measures have already provided at this site. |

| 37 | Remedial measures | Retaining structure & benching required. Drainage with proper culvert required at downslope. |

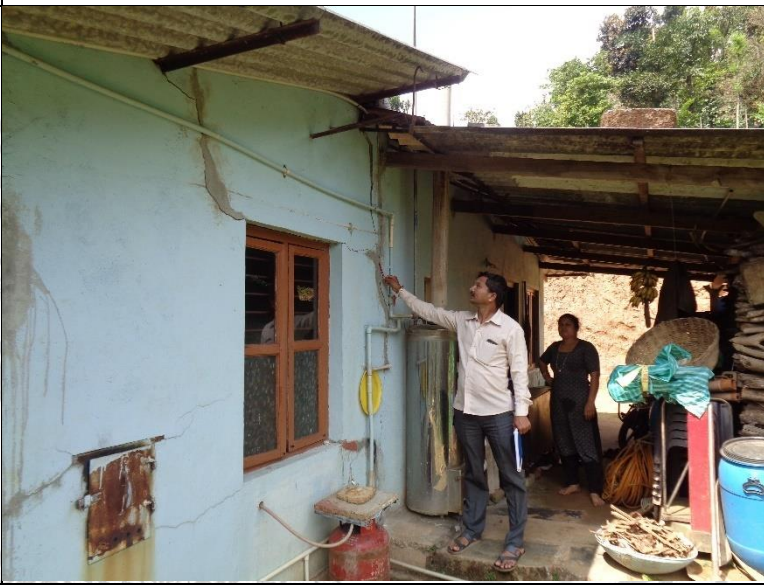
| No | Field | Description |
|---|---|---|
| 22 | Failure mechanism | Shallow planar failure |
| 36 | Geo-scientific Causes | Planar failure due to increasing of pore water pressure and reduction of strength on supersaturation. Anthropogenic activities which is unplanned cutting of slope. |

| 38 | Remarks, if any | 100 m ahead one SMS at risk which have developed cracks. House owner is Mr. Ashok. |
| 40 | Summary/Abstract | On road side small dimension stream is flowing, during rainy season half of stream water flowing in stream and half of water flowing towards house which is constructed below the stream and the house is not safe during intense rain. |

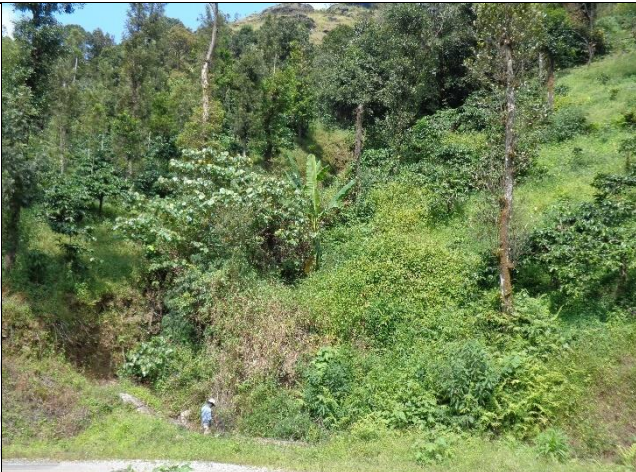
| No | Field | Description |
|---|---|---|
| 22 | Failure mechanism | Shallow planar failure |
| 36 | Geo-scientific Causes | Planar failure due to increasing of pore water pressure and reduction of strength on supersaturation. Anthropogenic activities which is unplanned cutting of slope. |

| 40 | Summary/Abstract | Planar failure due to increasing of pore water pressure and reduction of strength on supersaturation. Anthropogenic activities which is unplanned cutting of slope. Benching & slope easing should be required. |

| No | Field | Description |
|---|---|---|
| 37 | Remedial measures | Benching & slope easing should be required. |

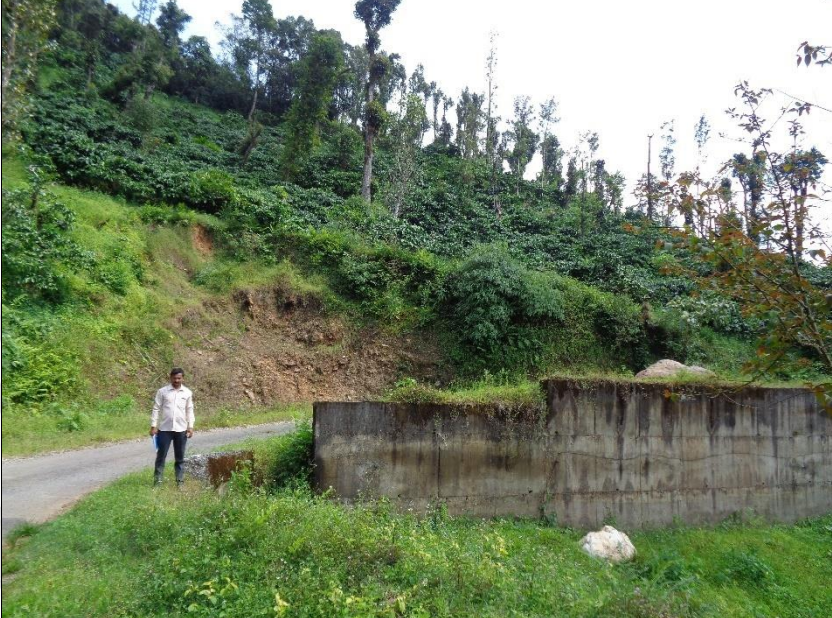
| No | Field | Description |
|---|---|---|
| 22 | Failure mechanism | Shallow planar failure |

| 36 | Geo-scientific Causes | Planar failure due to increasing of pore water pressure and reduction of strength on supersaturation. Anthropogenic activities which is unplanned cutting of slope. |
| 38 | Remarks, if any | Due to stream erosion slide occurred along stream due to intense rain. Downside of the road toe erosion by stream. |
| 40 | Summary/Abstract | Due to stream erosion slide occurred along stream triggered by intense rain. Downside of the road toe erosion by stream. Retaining wall is already constructed it should be monitored during monsoon. Culvert is provided but it should be channelized and proper maintenance should be required before monsoon. After 2019 landslide event retaining wall has already provided at this site. |

| 37 | Remedial measures | Slope grading and plantation of deep root trees. |

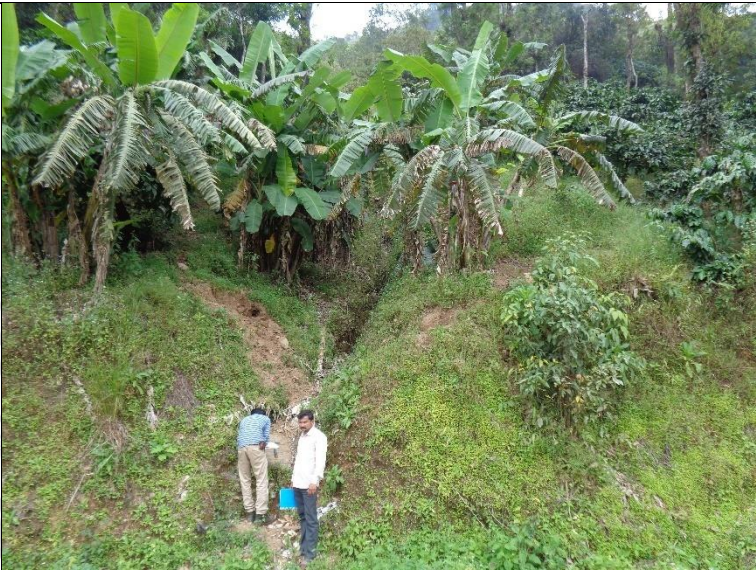
| 22 | Failure mechanism | Shallow planar failure |
| 36 | Geo-scientific Causes | Planar failure due to increasing of pore water pressure and reduction of strength on supersaturation. Anthropogenic activities which is unplanned cutting of slope. |

| 40 | Summary/Abstract | Along the stream landslide occurred due to intense rainfall. The area is fully weathered and converted into thick pile of overburden material. Planar failure due to increasing of pore water pressure and reduction of strength on supersaturation. Anthropogenic activities which is unplanned cutting of slope. |

| 37 | Remedial measures | Benching & proper drainage required |

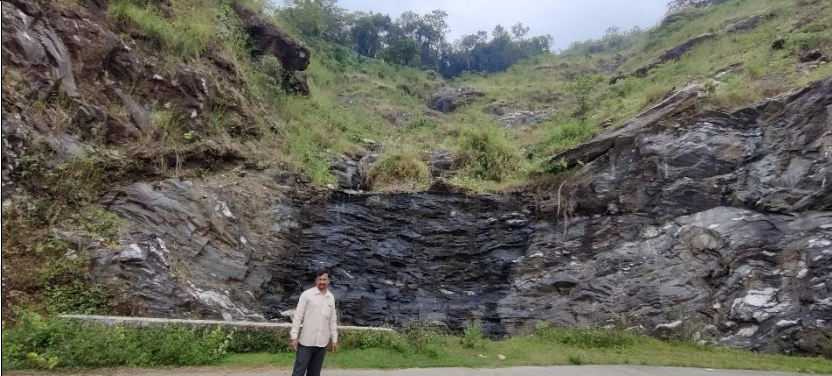
| No | Field | Description |
|---|---|---|
| 22 | Failure mechanism | Shallow planar failure |

| 36 | Geo-scientific Causes | Toppling & wedge failure due to intersection of joints and day lighted slope. Anthropogenic activities which is unplanned cutting of slope. |
| 40 | Summary/Abstract | Rocks deformed by shear deformation. Toppling & wedge failure due to intersection of joints and day lighted slope. Anthropogenic activities which is unplanned cutting of slope. |

| 38 | Remarks, if any | Remove the dislodge boulders from upslope. |

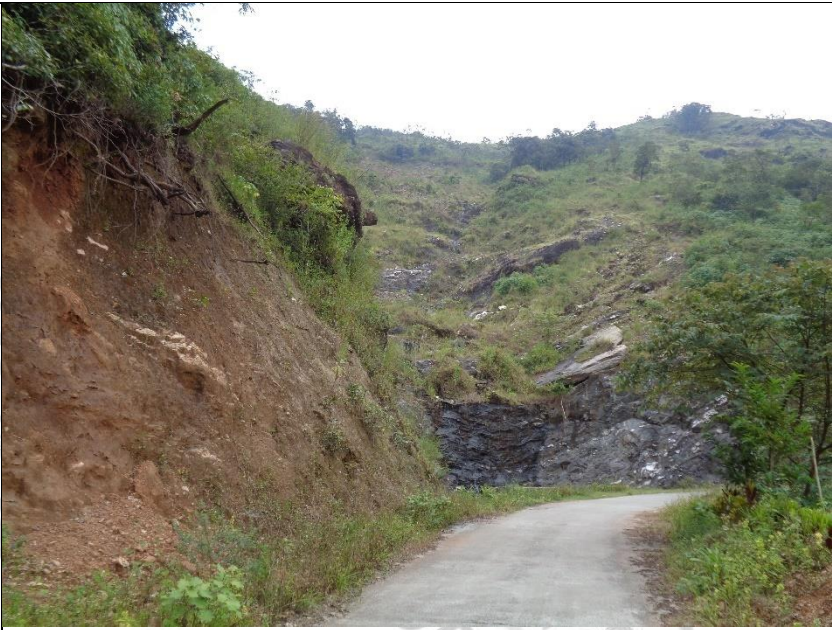
| 22 | Failure mechanism | Shallow planar failure |
| 36 | Geo-scientific Causes | Planar failure due to increasing of pore water pressure and reduction of strength on supersaturation. Anthropogenic activities which is unplanned cutting of slope. |

| 40 | Summary/Abstract | In adjacent area at upslope rock is exposed which is massive metabasalt exposure. Stream is flowing and there are no settlements in nearby. Multiple old scar of rock slide is present. Higher order stream is flowing near slide. Drainage and retaining wall is already constructed after landslide event in 2019. |

| 37 | Remedial measures | Higher order stream is flowing near slide. Drainage and retaining wall is already constructed after landslide event in 2019. |

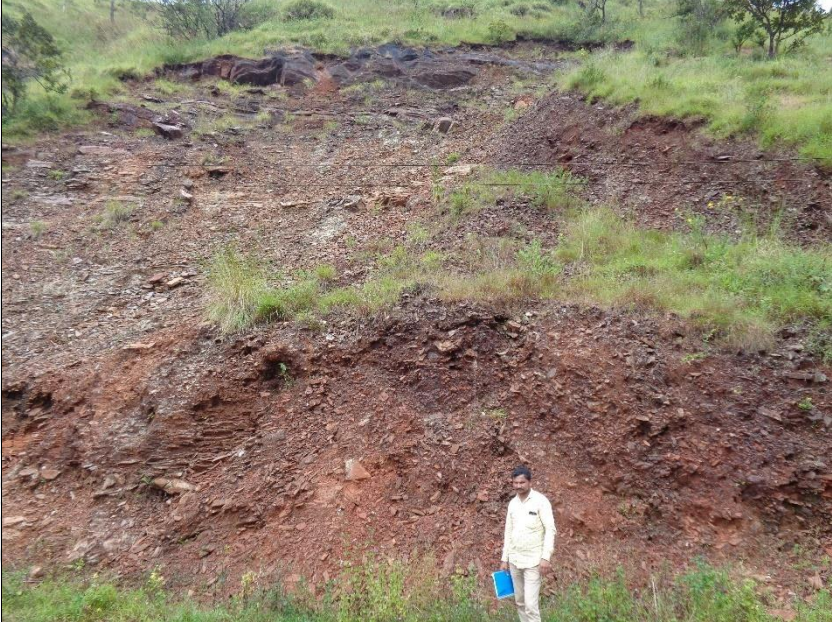
| 40 | Summary/Abstract | Planar failure due to increasing of pore water pressure and reduction of strength on supersaturation. Anthropogenic activities which is unplanned cutting of slope. Slope easing & drainage is recommended. |

| 37 | Remedial measures | Slope easing and drainage is recommended. |

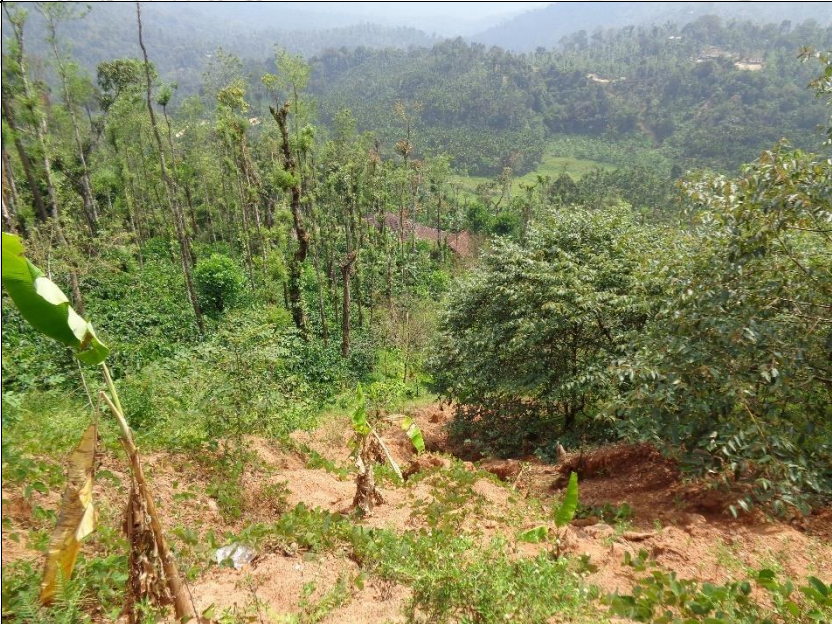
| 40 | Summary/Abstract | Down side of the slide one residential house is situated which is adjacent to the runout path. During heavy rainfall the house is not safe for living. |

| 37 | Remedial measures | Slope angle should be proper maintaining of slope during road cut. Vertical cut should be avoided. Drainage are required to free flow of water. Downside on landslide plantation are suggested. Benching should be done. |
