MESO-SCALE (1:10,000) LANDSLIDE SUSCEPTIBILITY MAPPING IN SUNKASALE  
AREA, CHIKMAGALUR DISTRICT, KARNATAKA.

Toposheet no. 48O/08

FSP CODE: M4LSSM/NC/SR/SU-KG/2022/42400

कार्य सत्र: 2022-23 का अंतिम प्रतिवेदन  
Final Report for Field Season 2022-2023

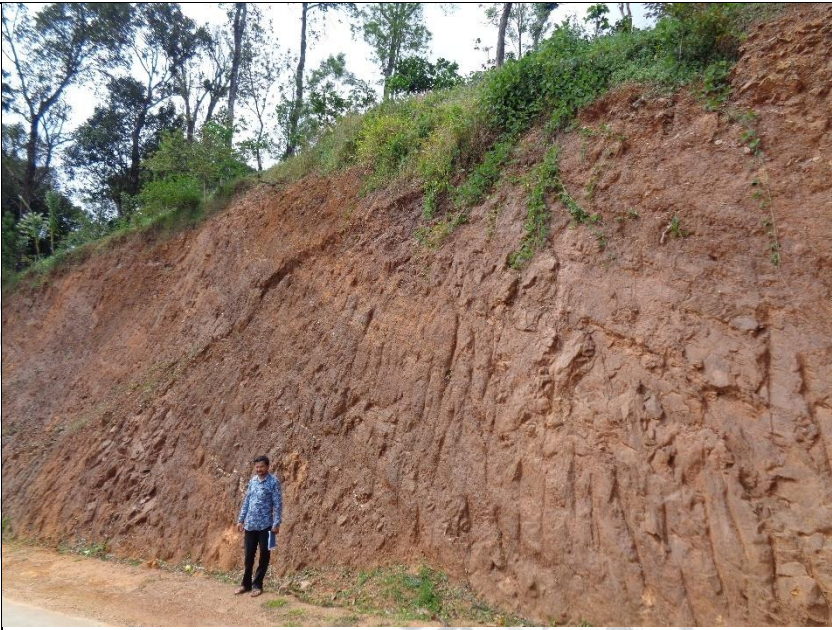
| 40 | Summary/Abstract | The rain water is directly flowing from slope to the road. The path of rain water is diverted by manmade pipe. At this site proper drainage is required. Adjacent to the site multiple small slump are also present. |

| No | Field | Description |
|---|---|---|
| 37 | Remedial measures | Drainage are required to free flow of water. Benching should be done. |

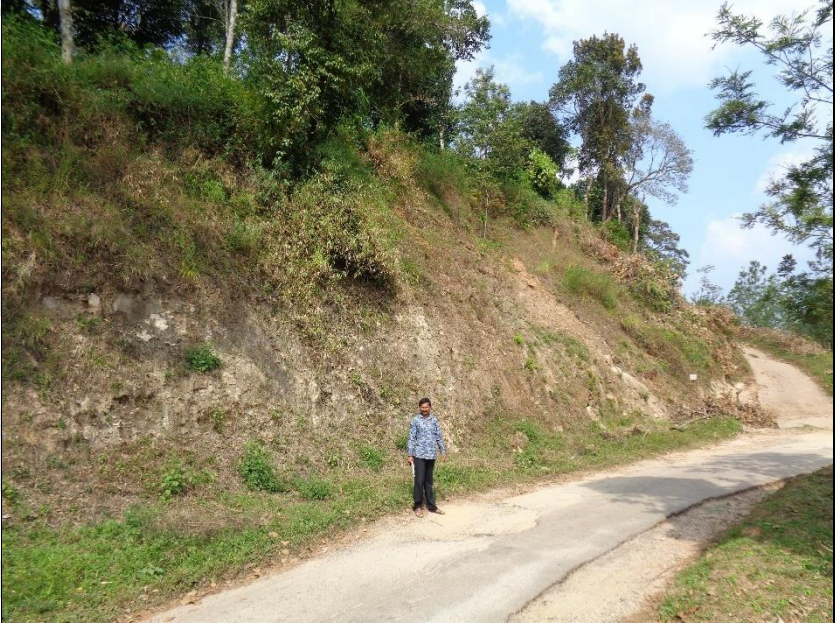
| 40 | Summary/Abstract | Anthropogenic activities which is unplanned cutting of slope. For remedial measure benching should be done. |

| 37 | Remedial measures | Benching should be done |

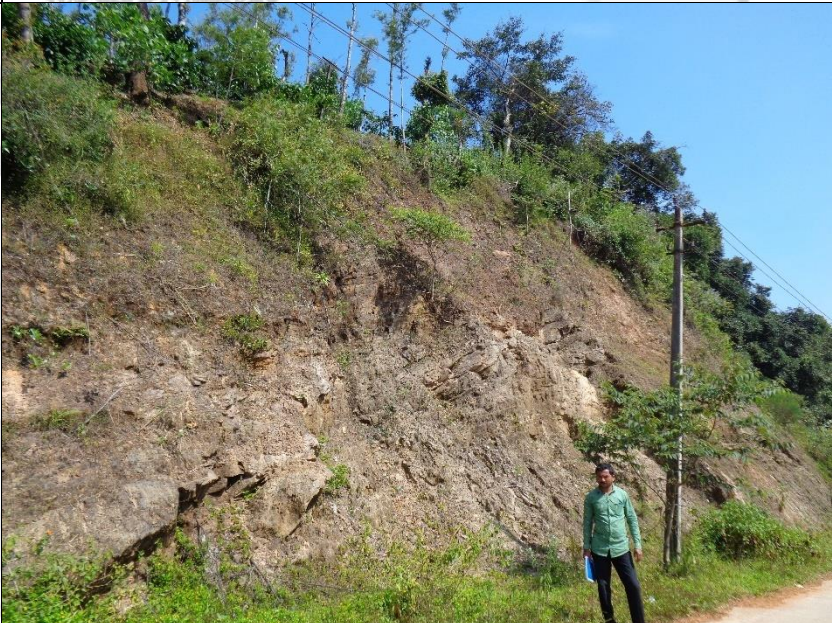
| 40 | Summary/Abstract | The overburden thickness is 3-4m. The rock which is fully weathered and producing loose soil with sandy portion is high. The cohesive strength is less. Extensive cut slope failed and landslide occurred. |

| 37 | Remedial measures | Drainage are required to free flow of water & benching should be done. |

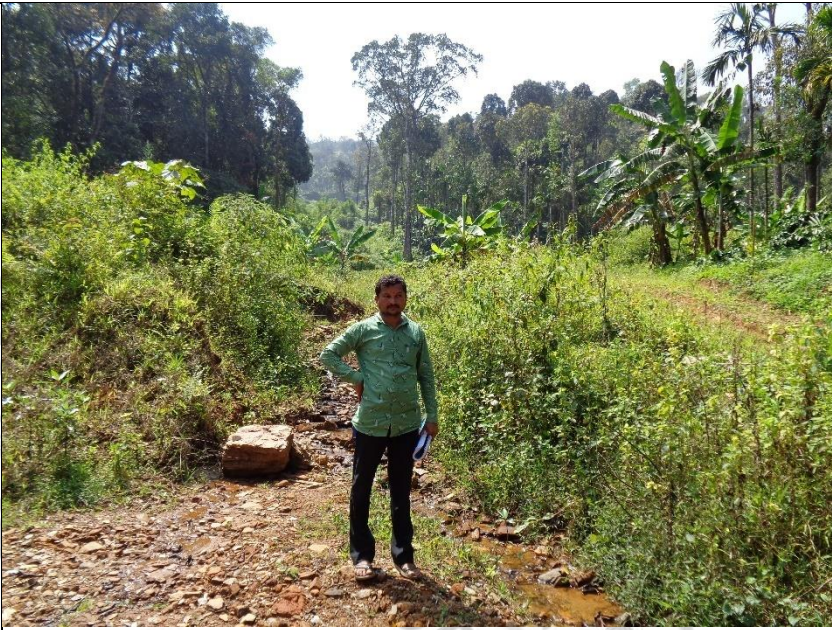
| No | Field | Description |
|---|---|---|
| 36 | Geo-scientific Causes | Planar failure due to increasing of pore water pressure and reduction of strength on supersaturation. Anthropogenic activities which is unplanned cutting of slope. |

| 40 | Summary/Abstract | Large debris flow occurred in 2019 in coffee plantation. Stream is flowing in the runout path continuously and there is no culvert. In the vicinity of the landslide one residential house is situated. |

| No | Field | Description |
|---|---|---|
| 37 | Remedial measures | Drainage with culvert is required & deep root plantations has suggested. |

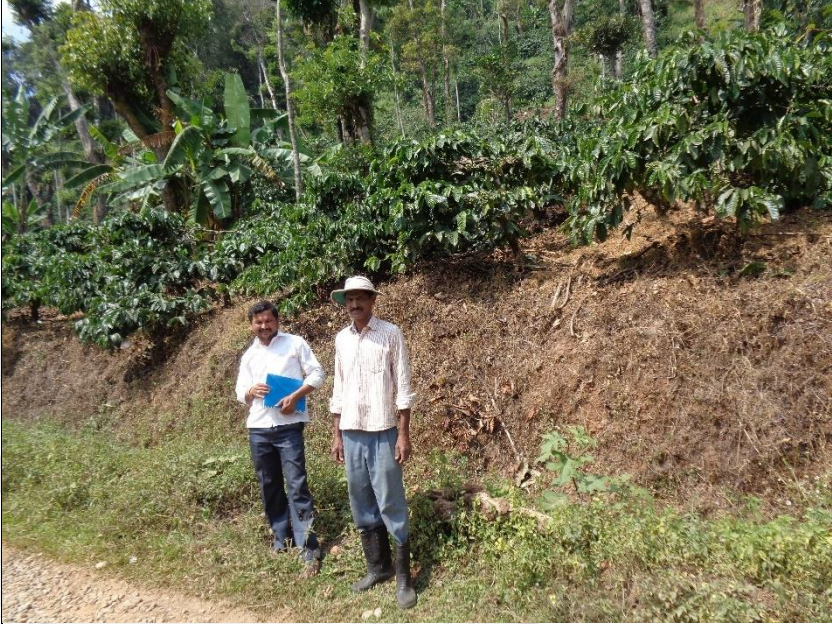
| 36 | Geo-scientific Causes | Planar failure due to increasing of pore water pressure and reduction of strength on supersaturation. Anthropogenic activities which is unplanned cutting of slope. |
| 40 | Summary/Abstract | Large debris slide occurred in 2019. One acre Coffee plantation was affected by this slide. The land owner is Mr. DV Subraya of this property. |

| 37 | Remedial measures | Drainage with culvert is required& deep root plantations are suggested. |

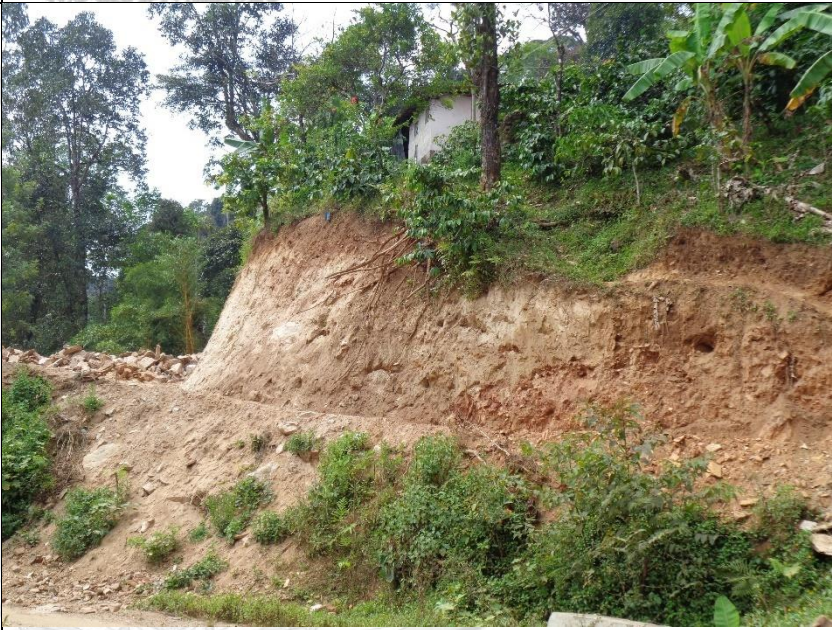
| 36 | Geo-scientific Causes | Planar failure due to increasing of pore water pressure and reduction of strength on supersaturation. Anthropogenic activities which is unplanned cutting of slope. |
| 38 | Remarks, if any | This site is at risk for any construction for future. |
| 40 | Summary/Abstract | Along the stream debris slide has occurred due to which present culvert is choked which should be clean. Adjacent to stream one SMS is present which is at risk. This site is not safe in monsoon. |

| 37 | Remedial measures | Compound wall for road is required & drainage with culvert required. |

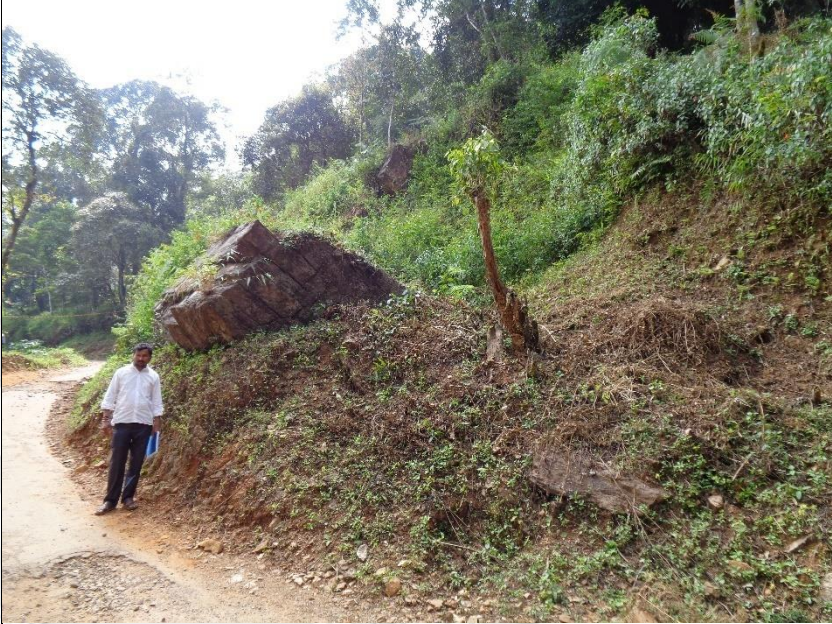
| 36 | Geo-scientific Causes | Planar failure due to increasing of pore water pressure and reduction of strength on supersaturation. Anthropogenic activities which is unplanned cutting of slope. |
| 40 | Summary/Abstract | Extensive cut slope failed and landslide occurred. Adjacent to the site Extensive cut slope is present which is made for road construction and material is continuously falling from cut slope. |

| 37 | Remedial measures | Drainage with culvert required. Slope benching and deep root plantations are suggested. |

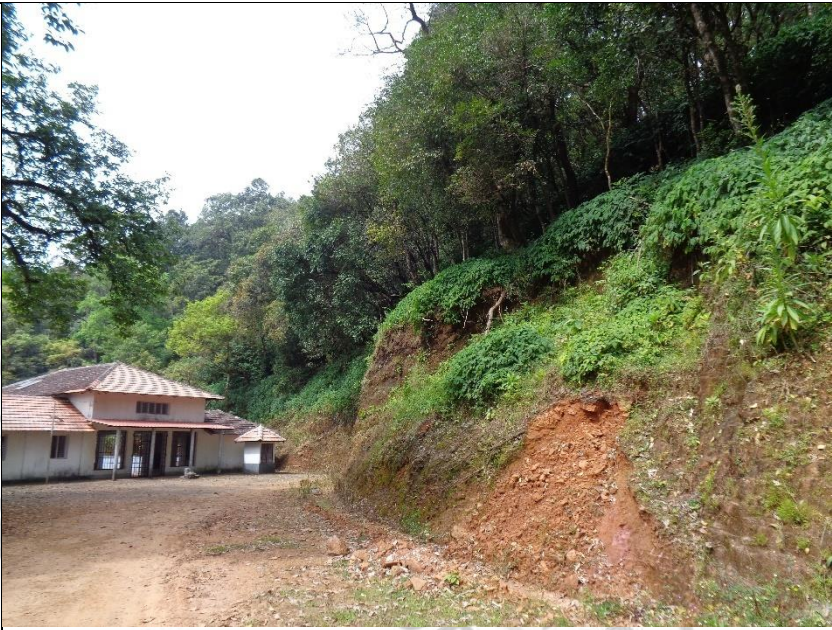
| No | Field | Description |
|---|---|---|
| 36 | Geo-scientific Causes | Planar failure due to increasing of pore water pressure and reduction of strength on supersaturation. Anthropogenic activities which is unplanned cutting of slope. |

| 40 | Summary/Abstract | The overburden material thickness is 4-5 meter. The rock is highly weathered. Retaining structure required for temple safety. Benching required. Drainage should be made along the temple boundary to avoid the water percolation within the area. |

| No | Field | Description |
|---|---|---|
| 37 | Remedial measures | Retaining structure required for temple safety. Benching required. Drainage should be made along the temple boundary to avoid the water percolation within the area. |

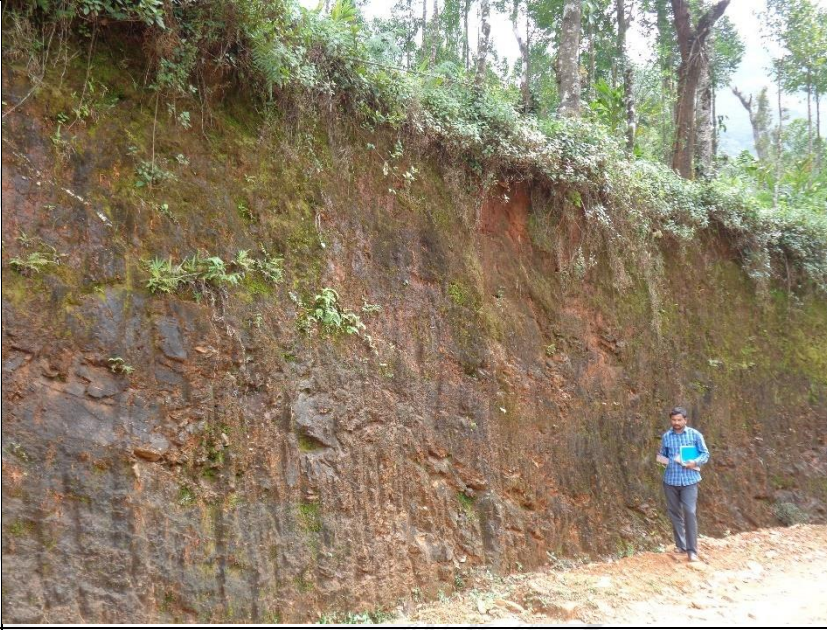
| 40 | Summary/Abstract | The katcha road is going to newly constructed homestay is the risk element as it is private coffee estate. |

| 37 | Remedial measures | Deep root plantation at downside as this site. Slope benching has suggested. |

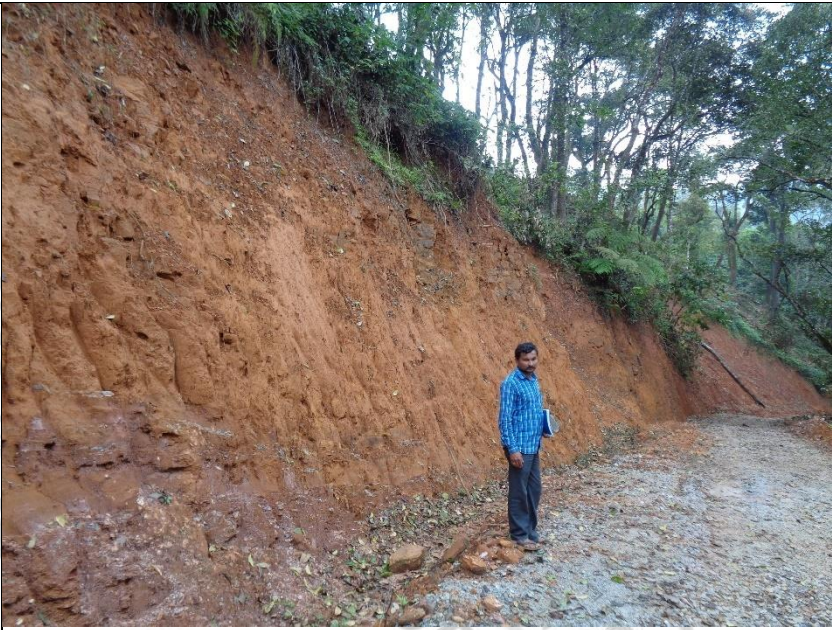
| 40 | Summary/Abstract | The katcha road is going to newly constructed homestay is the risk element as it is private property. |

| 37 | Remedial measures | Deep root plantation at this site. Slope benching & drainage management is required. |

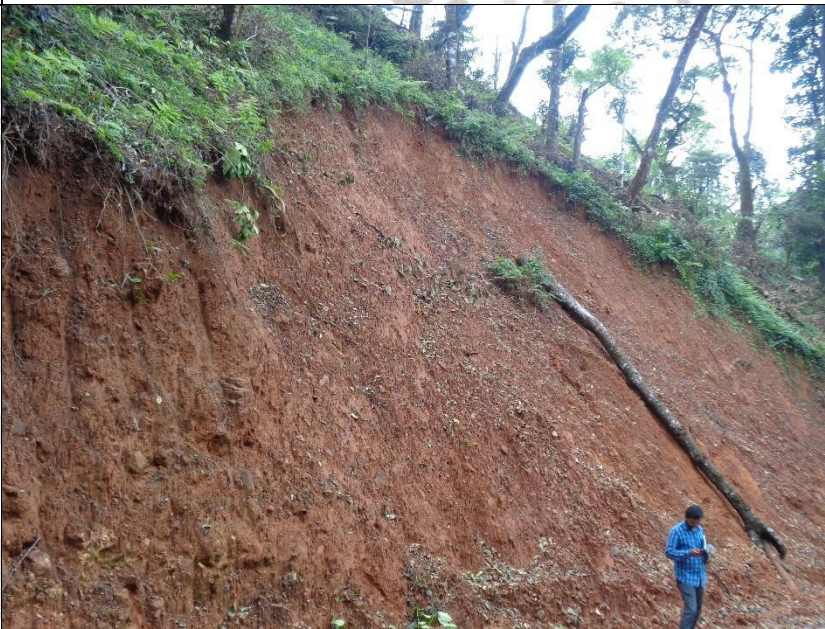
| 40 | Summary/Abstract | The original slope cut for making road and due to intense rain cut slope failed. Slope benching & drainage management is required. This is private property of Tripathi group. |

| 37 | Remedial measures | Slope benching & drainage management is required. |

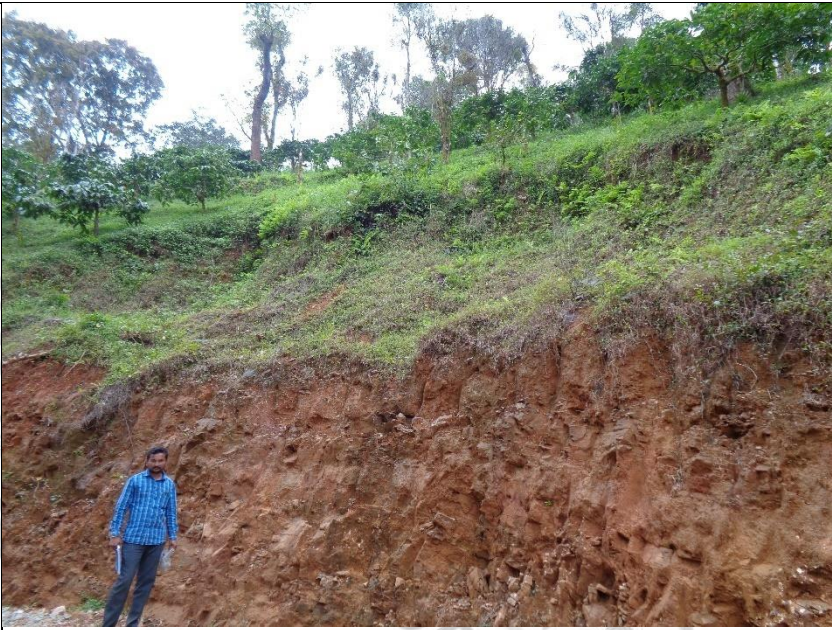
| 40 | Summary/Abstract | Road cut without any planned and cut slope made which is falling towards the steep slope. Downside stream is also flowing. Deep root plantation at this site, slope benching & drainage management is required. |

| 37 | Remedial measures | Deep root plantation at this site, slope benching & drainage management is required. |

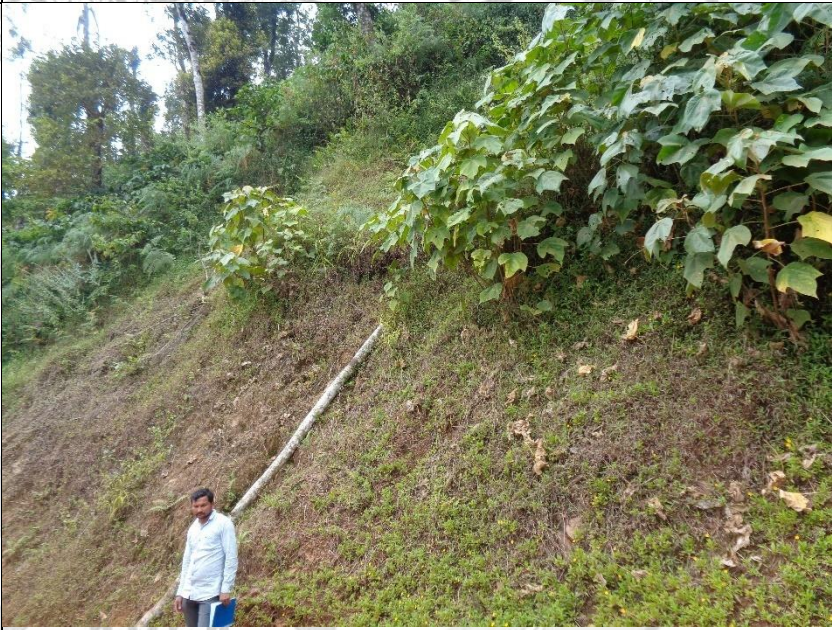
| 40 | Summary/Abstract | Anthropogenic activities which is unplanned cutting of slope. Slope benching & drainage management required. |

| 37 | Remedial measures | Slope benching & drainage management has suggested. |

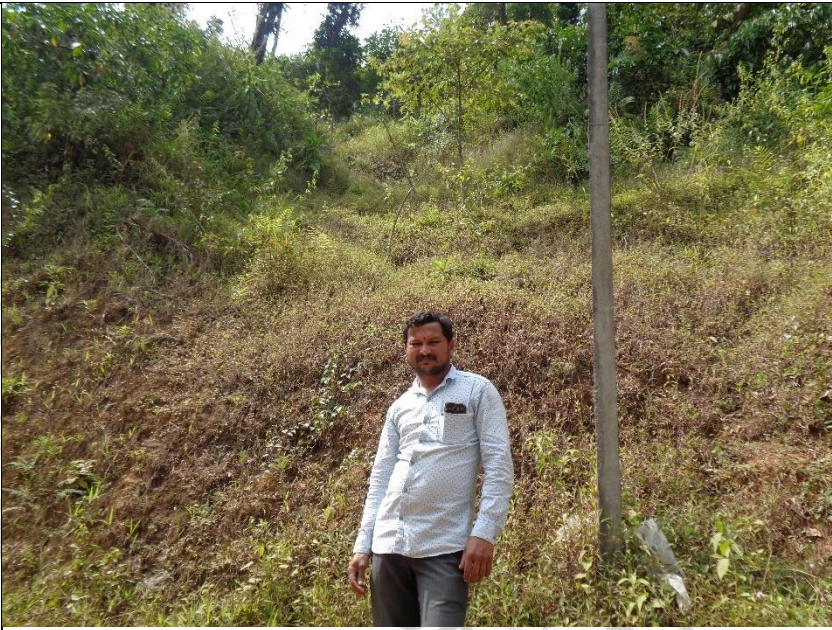
| 40 | Summary/Abstract | Anthropogenic activities which is unplanned cutting of slope. Vertical cut made for road. Slope benching & drainage management. At down side steep slope and stream is flowing. |

| 37 | Remedial measures | Slope benching & drainage management is required. |

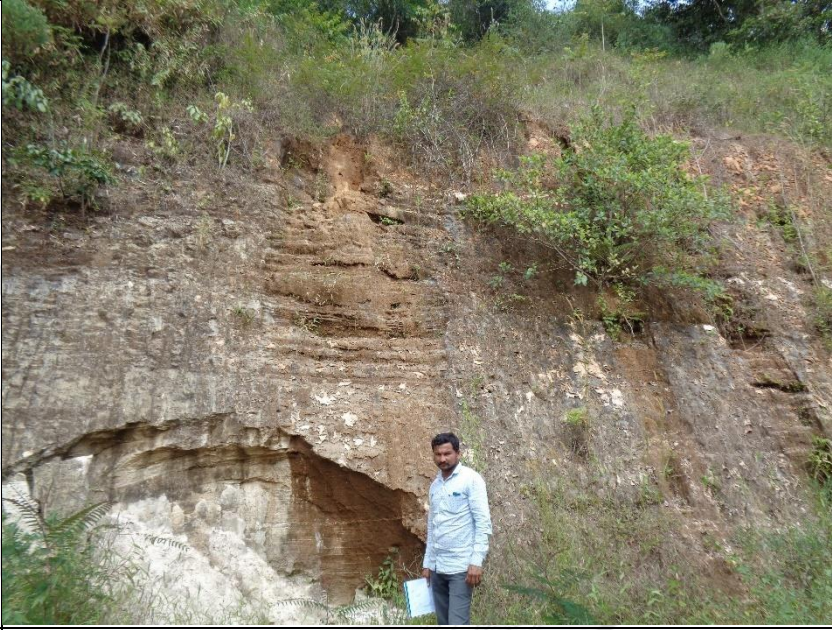
| 40 | Summary/Abstract | Anthropogenic activities which is unplanned cutting of slope. Vertical cut made for road. Slope benching & slope should be filled with sand bag for temporarily before monsoon & drainage management is required. |

| 37 | Remedial measures | Slope benching & slope should be filled with sand bag for temporarily before monsoon & drainage management is required. |

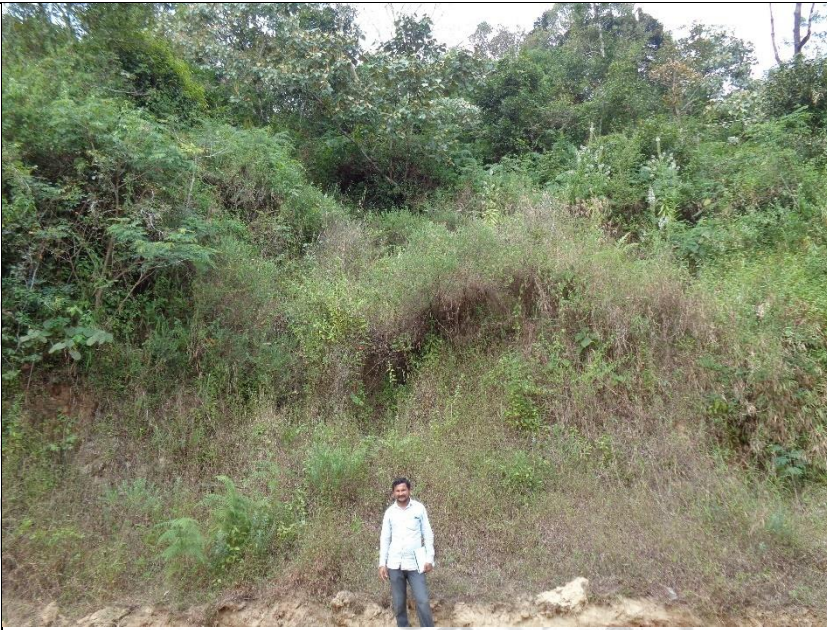
| 40 | Summary/Abstract | At downside steep slope is present. Anthropogenic activities which is unplanned cutting of slope. Vertical cut made for road. Slope benching, slope should be filled with sand bag for temporarily before monsoon & drainage management is required. |

| 37 | Remedial measures | Slope benching, slope should be filled with sand bag for temporarily before monsoon & drainage management is required. |

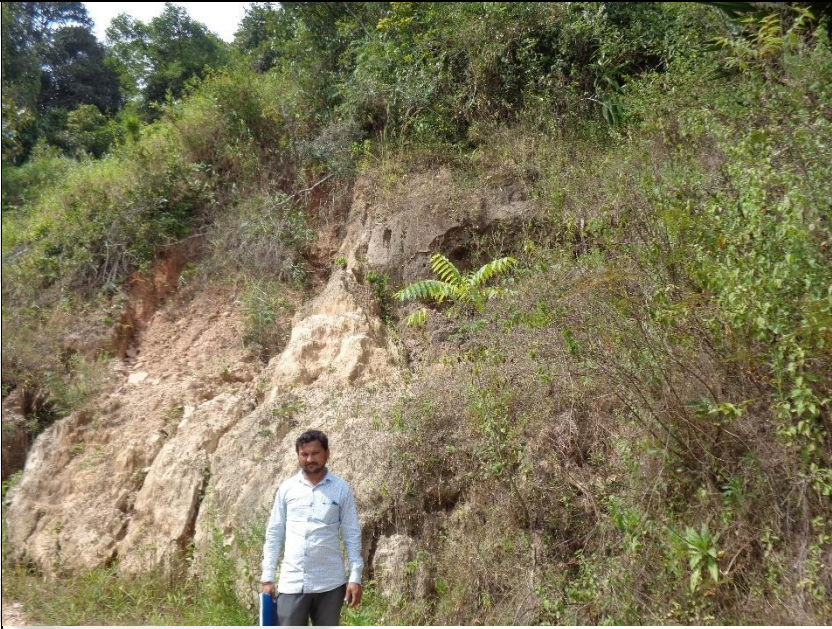
| 40 | Summary/Abstract | Anthropogenic activities which is unplanned cutting of slope. Vertical cut made for road. Slope benching, slope should be filled with sand bag for temporarily before monsoon & drainage management is required. |

| 37 | Remedial measures | Slope benching, slope should be filled with sand bag for temporarily before monsoon & drainage management is required. |

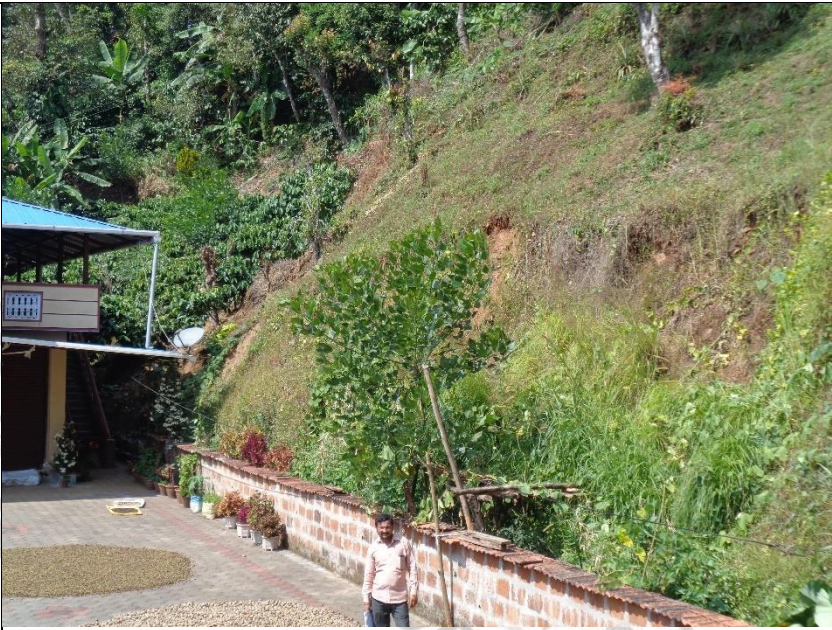
| 40 | Summary/Abstract | At this site upslope and downside water is flowing and passes through the residential house. Drainage management is required. This is due to unplanned cutting of slope. The house owner name is Mr. Chandra Gowda in which house two member is residing. |

| 37 | Remedial measures | Drainage management at upslope, benching required behind the house& retaining wall with weep hole is required. |

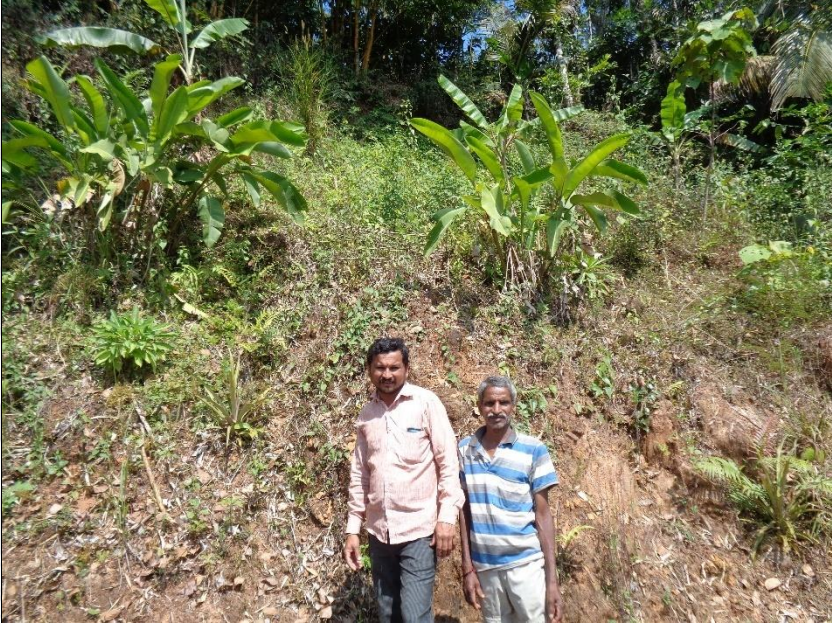
| 40 | Summary/Abstract | Anthropogenic activities which is unplanned cutting of slope. Vertical cut made for road. Drainage management at upslope& retaining wall with weep hole is required. |

| 37 | Remedial measures | Drainage management at upslope & retaining wall with weep hole is required. |

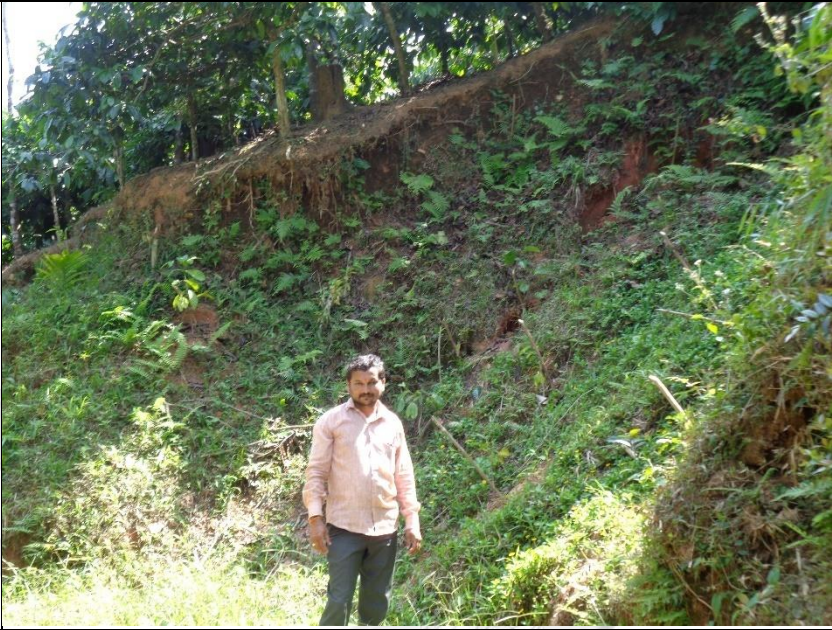
| 40 | Summary/Abstract | The landslide occurred within coffee estate as there is no risk element apart from agriculture land. Deep root plantation are required. |

| 37 | Remedial measures | Deep root plantation are required. |

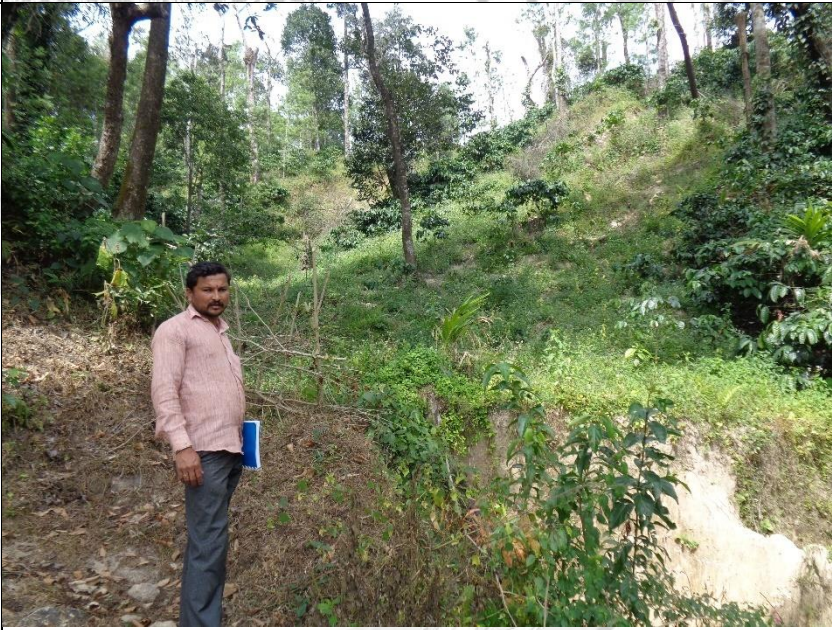
| 40 | Summary/Abstract | Due to increased pore water pressure and reduction of strength of super saturation landslide occurred in coffee plantation area. There is only risk element is agriculture land. Soil thickness at this place is more than 8 meter. There are no settlements at down side. |

| 37 | Remedial measures | Deep root plantations and slope grading is required. |

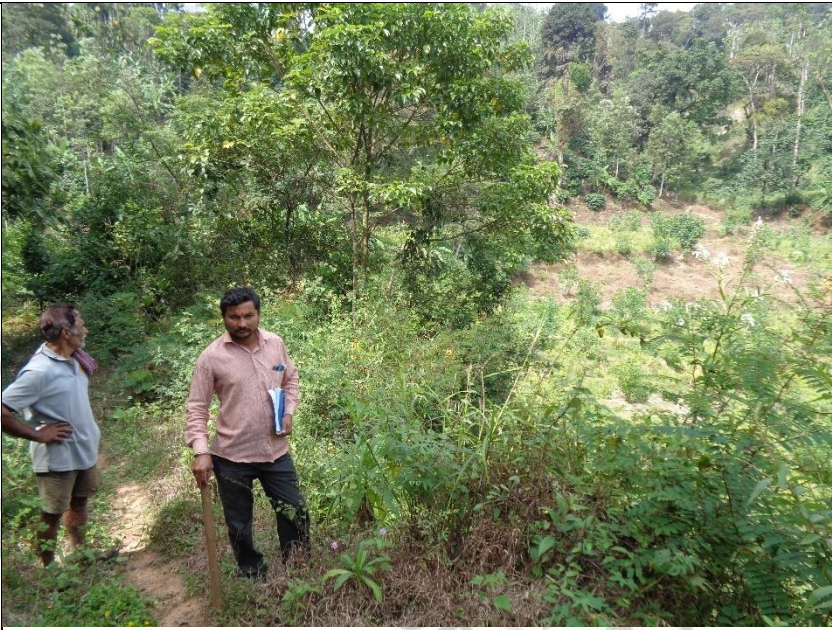
| 40 | Summary/Abstract | Due to increased pore water pressure and reduction of strength of super saturation landslide occurred in coffee plantation area. There is only risk element is agriculture land. Soil thickness at this place is more than 8 meter. There are no settlements are down side. |

| 37 | Remedial measures | Deep root plantations and slope grading is required. |

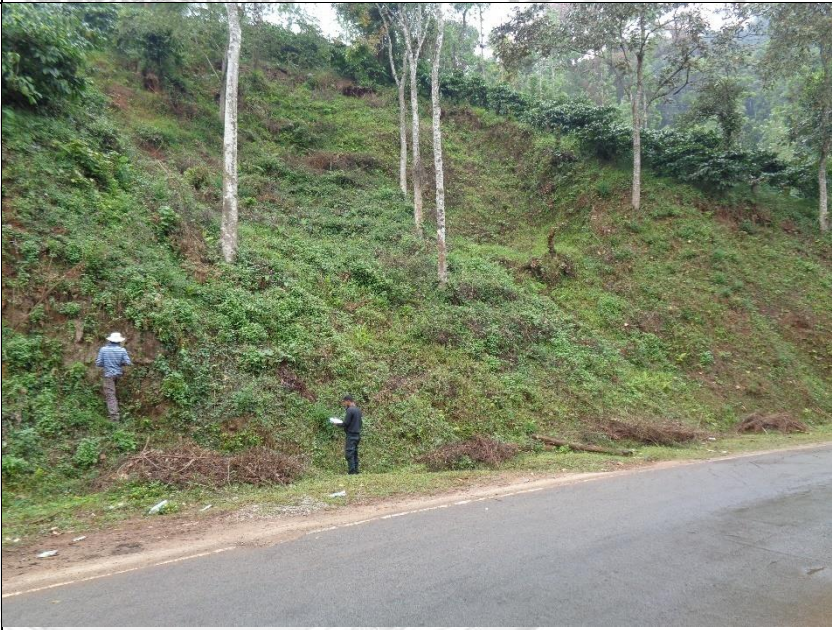
| 40 | Summary/Abstract | The extensive cut slope made for road cut the slope is steep and downside near the landslide flank stream is flowing. This site have soil thickness is 8m and rock is fully weathered and converted into thick pile of over burden materials. |

| 37 | Remedial measures | Benching and slope grading & drainage with culvert is required. |

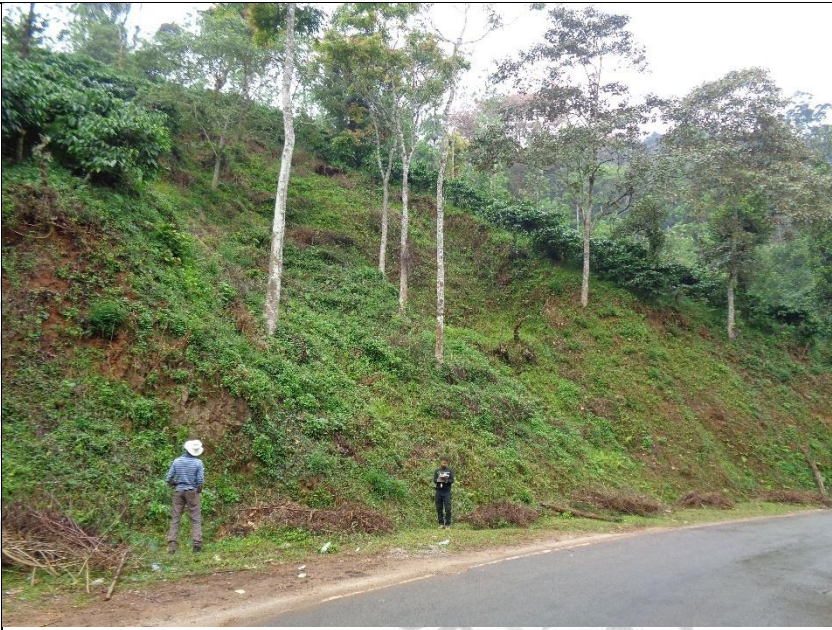
| 40 | Summary/Abstract | The extensive cut slope made for road cut the slope is steep and downside near the landslide flank stream is flowing. Upslope grading is required & drainage with culvert is required. |

| 37 | Remedial measures | Upslope grading is required & drainage with culvert is required. |

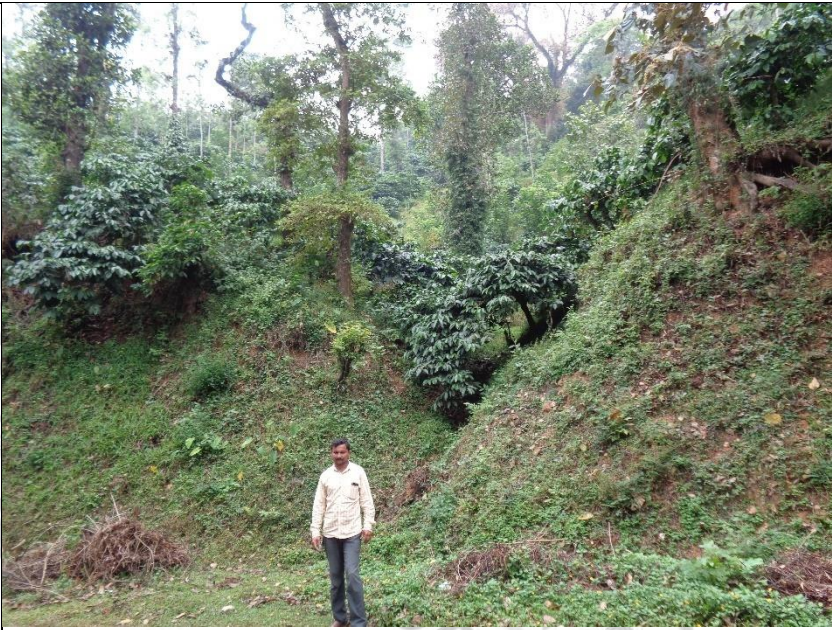
| 40 | Summary/Abstract | Vertical cut made for road which triggered by intense rain. Retaining wall is already given after 2019 landslide incidence. |

| 37 | Remedial measures | Retaining wall already provide. Slope grading is required & drainage management is required. |

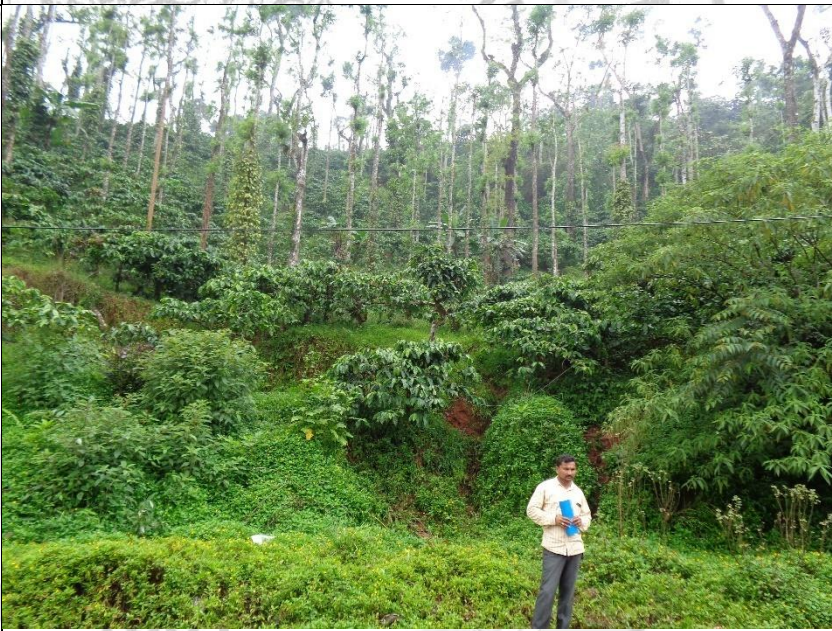
| 40 | Summary/Abstract | Vertical cut made for road which triggered by intense rain. Slope benching is required & drainage management is required. |

| 37 | Remedial measures | Slope benching is required & drainage management is required. |

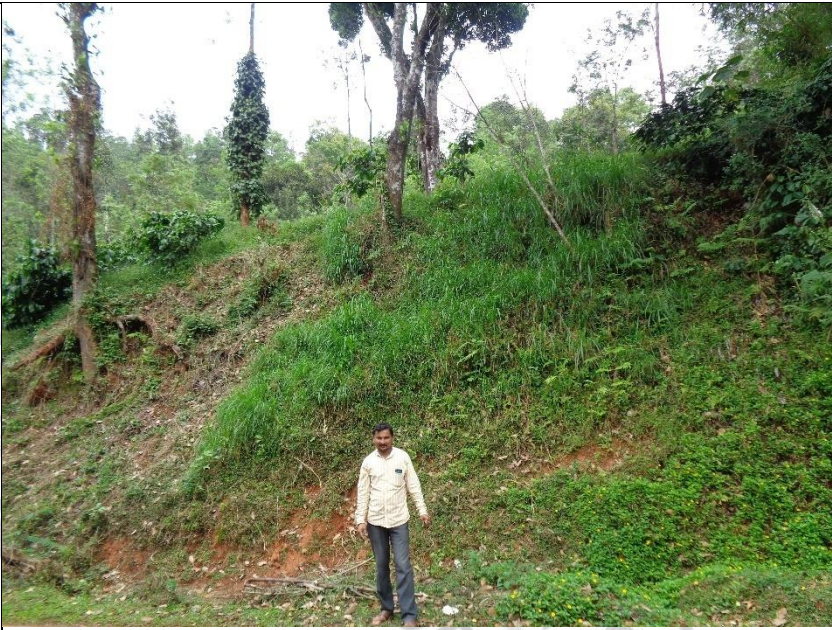
| 40 | Summary/Abstract | In the valley portion stream is flowing and toe erosion by stream. Vertical cut made for road which triggered by intense rain. |

| 37 | Remedial measures | Slope benching is required & gabion wall& Drainage management is required. |

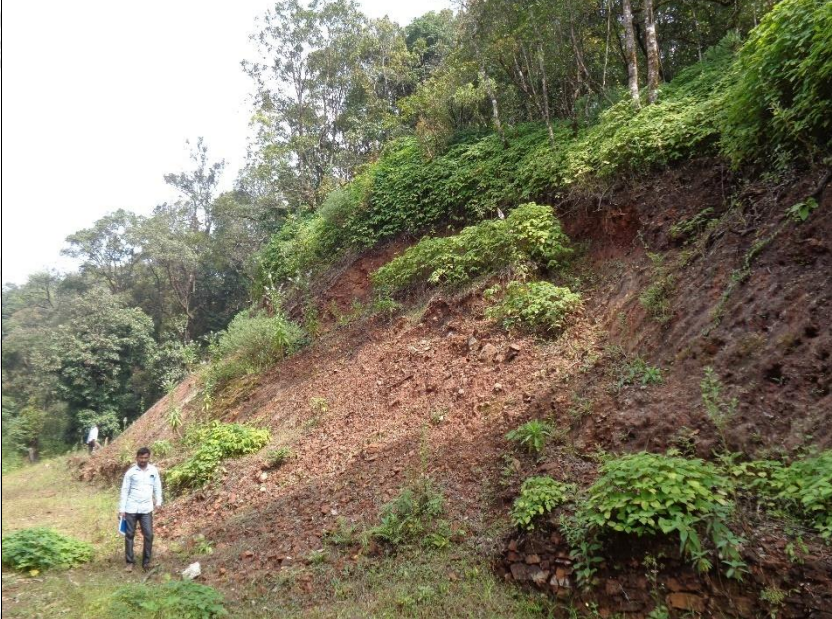
| 40 | Summary/Abstract | The slope cut to construct the road to connect homestay. Cut slope failed which triggered by heavy rain. Slope benching is required & drainage management is required. |

| 37 | Remedial measures | Slope benching is required & drainage management is required. |

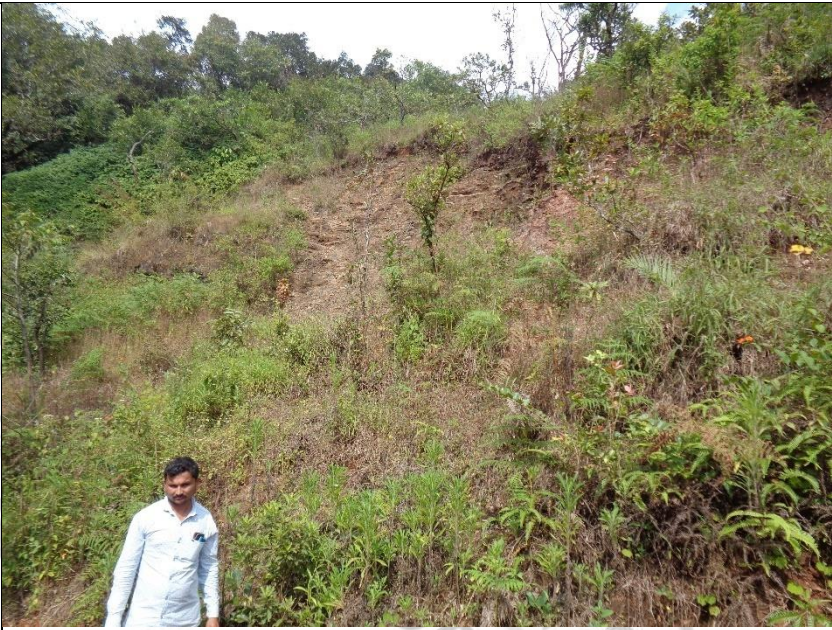
| 40 | Summary/Abstract | Anthropogenic activities which is unplanned cutting of slope. Vertical cut made for road. Slope benching is required, drainage management is required & deep root plantation required. The unmetalled road is the risk factor which connected to Maitalkhan coffee estate. |

| No | Field | Description |
|---|---|---|
| 37 | Remedial measures | Slope benching is required, drainage management is required & deep root plantation required. |

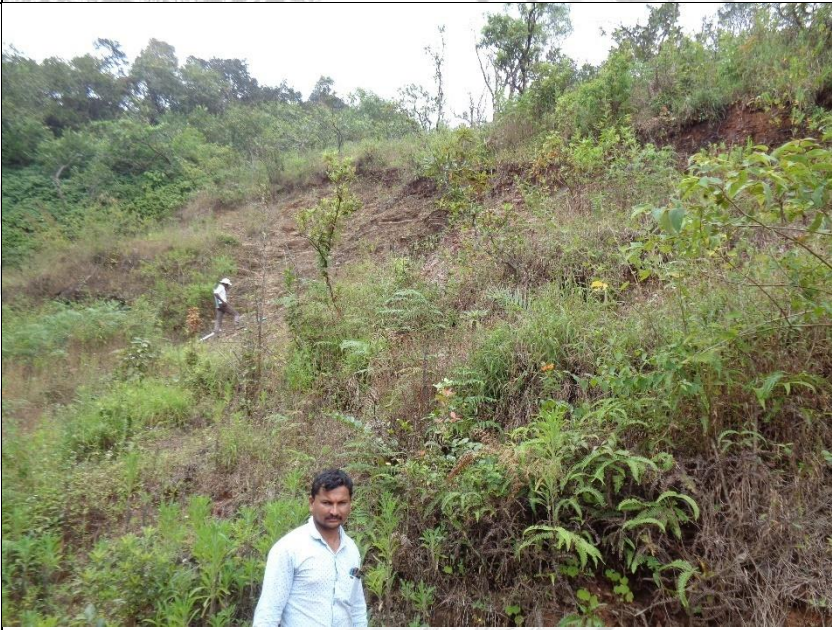
| 38 | Remarks, if any | The slide is falling within jungle. |
| 40 | Summary/Abstract | The landslide occurred within forest area as such there is no risk element. The unmetalled road is the risk factor which connected to Maitalkhan coffee estate. Due to unplanned cutting of slope landslide occurred. Slope benching is required & deep root plantation required. The slide is falling within jungle. |

| 37 | Remedial measures | Slope benching is required & deep root plantation required. |

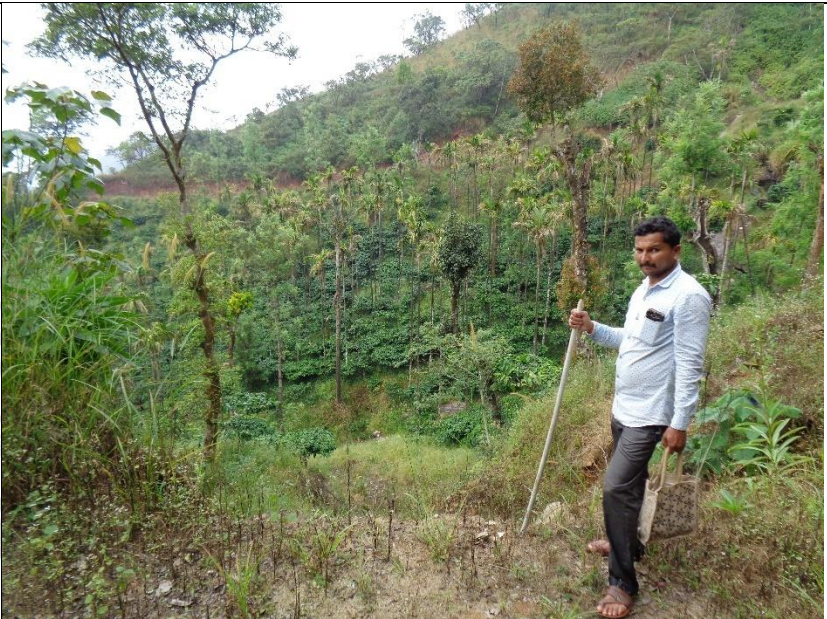
| 22 | Failure mechanism | Shallow rotational failure |
| 36 | Geo-scientific Causes | Anthropogenic activities which is unplanned cutting of slope.<br>Vertical cut made for road. |

| 40 | Summary/Abstract | The landslide occurred within forest area as such there is no risk element. Due to unplanned cutting of slope landslide occurred. |

| 37 | Remedial measures | Slope benching is required & deep root plantation required. |

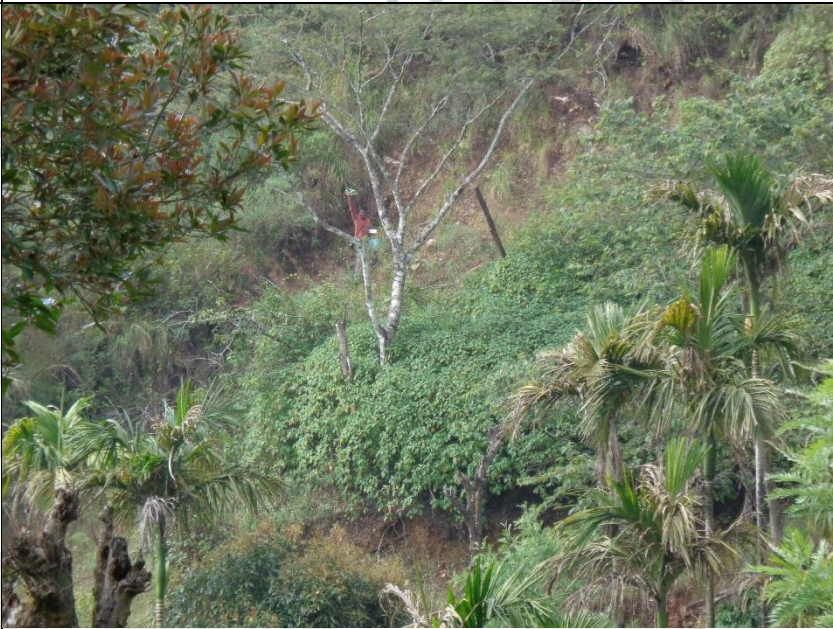
| No | Field | Description |
|---|---|---|
| 22 | Failure mechanism | Shallow rotational failure |

| 36 | Geo-scientific Causes | Anthropogenic activities which is unplanned cutting of slope. Cut made for estate road (mud road). |
| 40 | Summary/Abstract | The landslide occurred within forest area as such there is no risk element. Due to unplanned cutting of slope landslide occurred. |

| 37 | Remedial measures | Slope benching is required. |

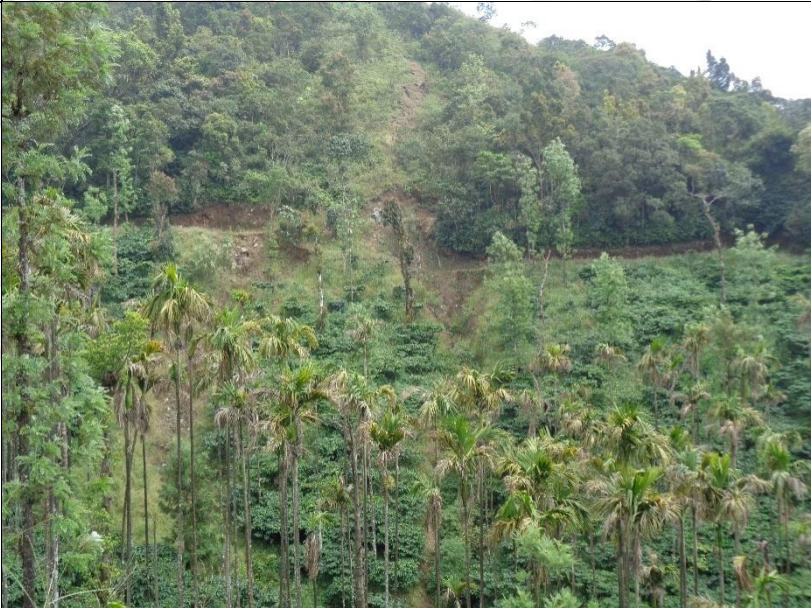
| 22 | Failure mechanism | Shallow rotational failure |
| 36 | Geo-scientific Causes | Anthropogenic activities which is unplanned cutting of slope. Cut made for estate road (mud road). |

| 40 | Summary/Abstract | The landslide occurred within forest area as such there is no risk element. The risk element is agriculture land & the unmetalled road is the risk factor which connected to coffee estate. Due to unplanned cutting of slope landslide occurred. |

| 37 | Remedial measures | Slope benching is required. |

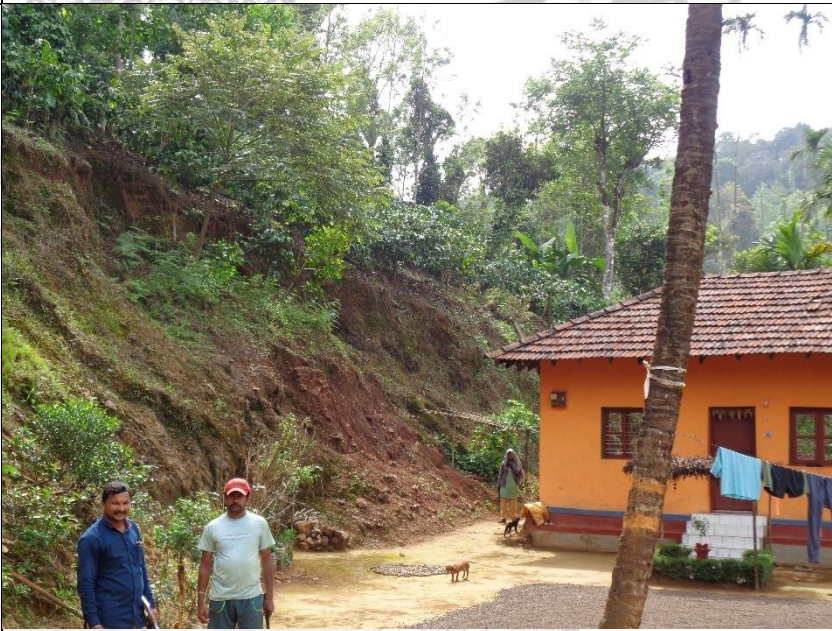
| 22 | Failure mechanism | Shallow rotational failure |
| 36 | Geo-scientific Causes | Anthropogenic activities which is unplanned cutting of slope. Cut made for house construction. |
| 38 | Remarks, if any | New house has been provide by DC office. |
| 40 | Summary/Abstract | The landslide occurred adjacent to the residential house. The house is at risk during heavy rain. Stream is also flowing adjacent to the house. New house site has been provide by DC office Ckikkamagaluru. |

| 37 | Remedial measures | Slope benching is required. Drainage is required to avoid percolation of rain water within the foundation. |
