REPORT ON MESO-SCALE LANDSLIDE SUSCEPTIBILITY MAPPING (1:10,000) IN AND  
AROUND NIDUVATTU, MUKKODLU & MEGATTALU AREAS, KODAGU DISTRICTS OF  
KARNATAKA

Item no.: M4LSSM/NC/SR/SU-KG/2018/26601

Final report for field season 2018-19

Aijaz Ahmad Bhat, Senior Geologist & Dr. Zameer Ahmad Shah, Geologist

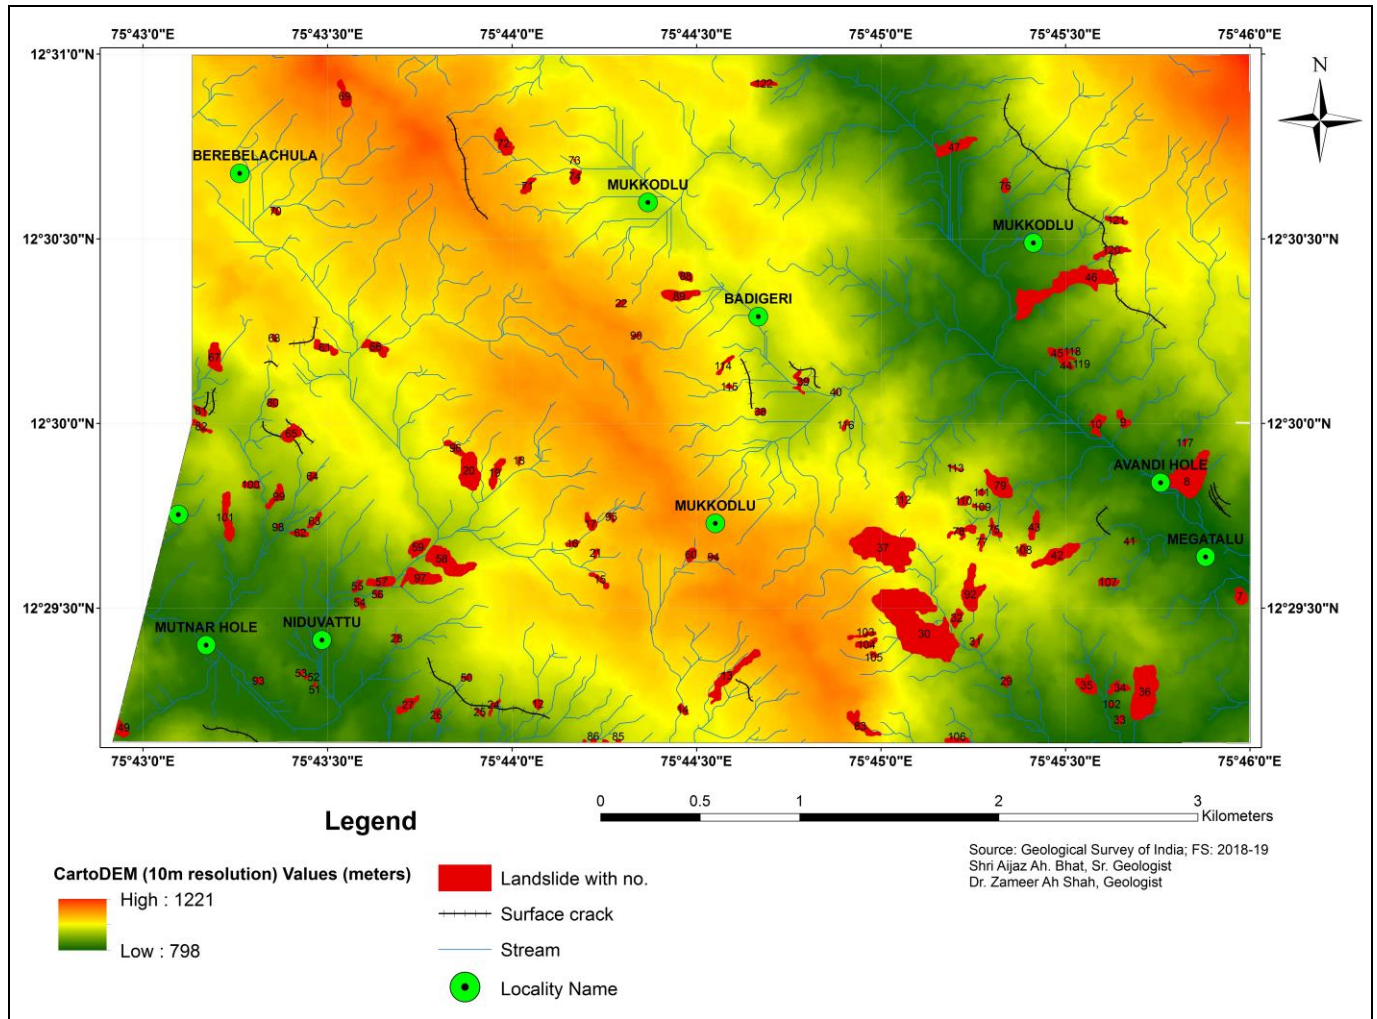
Figure-3.1: Landslide inventory map showing landslides with number and surface cracks overlapped with drainage and DEM

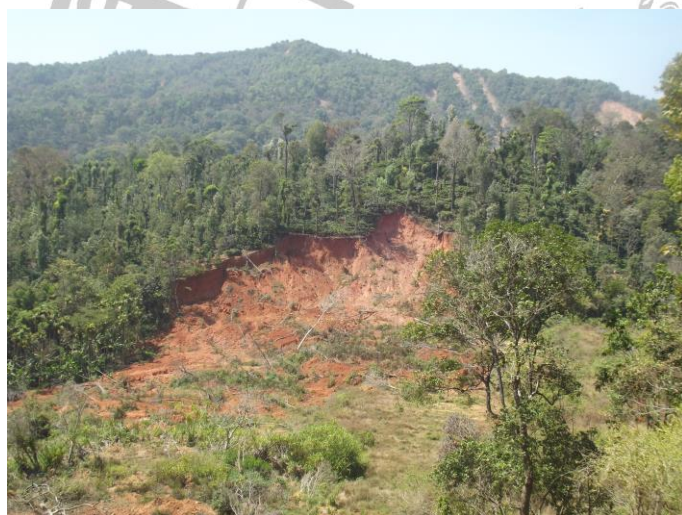
(a) Earth slide occurred on gentle side slope of a major stream in Megatalu village

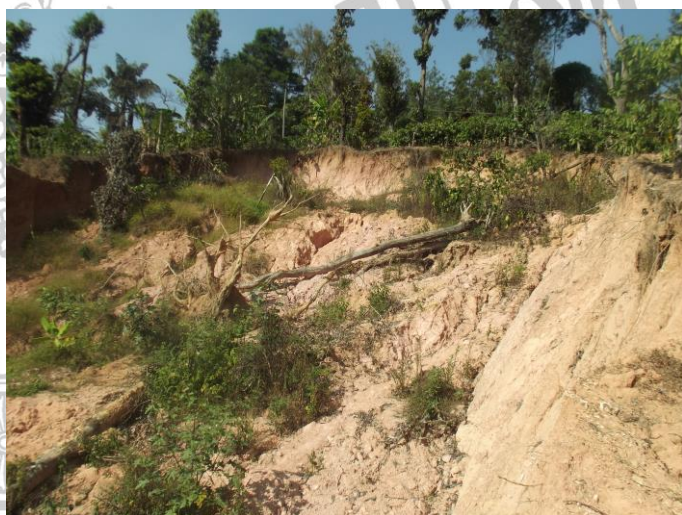
(b) Earth slide occurred in cultivated land on moderate slope by water saturation in Megatalu village

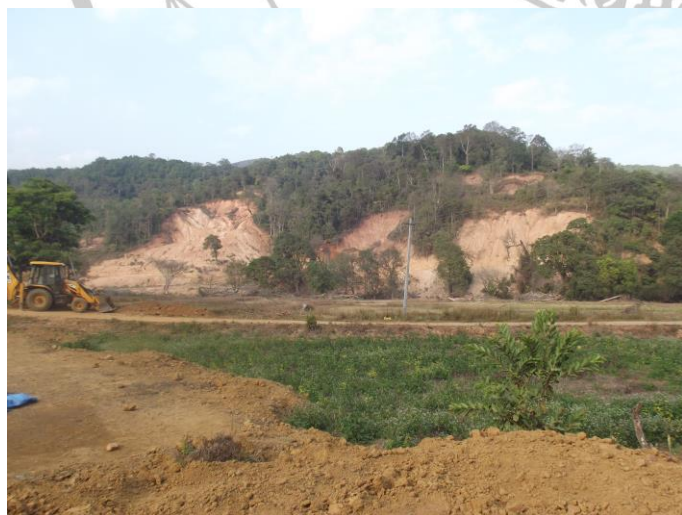
(c) Earth flow and channel erosion (no.8) occurred on moderate to high left side slopes of Avandi Hole in Megatalu village

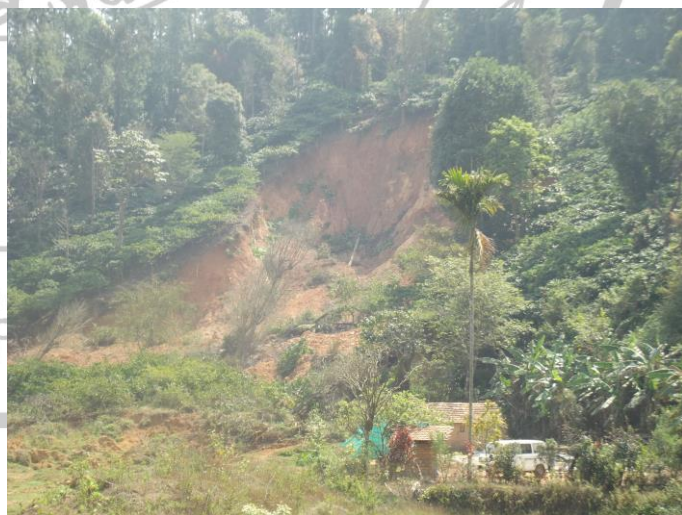
(d) Debris slide occurred on right side high slopes of Avandi Hole in Megatalu village

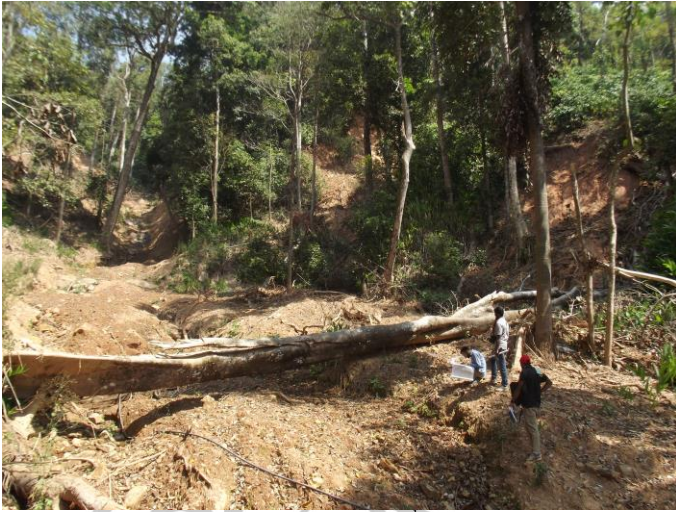
(e) Channel erosion and flow along a 2<sup>nd</sup> order stream in Badigeri village

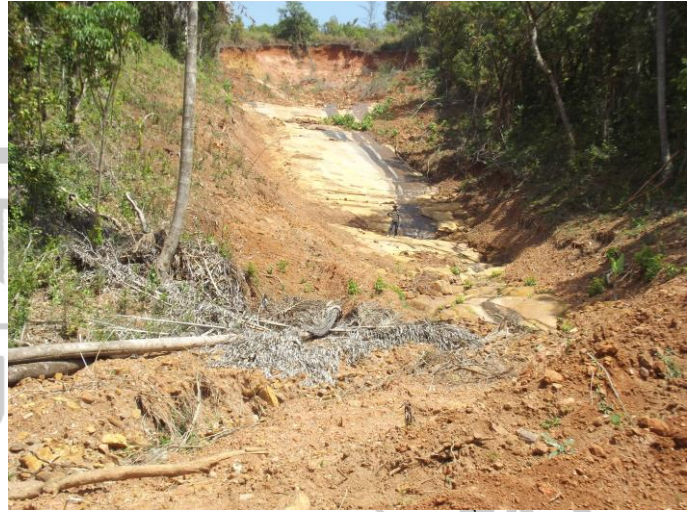
(f) Channel erosion and flow along a 1<sup>st</sup> and 2<sup>nd</sup> order stream in south Mukudlu village. The rock exposed here is Granite Gneiss with some Amphibolite layers.

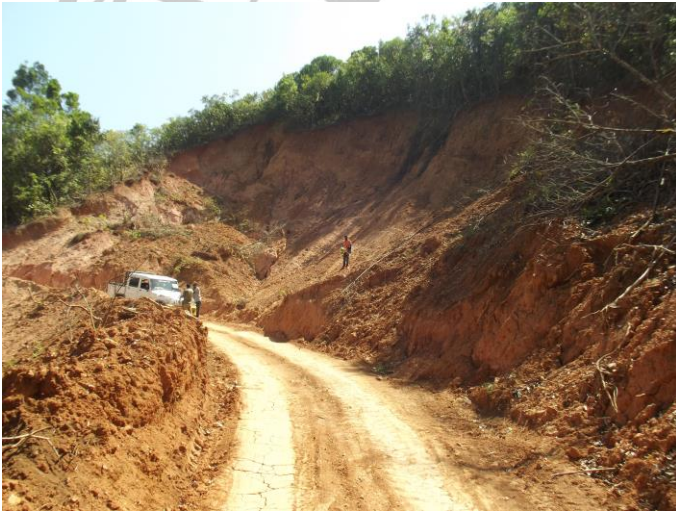
(g) Earth slide occurred on moderate to high slope which have affected the local road to north-eastern Niduvatu village

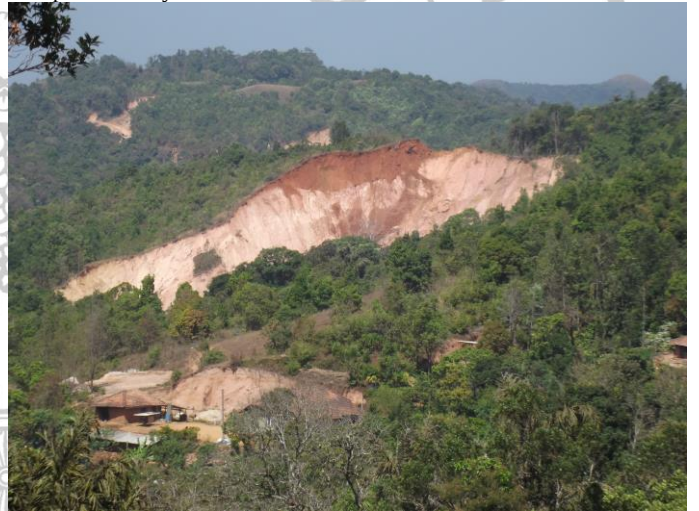
(h) Earth flow occurred along 1<sup>st</sup> order stream developed on moderate slope with thick overburden cover (weathered black color material of Amphibolite rock and milky white material of Granite Gneiss) in north-eastern Niduvatu village

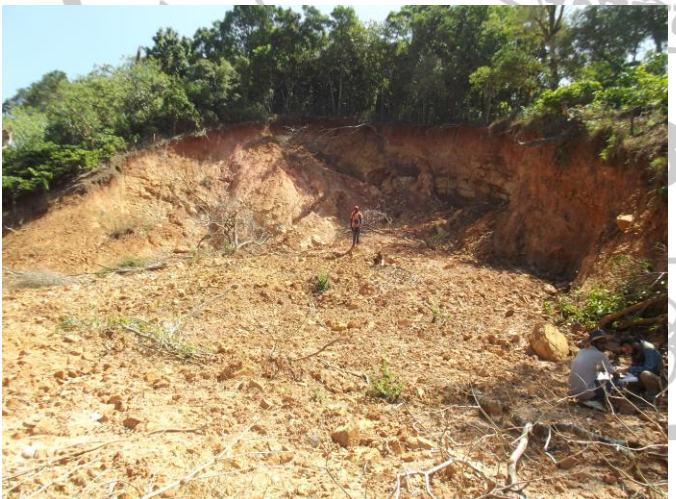
(i) Debris flow occurred on moderate side slope of 2<sup>nd</sup> order stream in which rock fragments of different sizes have flown down in north-eastern Niduvatu village

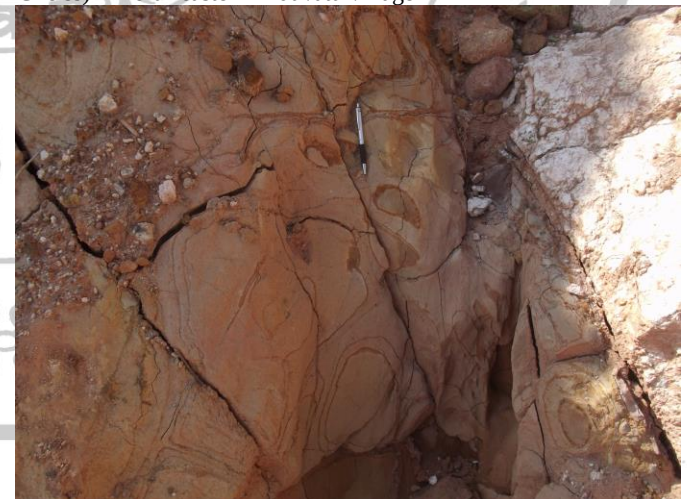
(j) Dewatering structures developed in the vicinity of landslide shown in (h) above. These structures are developed in very fine grained weathered rock associated with Granite Gneiss along a faulted contact in north-eastern Niduvatu village

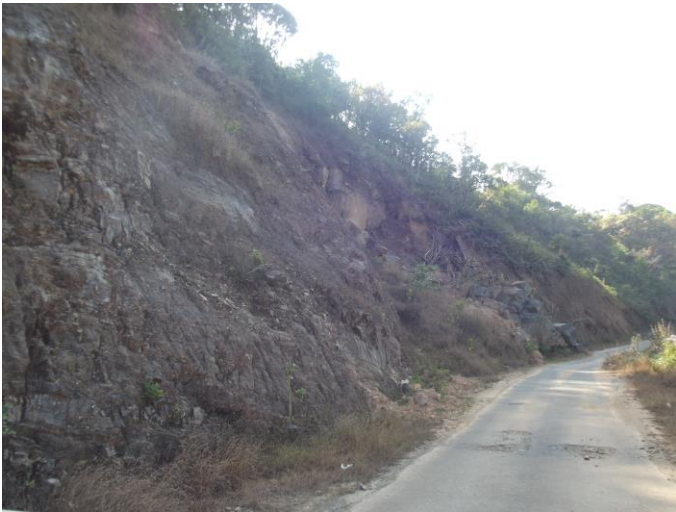
(k) Rock slide occurred in Granite Gneiss with Amphibolite bands in north Berebelachula village

- ❖ All the landslides occurred in the area are confined to overburden, except at one place, where rock slide (wedge failure) has occurred due to favorable angular relationship of foliation plane and joint planes.

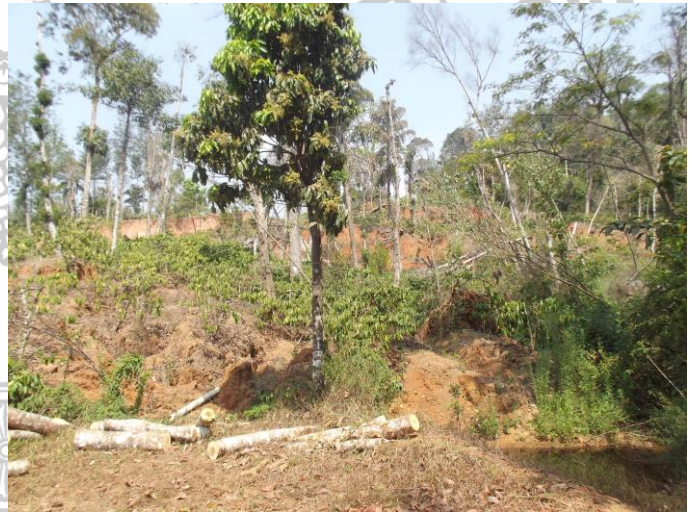
(n) A lateral spread type of landslide occurred in south of Megatalu village. The overburden material have spread at different dimensions rather than flown, along with surface objects after might getting liquefy.

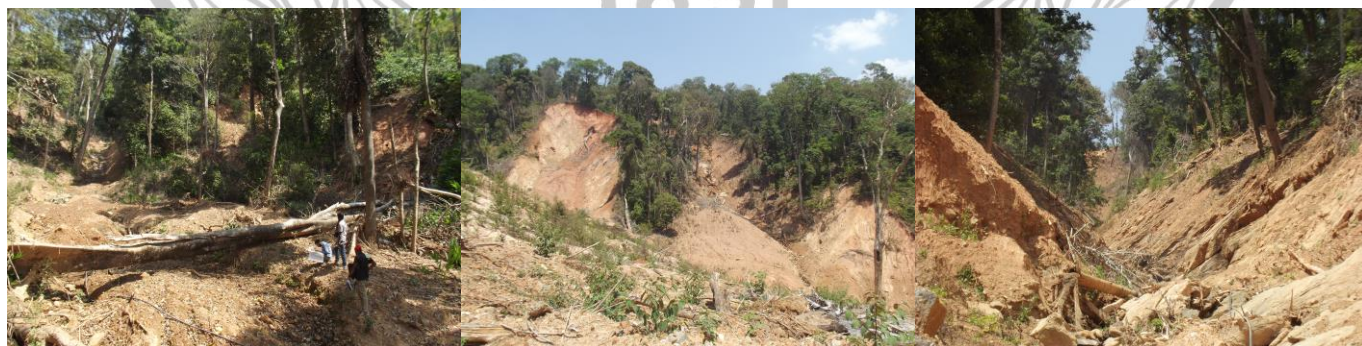
Figure-4.4: Shows how the overburden material has eroded and flown along the drainage of different stream orders

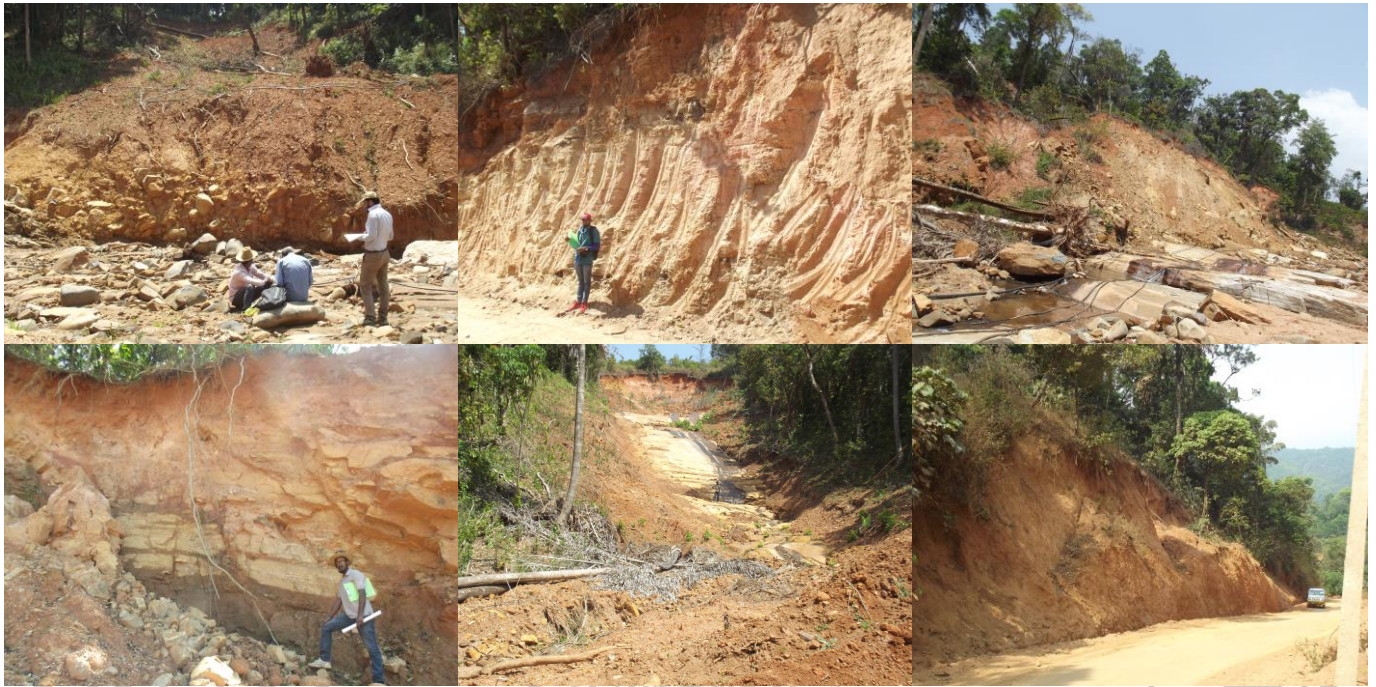
Figure-4.8: Shows field photographs of bedrock surface and overburden thickness sections and cut slopes in different places of study area which became very helpful to assume the overburden thickness

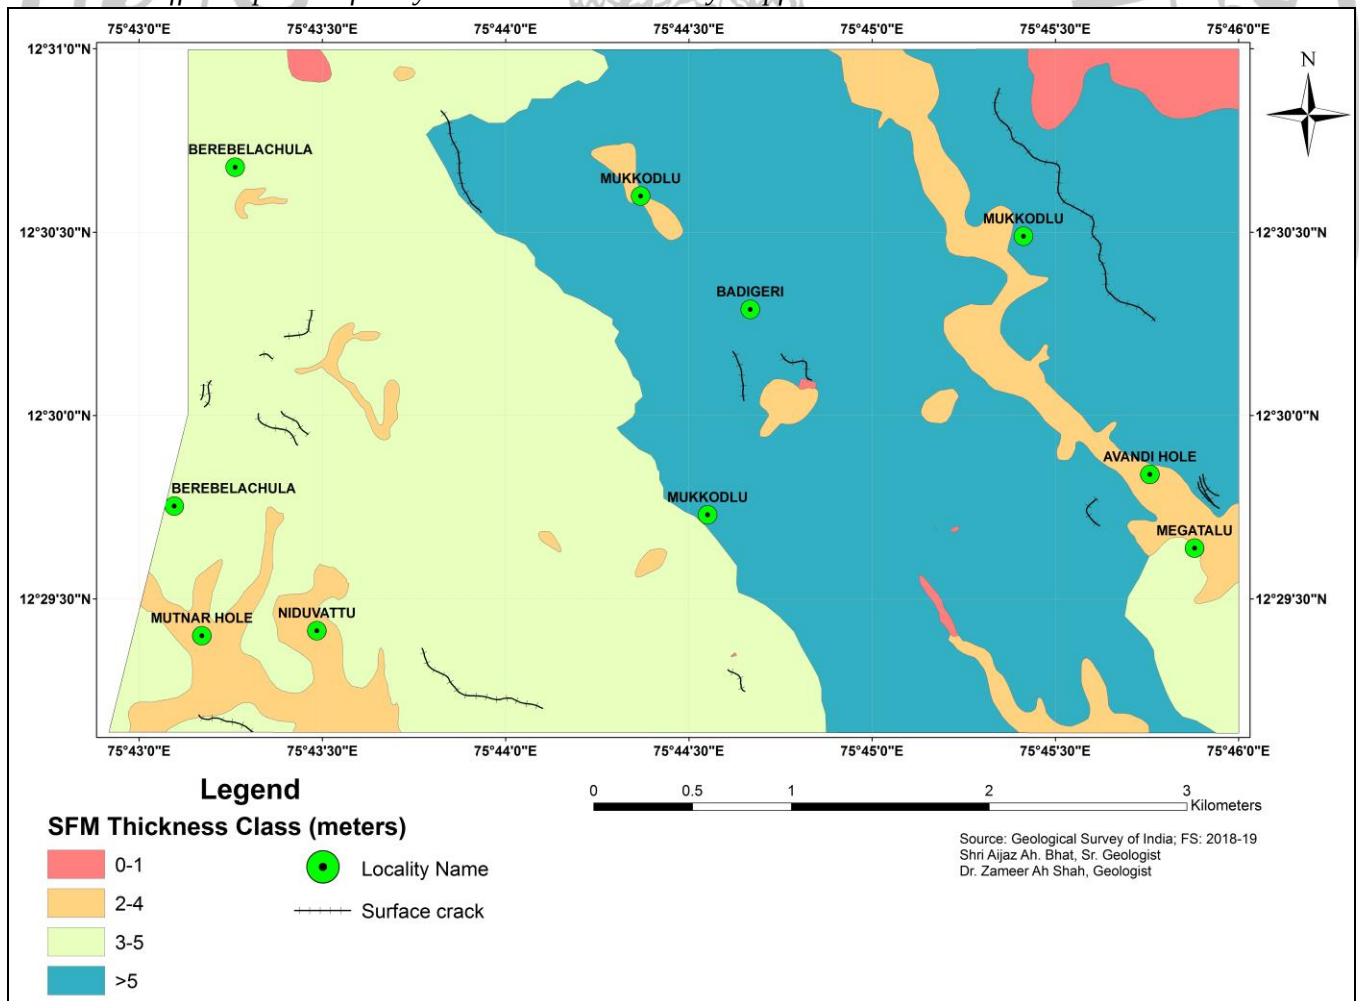
Figure-4.9: Shows SFM thickness map prepared during field studies

The hill slope overburden classes have played major role in occurrence of overburden involved landslides in the area and became the primary factor in which different hydrological processes and various mass involved forces have acted during rainfall to change different geotechnical parameters. The >5m thick overburden class is more positively responded to occur the landslides (see table-4.6) which likely signifies the fact that the stuck of infiltrated rain waters in this quite thick overburden of >5m due to poor performance of drainage network parameters (see fig. 6.2-6.4) have generated variable pore pressures which have impacted the geotechnical parameters of overburden quite strongly to occur the slope failures particularly in natural slopes without cut-slopes and where there are no interventions of human activity or stream erosion.

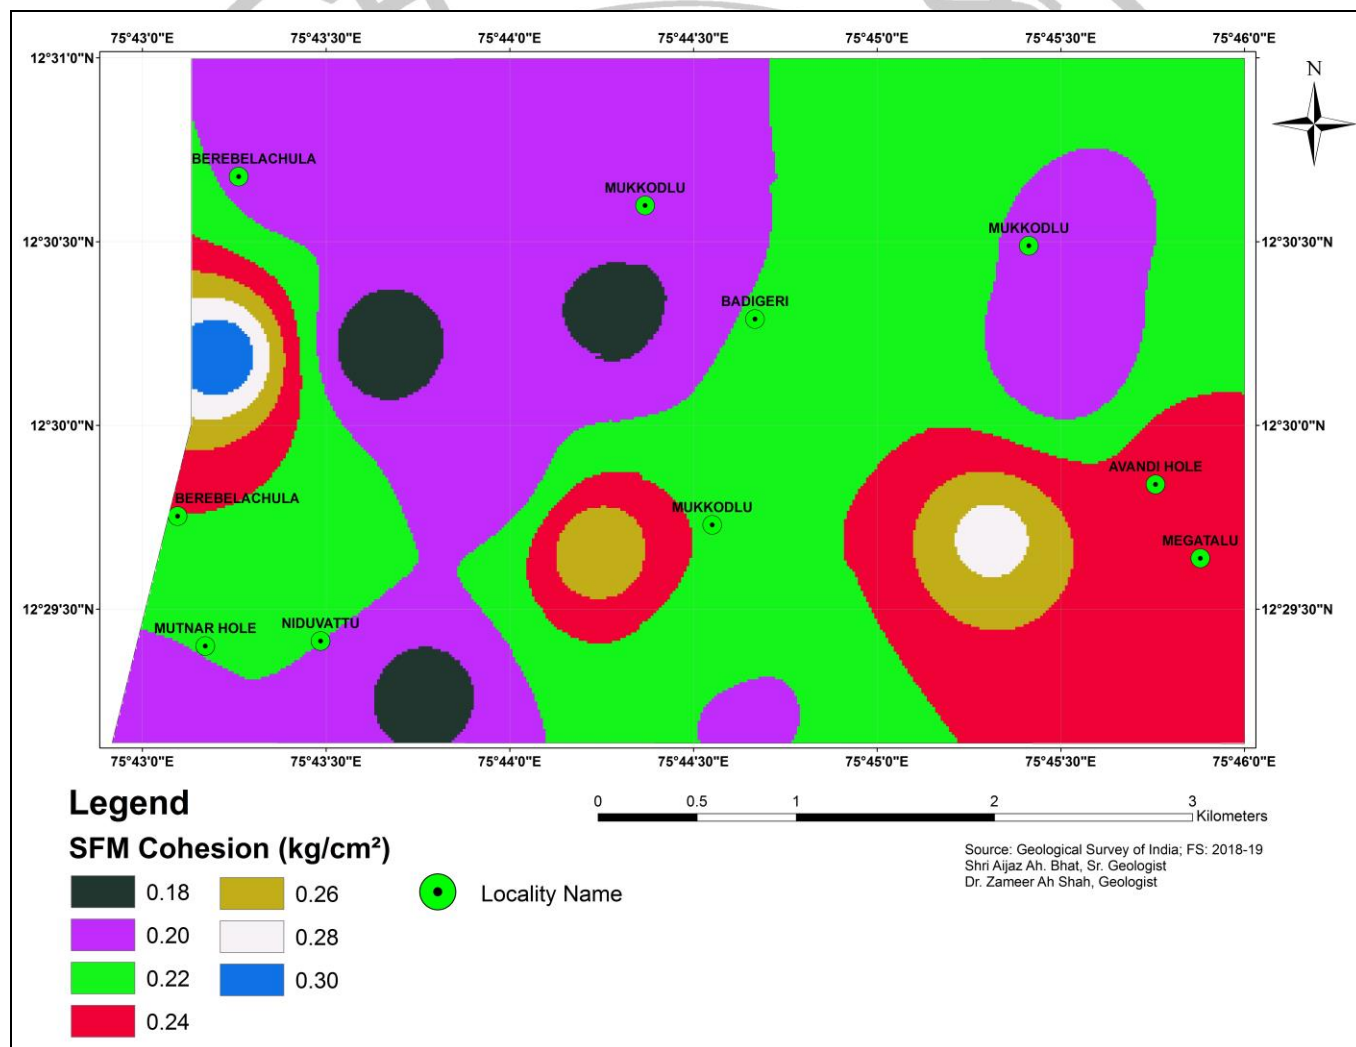
based theme of cohesion is reclassified in to 7 classes (see fig 4.10). Although the overburden material having high cohesion values signifies high shear strength of the material but in present study area the overburden material with high cohesion values are witnessed by high LOFS ratings (means the material has suffered lot by landslides) which should not be the case as compared to overburden material with low cohesion values. This fact reveals that the overburden material with high cohesion has lost shear strength by stuck of infiltrated rain waters due to poor performance of drainage network parameters.

Figure-4.10: Shows spatial distribution of cohesion of overburden material of study area

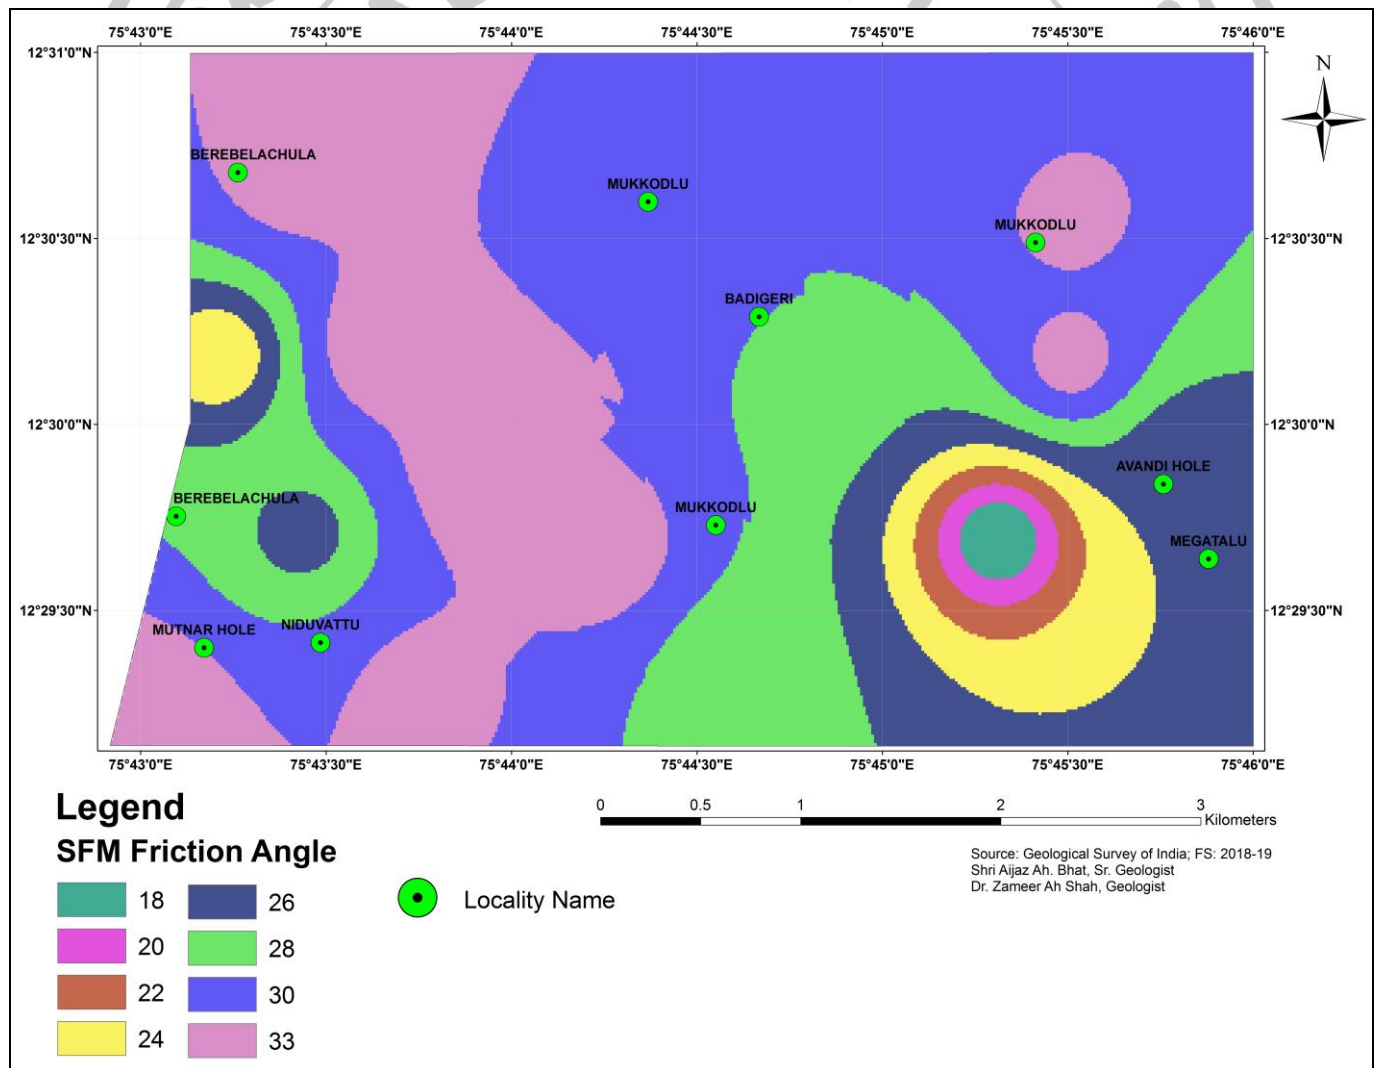
Figure-4.11: Shows spatial distribution of friction angle of overburden material of study area

The overburden material with low friction angle values experimentally proved to withstand a shear stress for short time limit as compared to the material with high friction angle values. In the present area the failures have occurred during rainfall event, hence the shear stress is likely in the form of variable pore

water pressures under which the overburden material with low friction values did not withstand for longer time limit. The overburden material with low friction angle values are witnessed high LOFS ratings which is quite relevant or true to SFM classes with fine grained material like in-situ soil with moderate to high slope gradients. As there is quite strong negative correlation between friction angle and cohesion ([see table-4.8](#)) and this thing reveals that overburden material with low friction angle and high cohesion values has got failures in the form of landslides and tensional cracks under the influence of variable pore water pressures developed by stuck of infiltrated rain waters due to poor performance of drainage network parameters.

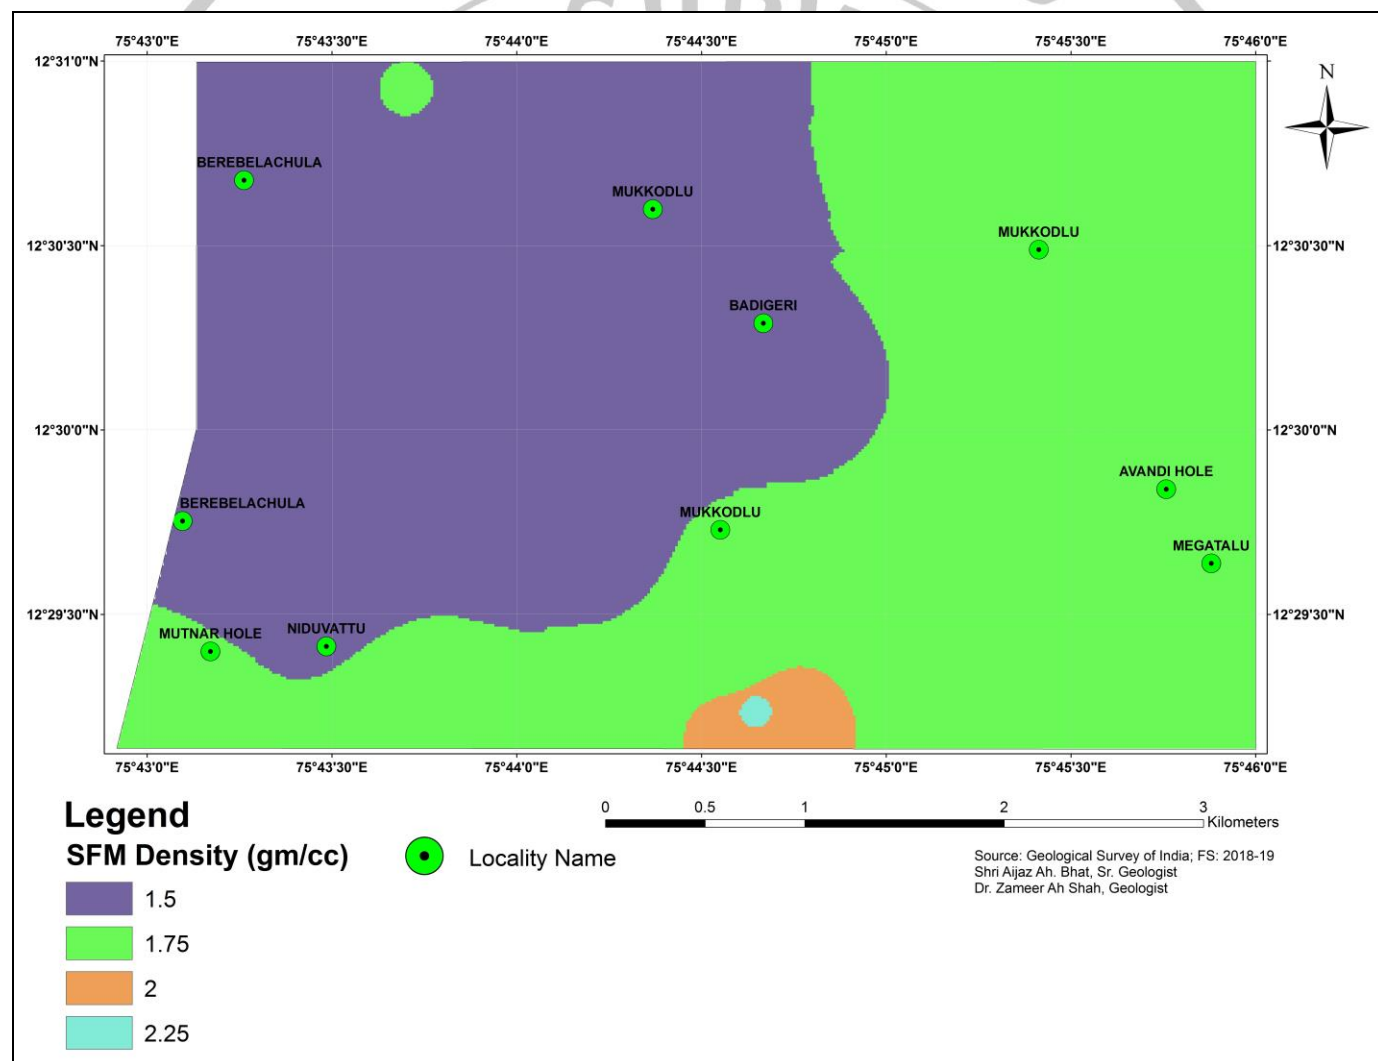
*Figure-4.13: Shows spatial distribution of density of overburden material of study area*

In present study the density of overburden material has strong correlation with porosity and void ratio and has quit moderate positive correlation with larger grain size particles such as gravel. The overburden material with low density values have suffered more landslides and are witnessed by high LOFS ratings as compared to overburden material with high density values. This thing reveals that overburden material with low density values is of fine texture, loose and porous with less compactness in

nature. This nature would have allow the material to generate variable pore water pressures on saturation particularly when infiltrated water flow get stuck and would have result natural slope failures irrespective of any human interference.

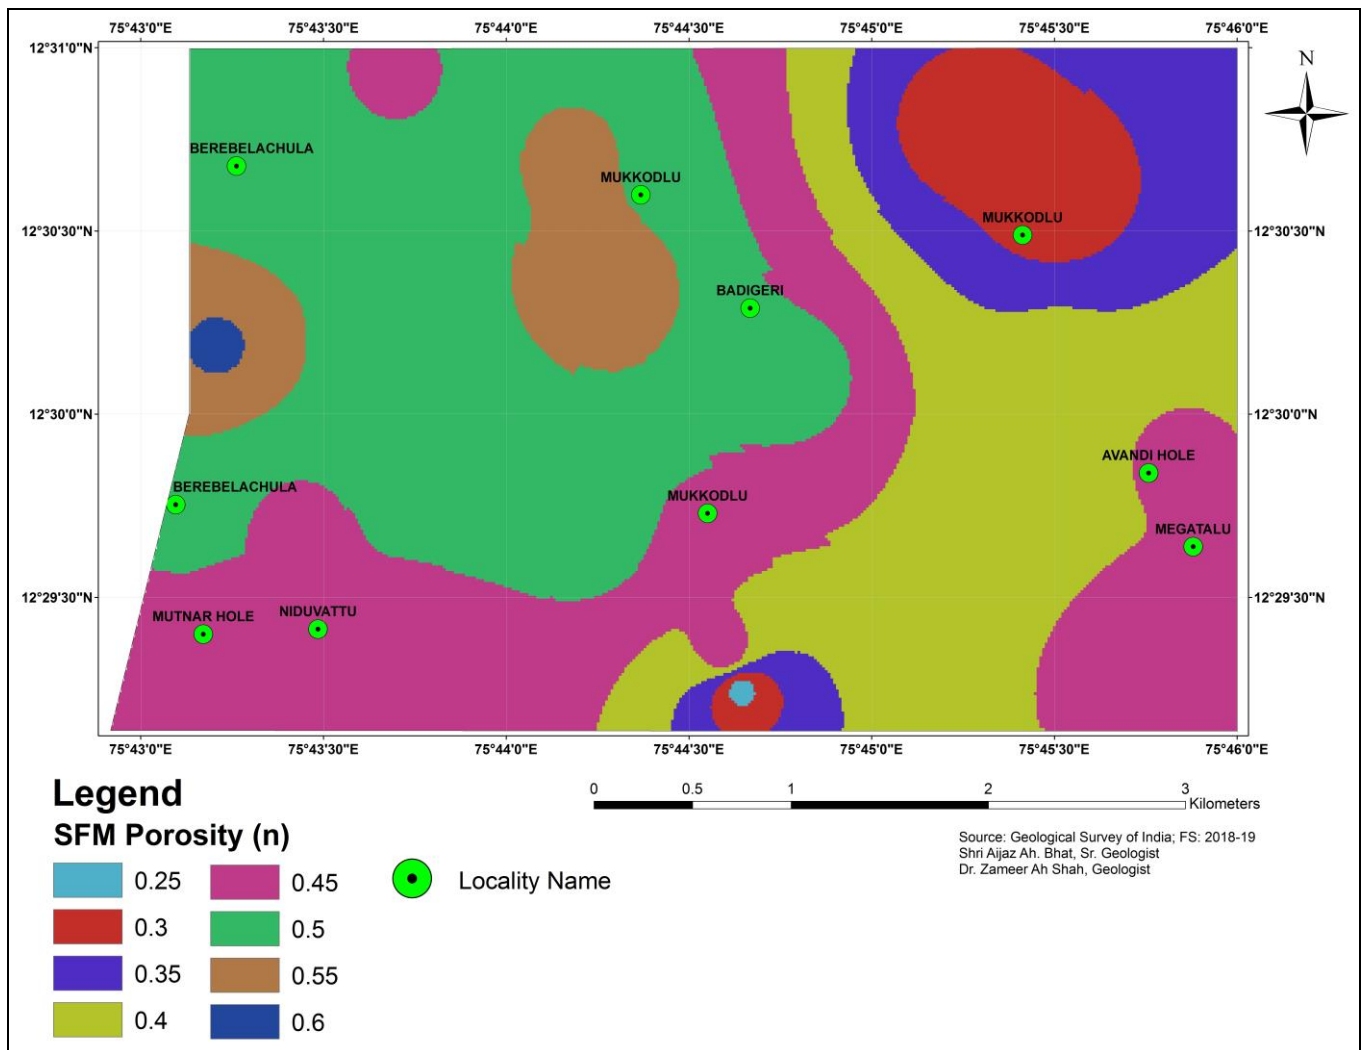
In present study the porosity of overburden material has quite moderate negative correlation with larger grain size particles (gravel) as the case should be. The overburden material with increasing porosity values reveals finer material and has affected much by landslides. This thing reveals again the fact like density that high porous nature would have allow the material to generate variable pore water pressures on

saturation particularly when infiltrated water flow get stuck and would have result natural slope failures irrespective of any human interference.

Figure-4.14: Shows spatial distribution of porosity of overburden material of study area

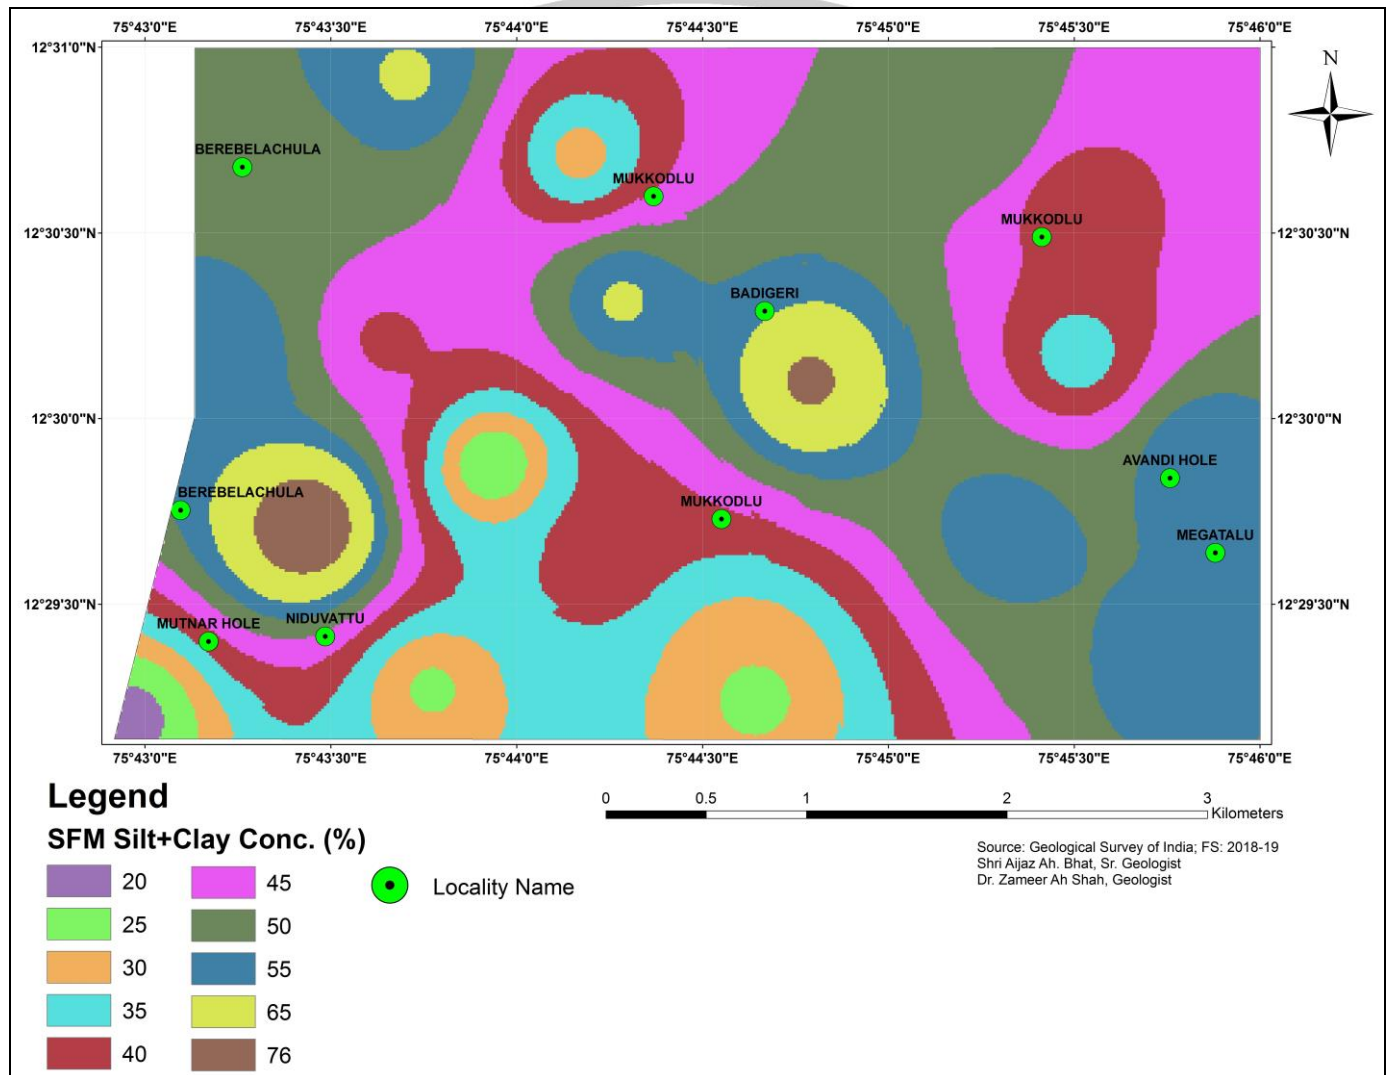
Figure-4.15: Shows spatial distribution of silt+clay percentage of overburden material of study area

The overburden material with low silt+clay percentage has witnessed by high LOFS ratings. It is basically the run-out debris reached the interpolated grain size classes with low silt+clay percentage in low lying areas where transported overburden material deposited. These overburden classes are quite vulnerable to movement during heavy rainfall. The overburden material with increasing silt+clay percentage is supported by high porosity, low density, high cohesion and low friction angle and is much influenced by landslides. This thing again reveals that overburden material with increasing silt+clay percentage and other properties discussed above have allow the material to generate variable pore water pressures on saturation particularly when infiltrated water flow get stuck and would have result natural slope failures irrespective of any human interference.

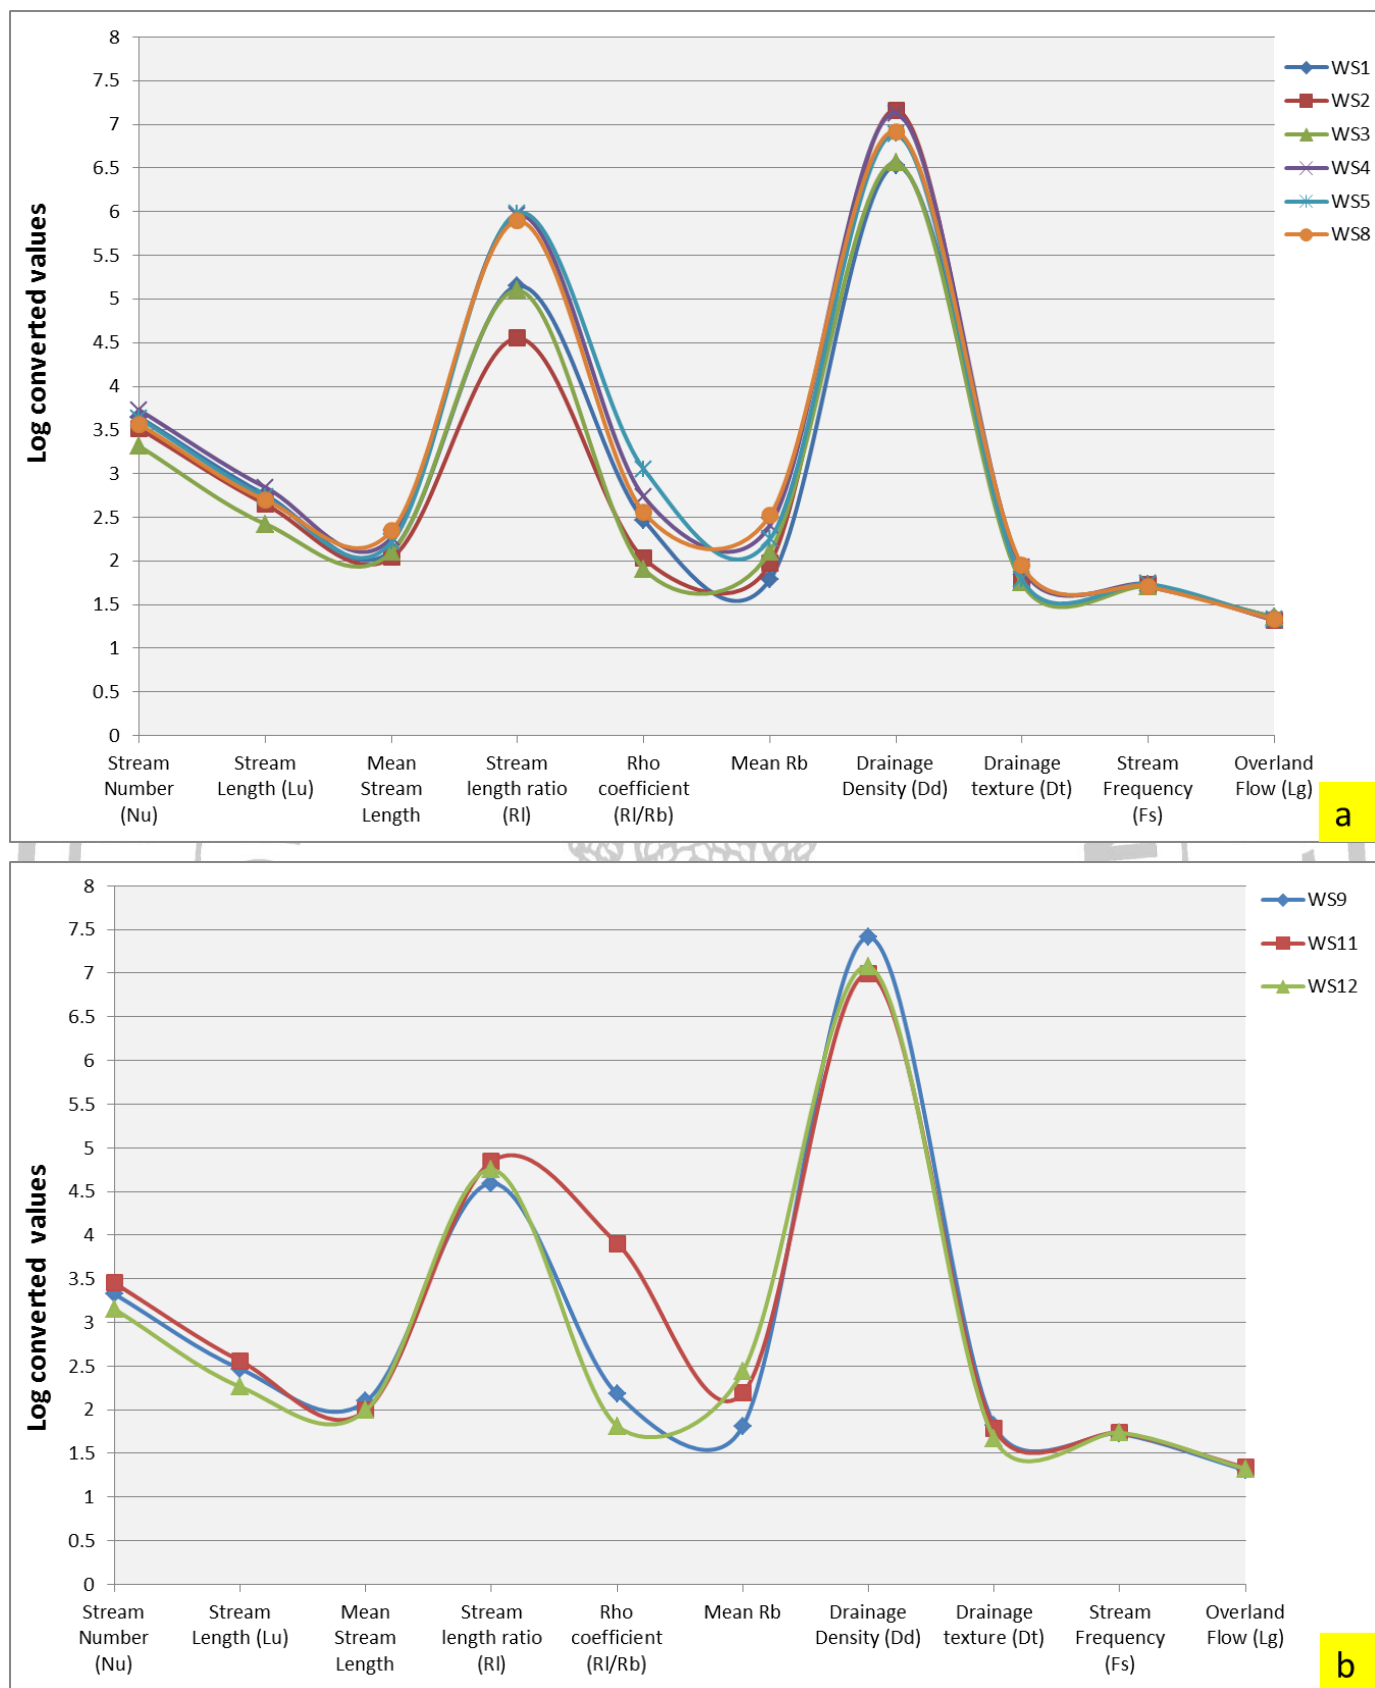
Figure-5.2: Shows mean average values of various morphometric attributes of watersheds of 7<sup>th</sup> order (a) and 6<sup>th</sup> order (b) level.

more runoff and low to moderate infiltration which leads to chances of high risk of erosion and flooding (S Sukristiyanti et. al, 2018). The stream length ratio, stream length, Rho coefficient, mean bifurcation ratio and drainage density are observed low for poorly draining watersheds (WS1, WS2, WS3) of 7<sup>th</sup> order level and WS9 of 6<sup>th</sup> order level which have suffered lot by landslides, scouring and channel erosion as compared to well drained watersheds (WS4, WS5, WS8) of 7<sup>th</sup> order level and WS11, WS12 of 6<sup>th</sup> order level (see fig. 5.2).
