REPORT ON MESO-SCALE LANDSLIDE SUSCEPTIBILITY MAPPING (1:10,000) IN AND  
AROUND NIDUVATTU, MUKKODLU & MEGATTALU AREAS, KODAGU DISTRICTS OF  
KARNATAKA

Item no.: M4LSSM/NC/SR/SU-KG/2018/26601

Final report for field season 2018-19

Aijaz Ahmad Bhat, Senior Geologist & Dr. Zameer Ahmad Shah, Geologist

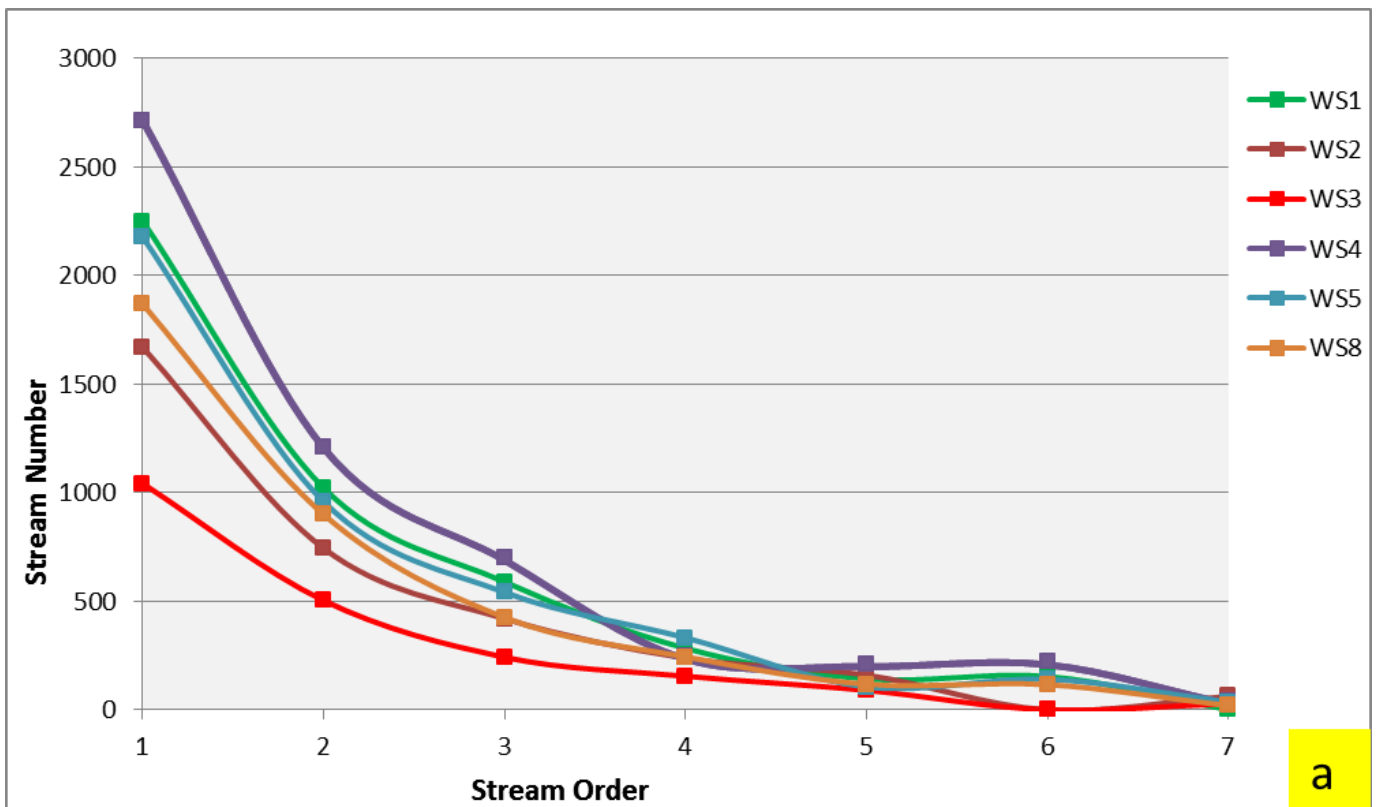
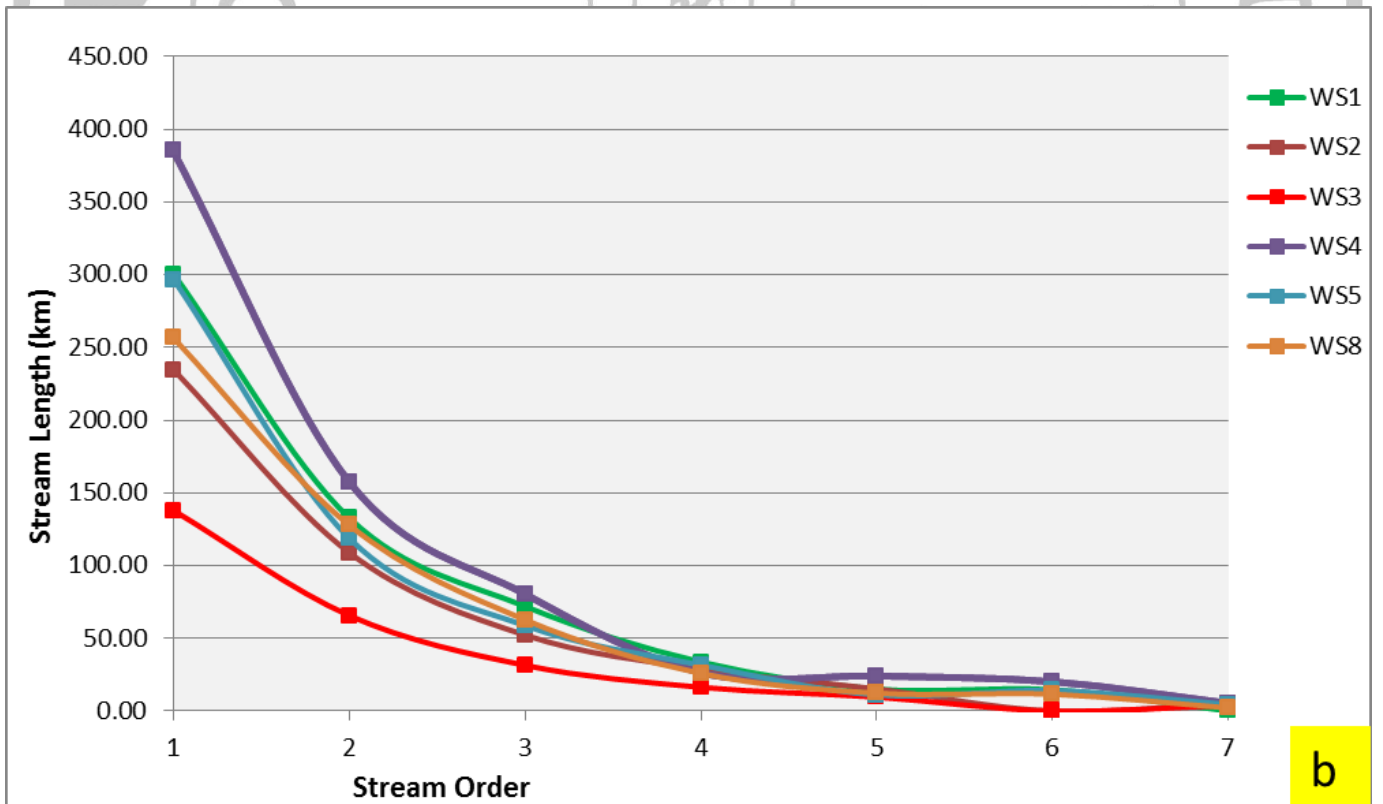
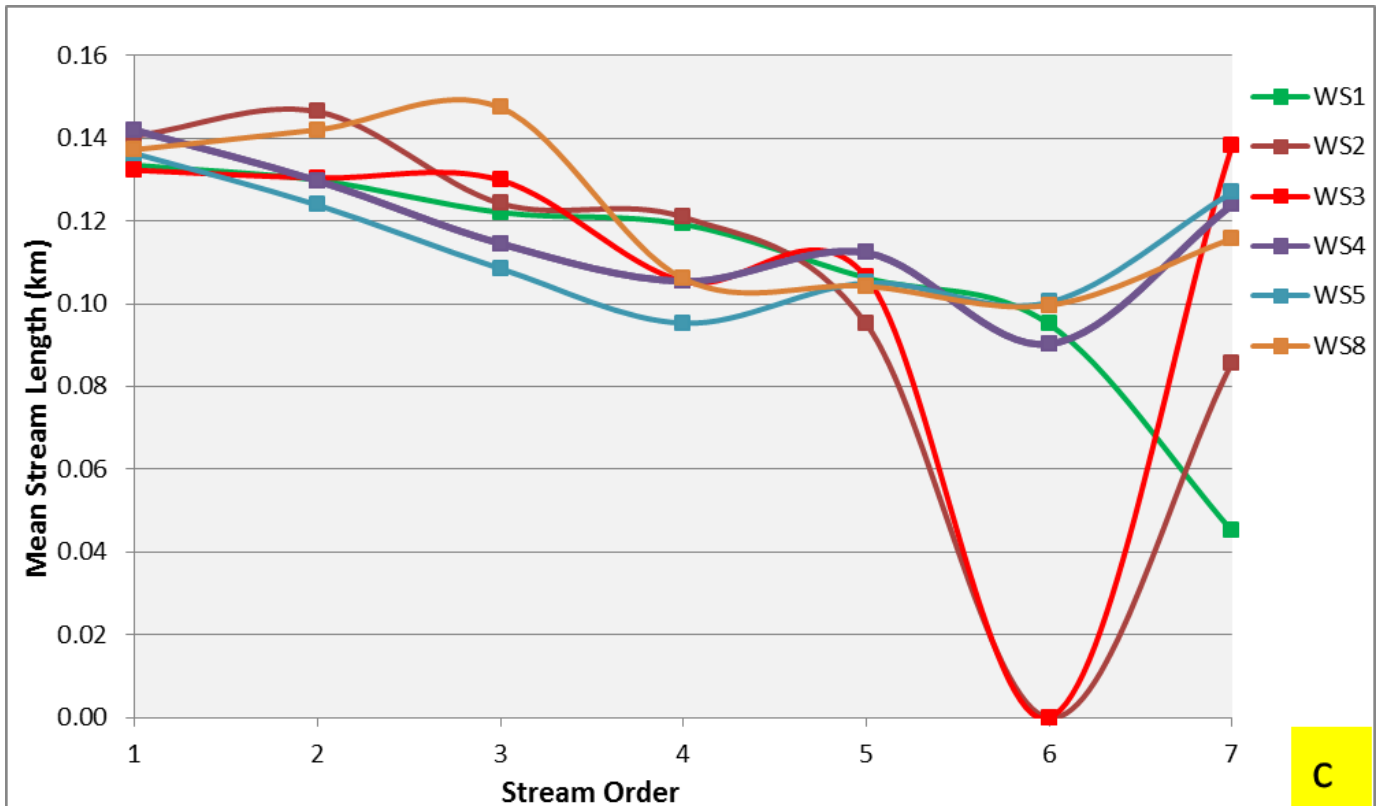
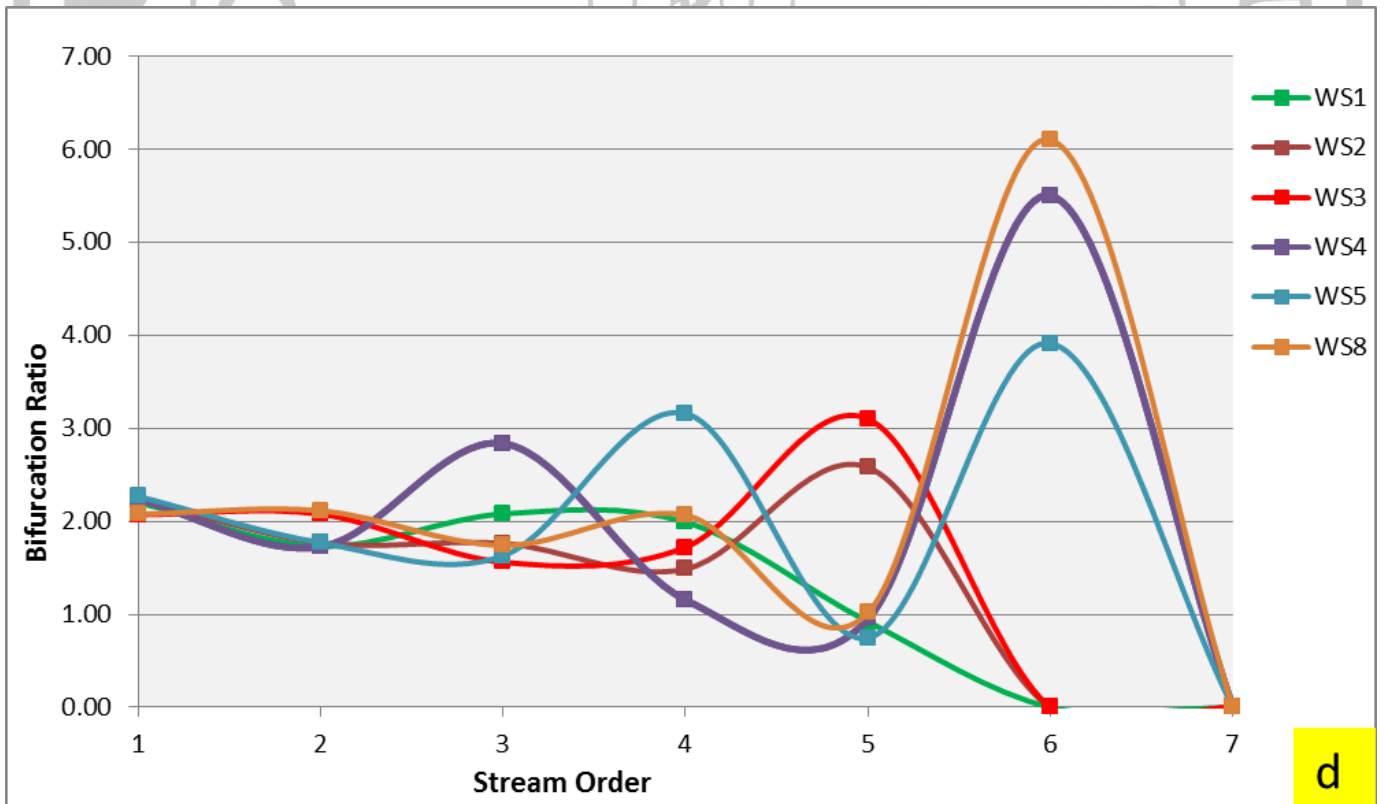
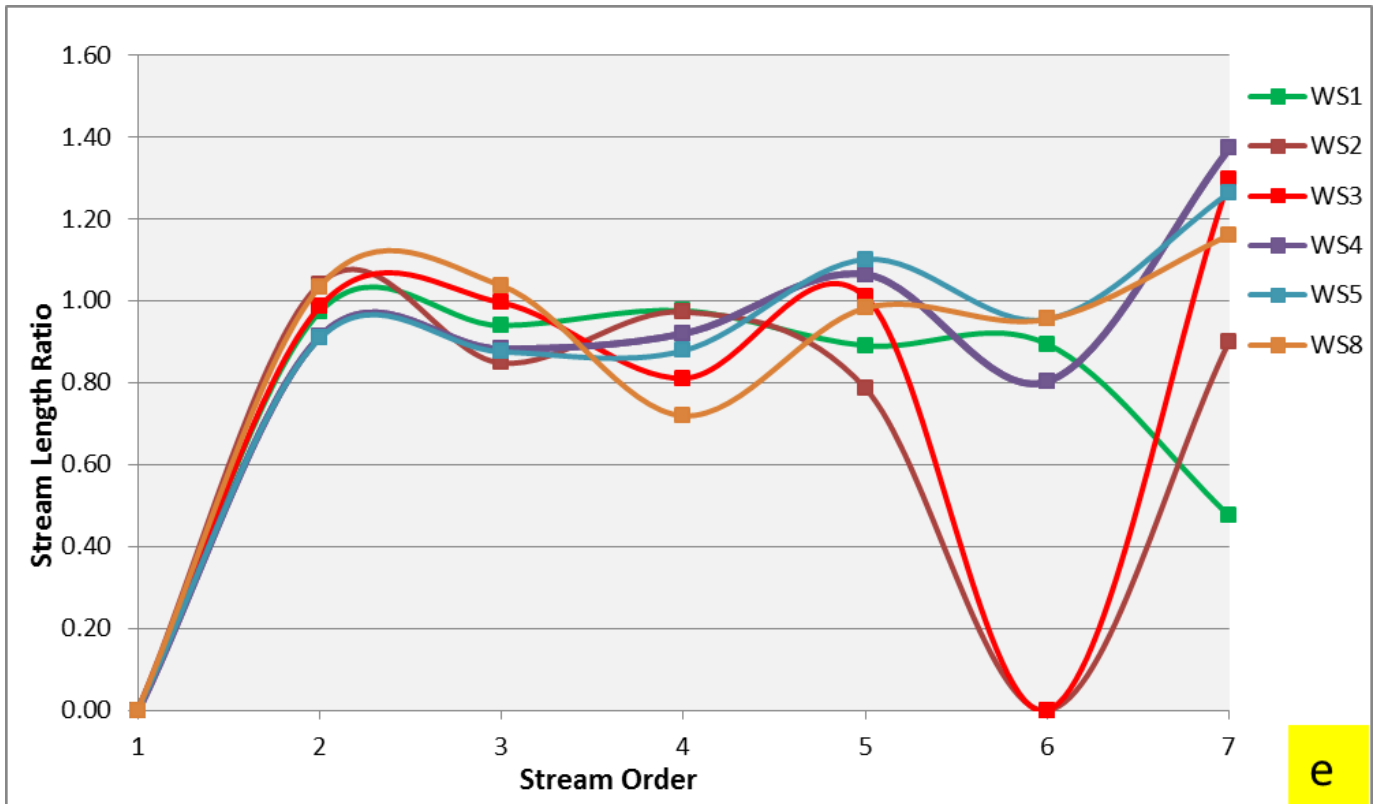
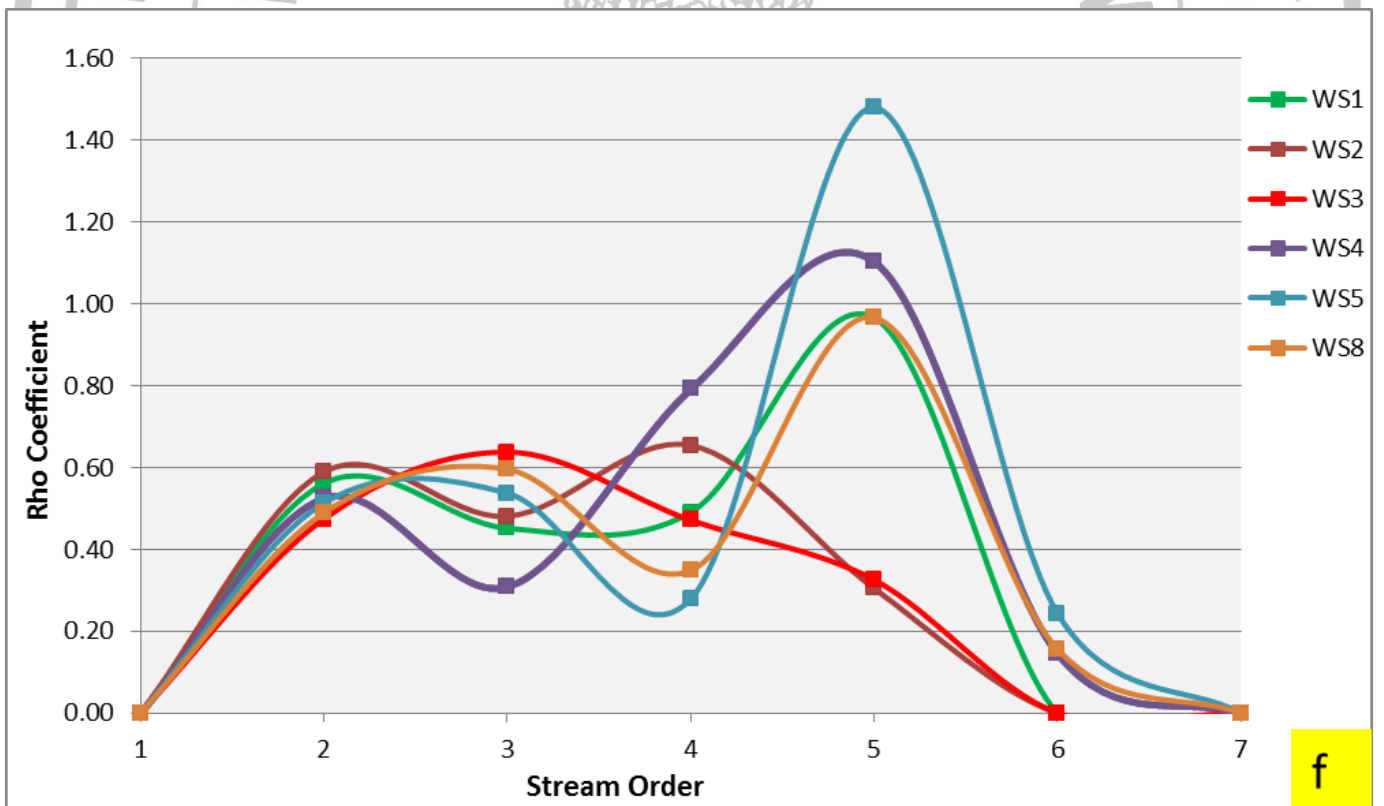
Figure-5.3(a)-(f): Shows performance of individual stream morphometric attributes of 7<sup>th</sup> order watersheds

- ❖ The first major causative factor was found by drainage network problem as there was poor performance to drain and distribute storage capacity of available waters in hierarchy stream orders during precipitation in landslide and channel erosion affected watersheds WS1 and WS2 wherein present study area lies (*see fig. 5.1*). This leads significant changes in various inherited equilibrated factors/parameters or processes acting within these watershed boundaries. These significant changes came in response after rise in actual rainfall by 2000mm not annually but eventually during June-September period 2018 and leads occurrence of channel erosion, scouring and landslides in clustering form. That is why the areas which were not witnessed by landslides or channel erosion lies in watersheds which have well performed to drain and distribute storage capacity of available waters in hierarchy stream orders during 2018 precipitation (*see fig. 5.3 & 5.4*).

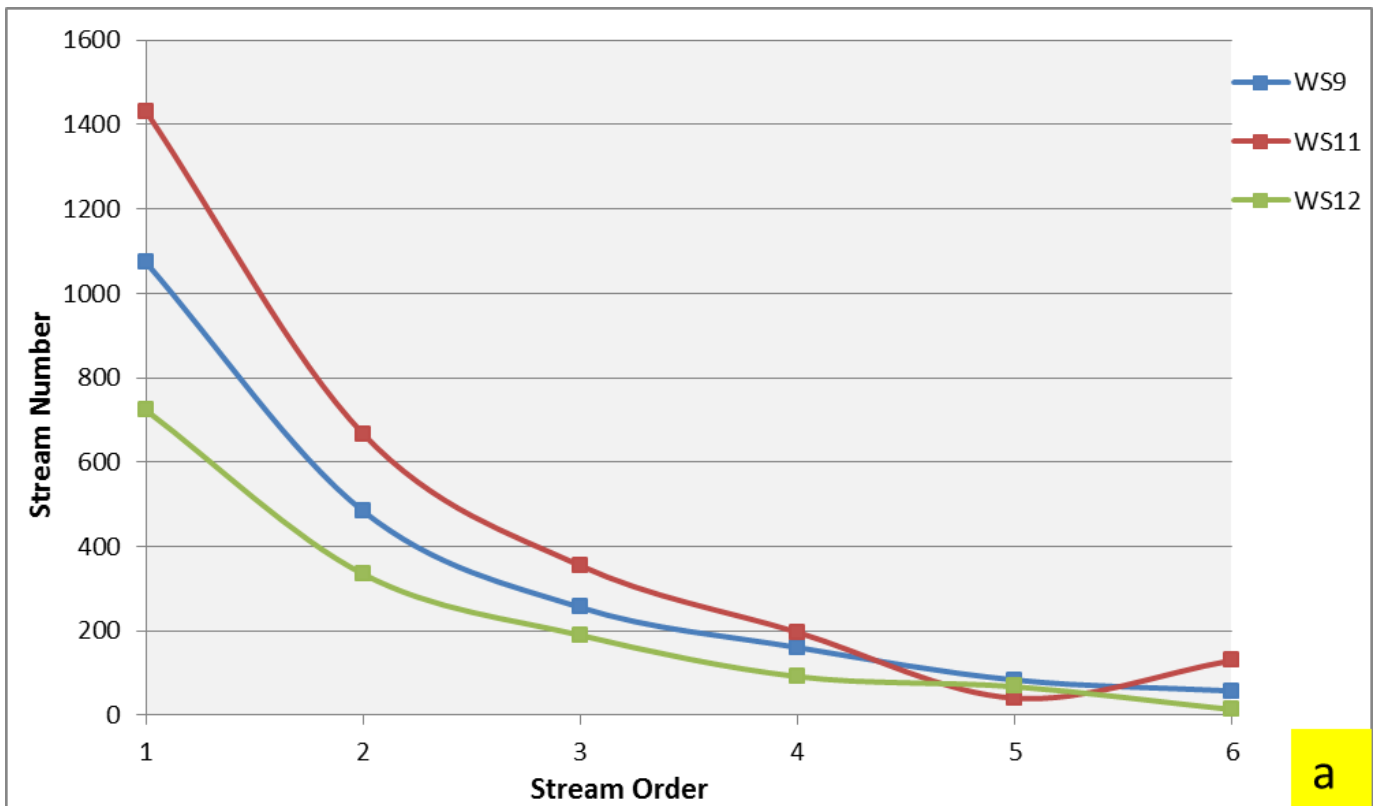
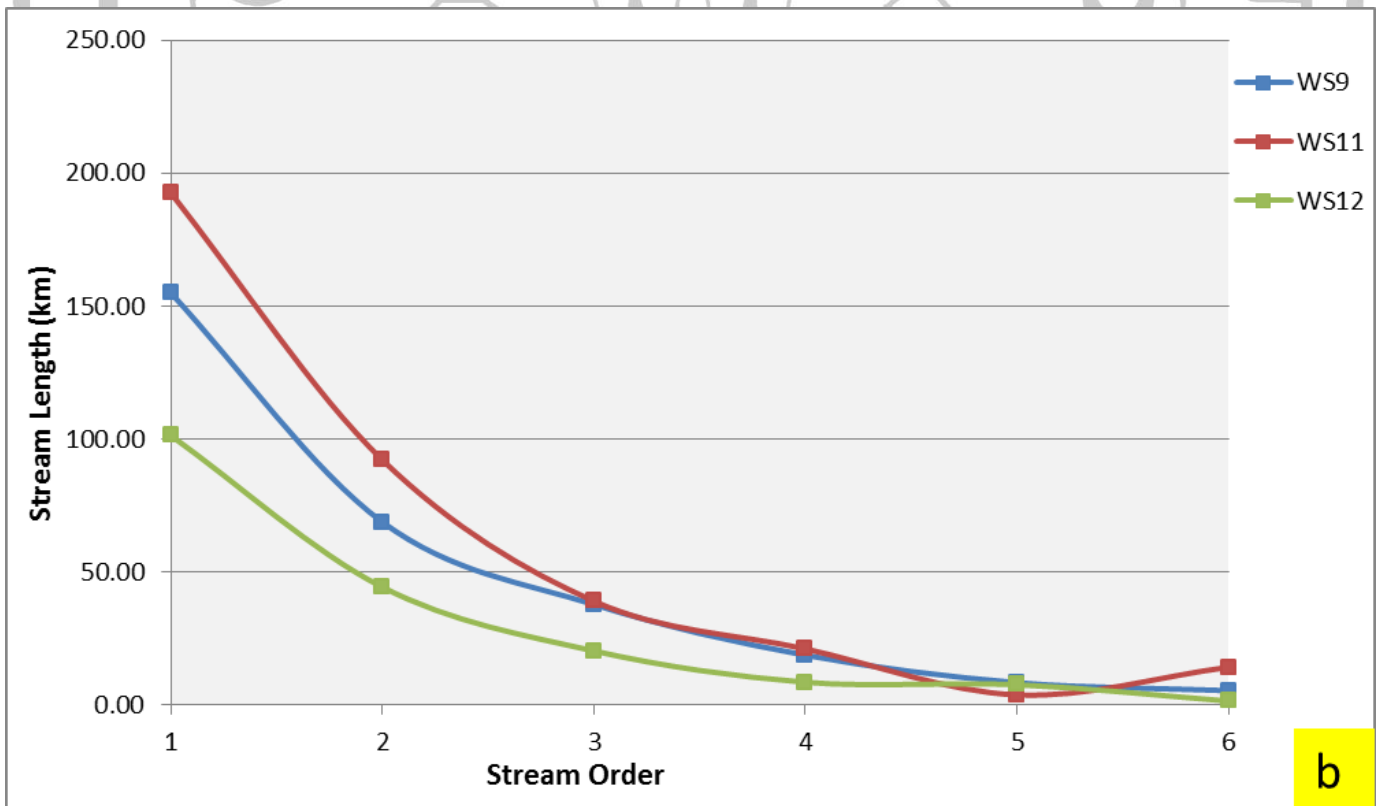
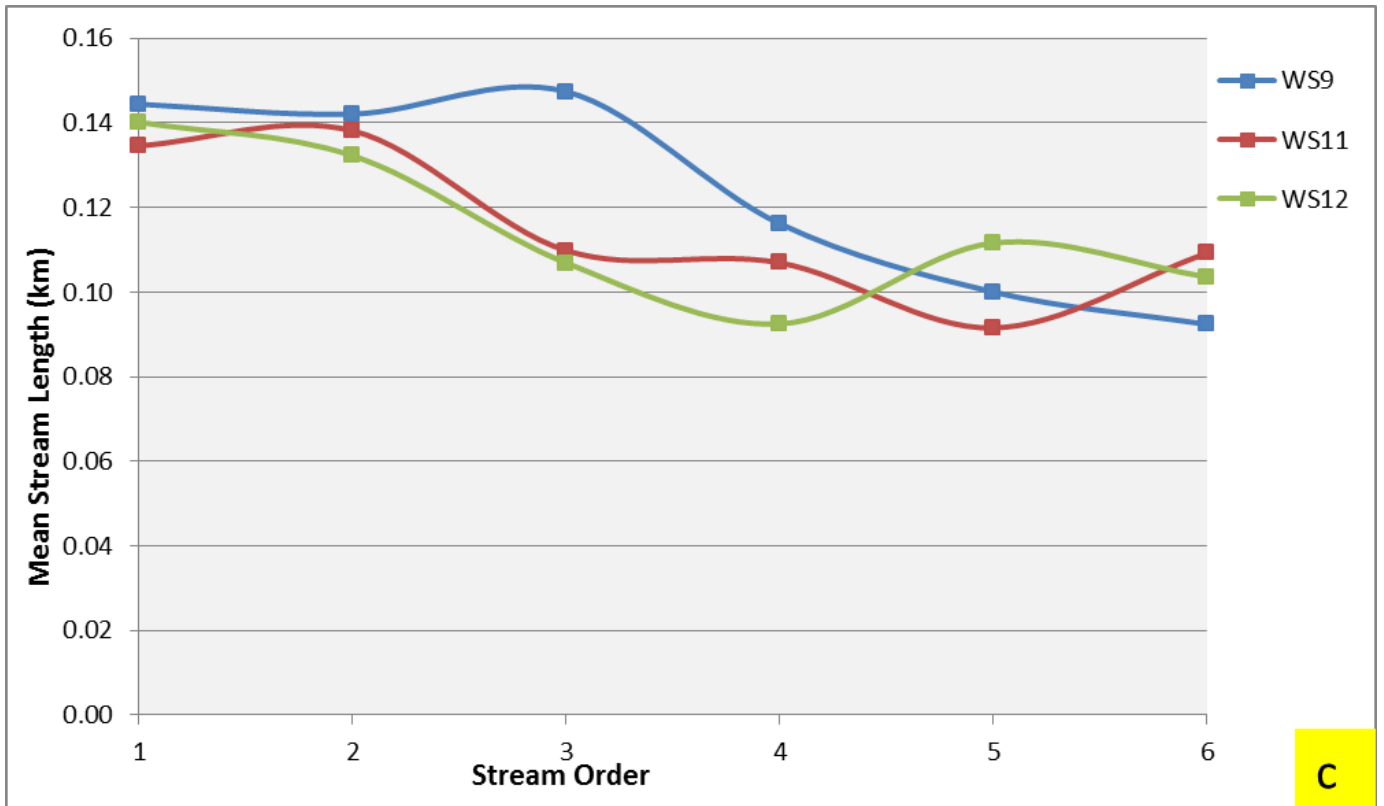
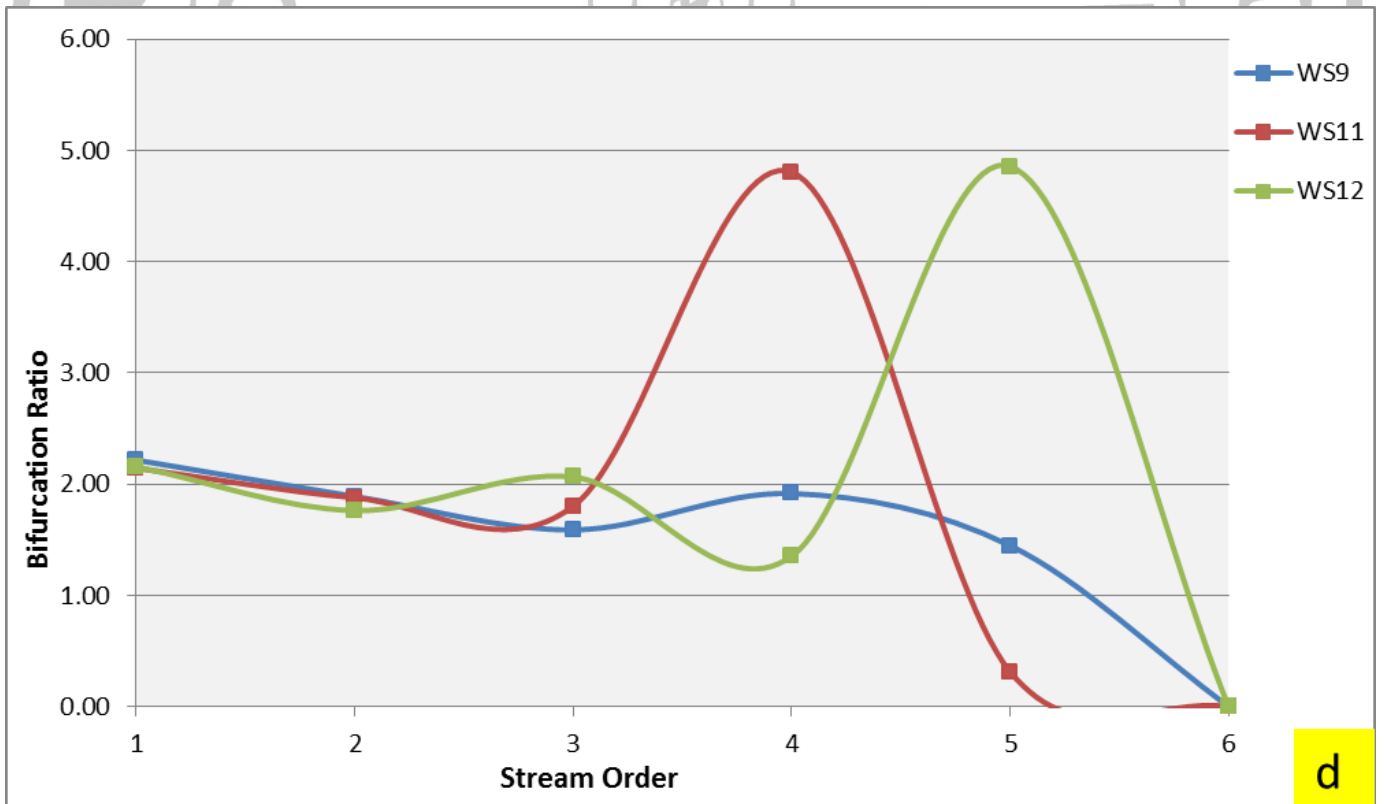
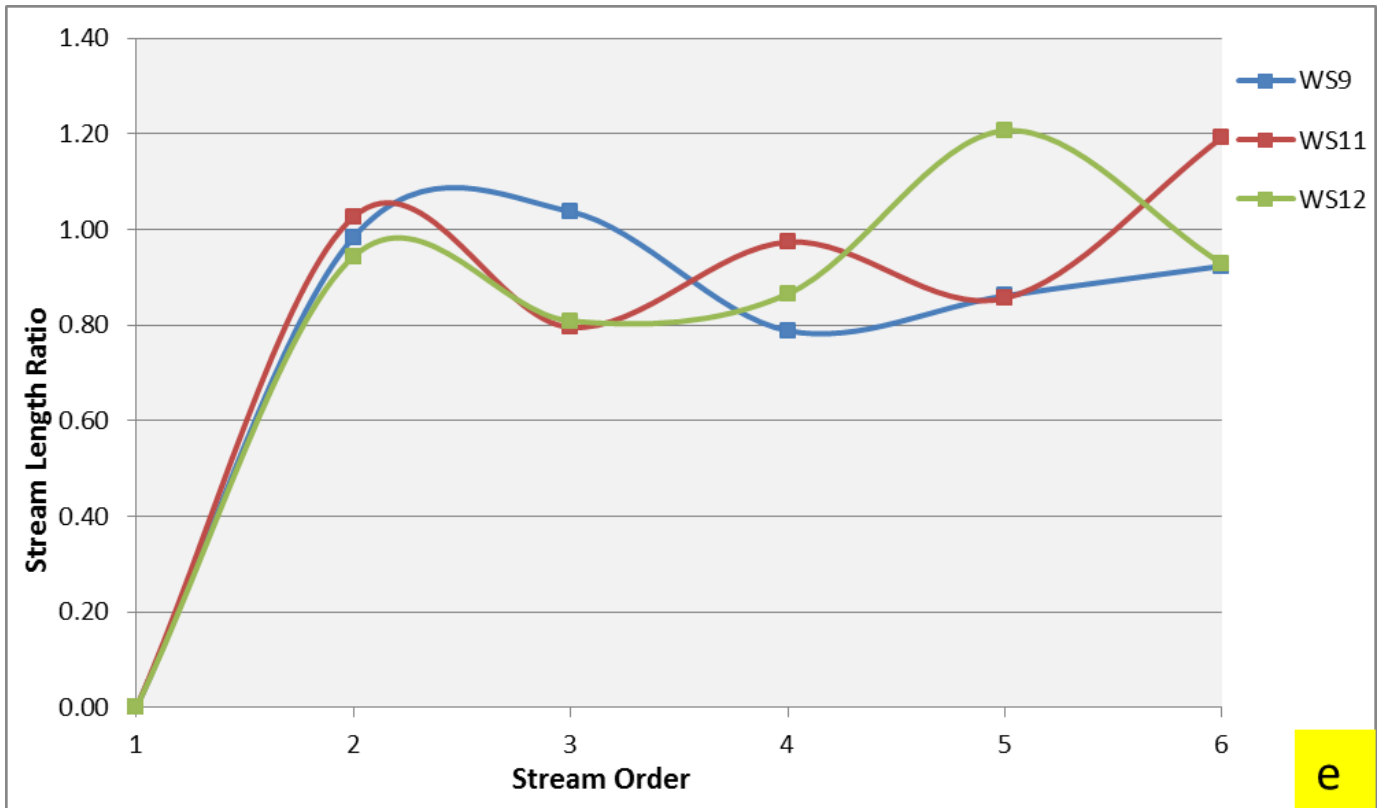
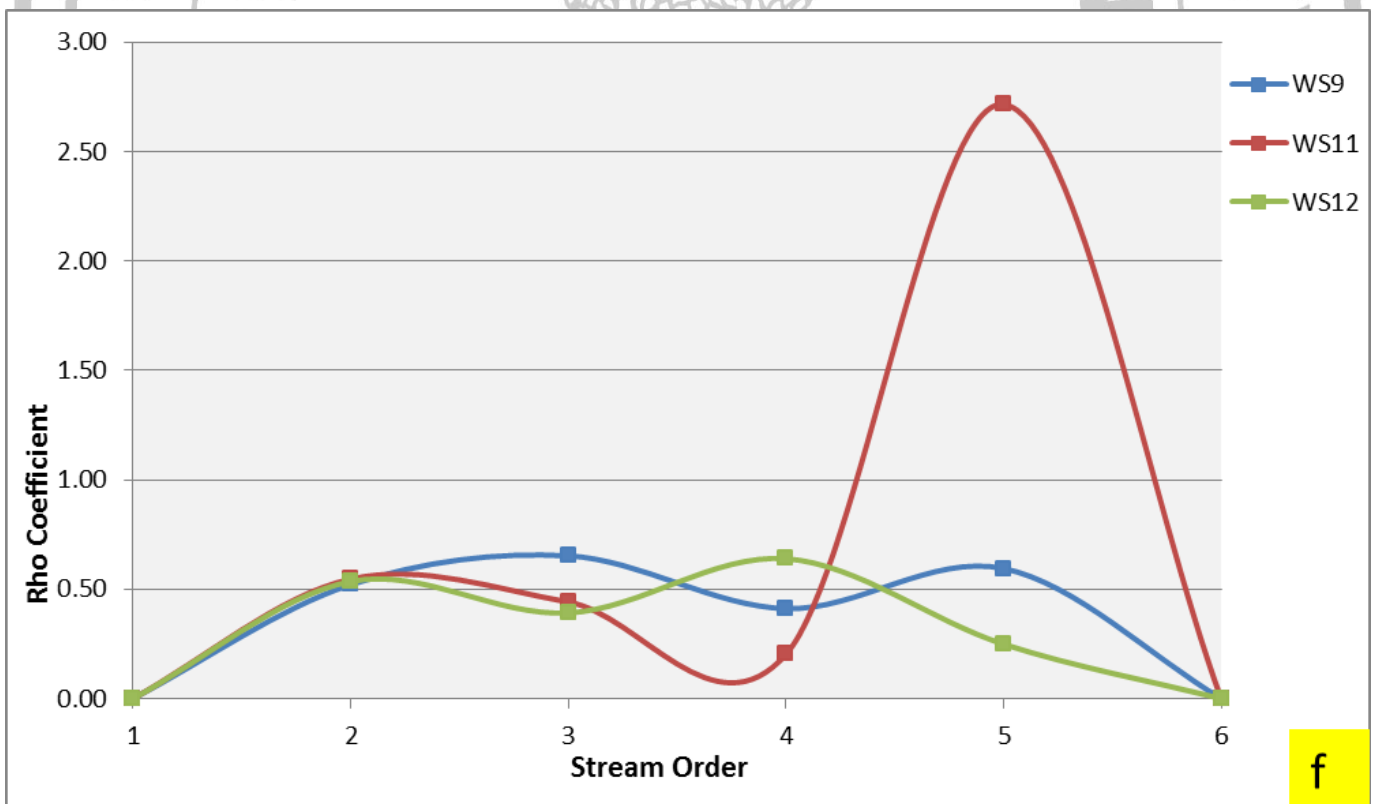
Figure-5.4(a)-(f): Shows performance of individual stream morphometric attributes of 6<sup>th</sup> order watersheds

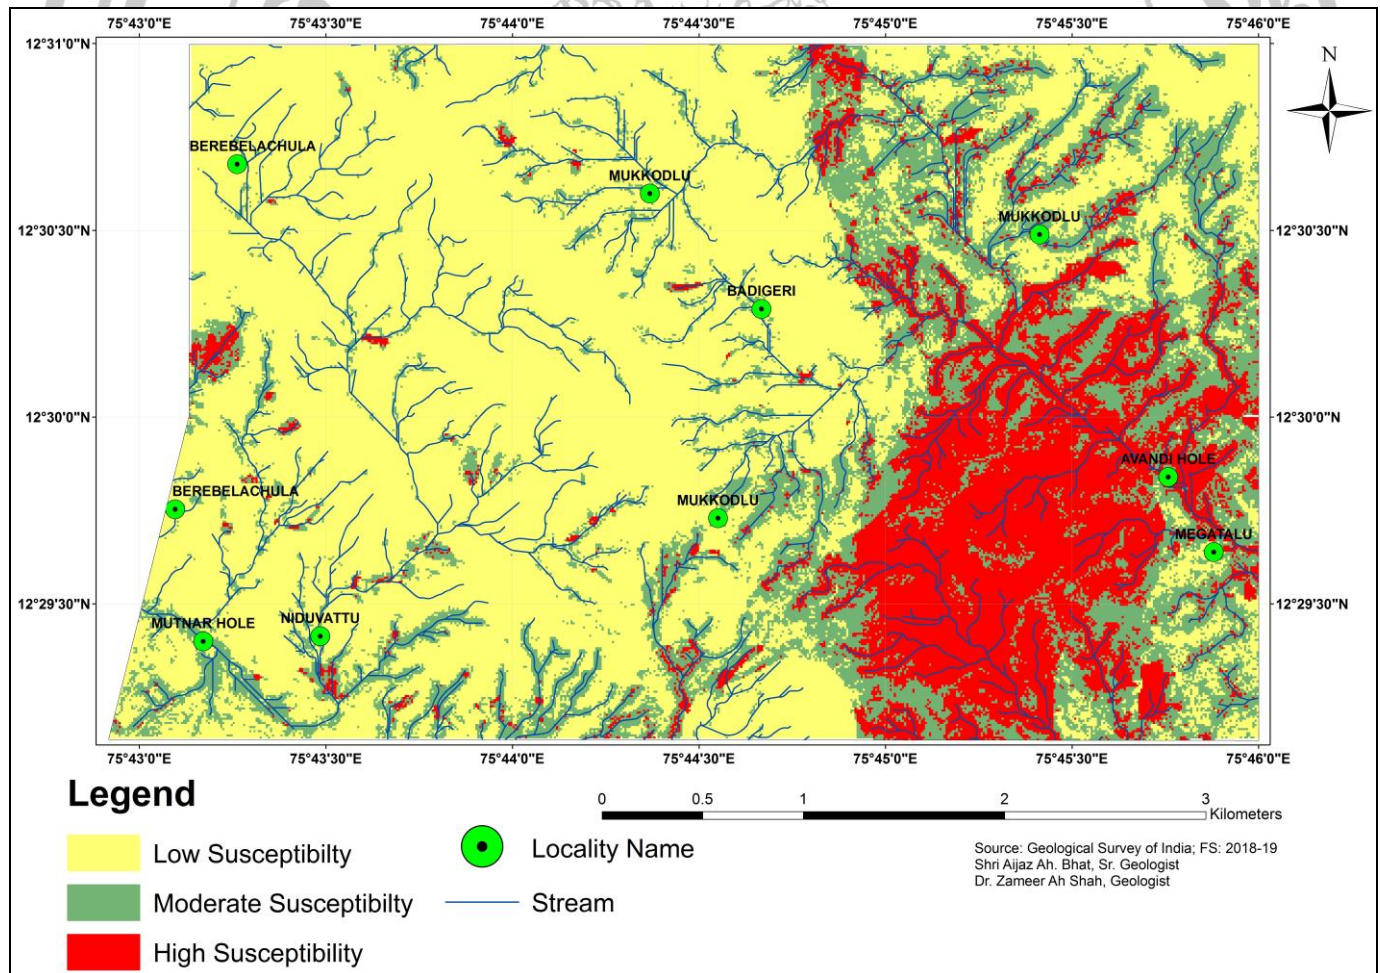
The cut-off where 70.02 cumulative percent of landslides (percensld) are classified, has considered as the boundary between “High” and “Moderate” susceptibility zones. Similarly, the cut-off where 90.31 cumulative percent of landslides (percensld) are classified, has considered as the boundary between “Moderate” and “Low” susceptibility zones. The statistical attribute table of success rate curve of present area of investigation reveals that 15.73 cumulative map area percentage (percmap) falls under “High” landslide susceptible zone whereas 38.88 cumulative map area percentage (percmap) falls under “Moderate” landslide susceptible zone and rest 45.39 cumulative map area percentage (percmap) falls under “Low” landslide susceptible zone. The statistical analysis of landslide susceptibility score map of present investigated area reveals that out of 18 sq.km area, 2.83 sq.km (15.73 cumulative map area percentage) area falls under “High” landslide susceptible zone, 7.00 sq.km (38.88 cumulative map area percentage) area falls under “Moderate” landslide susceptible zone and rest 8.17 sq.km (45.39 cumulative map area percentage) area falls under “Low” landslide susceptible zone.

Figure-6.2: Landslide susceptibility map on 1:10,000 scale generated for present investigated area of 18 sq.km in year 2018

- ❖ The first major causative factor related to drainage network problem has been evaluated and proved precise by landslide susceptibility score map which has classified almost all drainage influenced portions in moderate to high landslide susceptibility range and the area away from drainage components are classified into low landslide susceptibility zone where any landslide if occurred is due to other relevant factors like cut-slope, pulverized zones under high strain condition etc.

5. The areas which come under high-moderate landslide susceptibility zone (*see fig. 6.2 in which red colour denotes high landslide susceptibility zone and light green colour denotes moderate susceptibility zone*) in present investigated area should be given priority for making proper drainage arrangements and giving reinforcement measures wherein necessary such as cut-slopes, steep gradient slopes, stream or river bank eroded sections, river bridge abutments, toe of landslides etc.

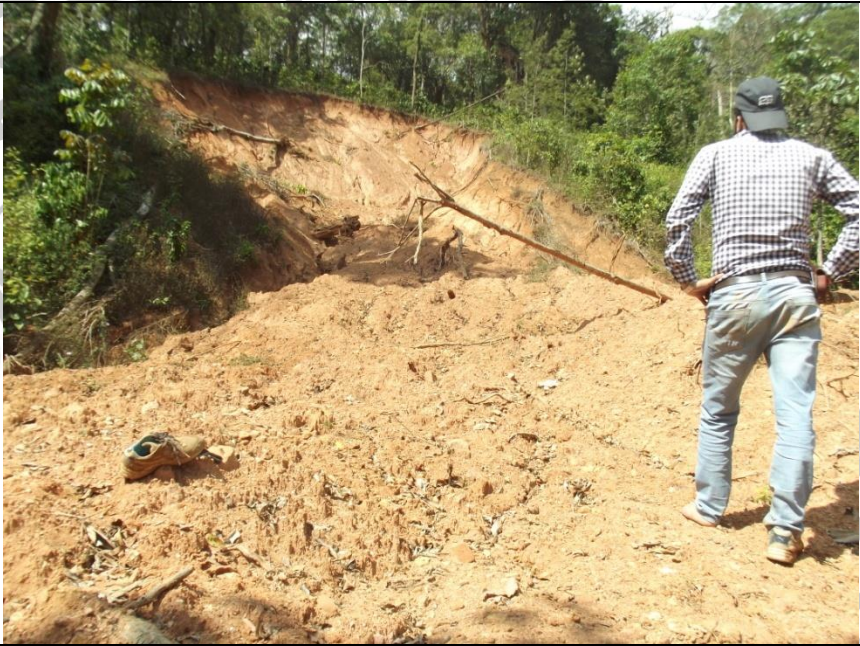
| Geo-parameter | Details |
|---|---|
| Geo-scientific Causes | Pore-water pressure, reduction of strength on super saturation. |

| Summary/Abstract | <p><i>Here the rock weathering is deep and penetrative. Overburden zone is thick containing fine sediments with some weathered rock fragments.</i></p> |

| Remedial measures | Proper drainage maintenance |

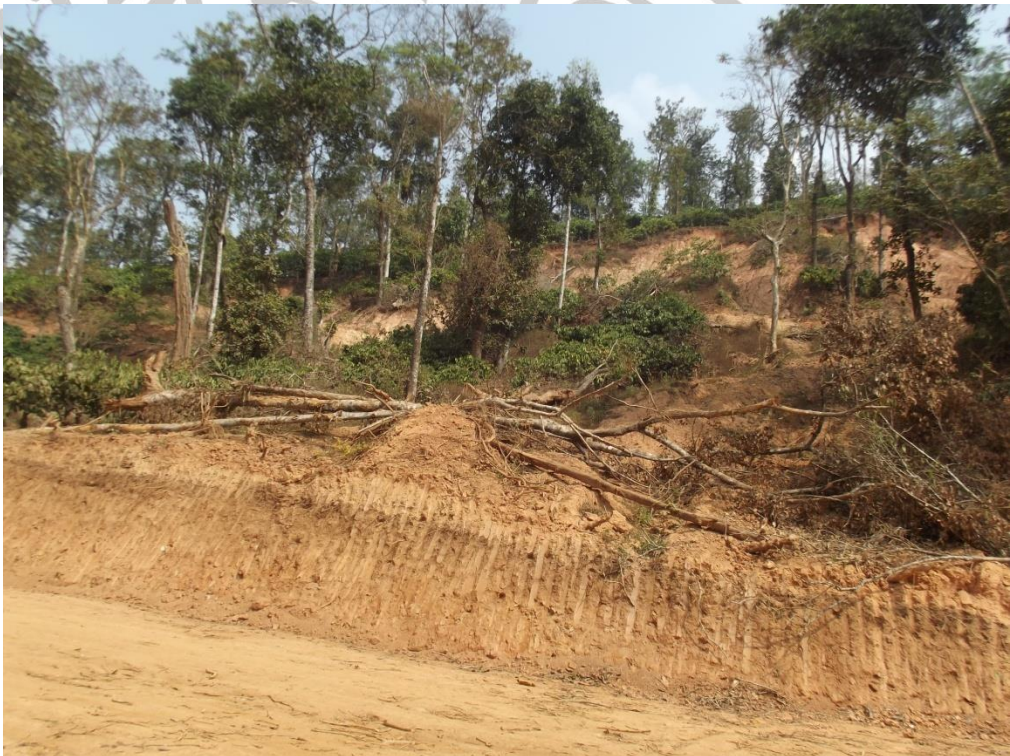
| Geo-parameter | Details |
|---|---|
| Geo-scientific Causes | Reduction of shear strength due to super saturation |

| Summary/Abstract | <p><i>Here the plane exposed in middle part of slide shows some indications of shearing in the form of sheared fabric (pyroblast) showing dextral movement. The role of this shearing in promoting slide cannot be ruled out as both slide and shear are trending in the same direction.</i></p> |

| Remedial measures | Proper toe support, Nailing, Drainage arrangements, support at defined contour levels. |

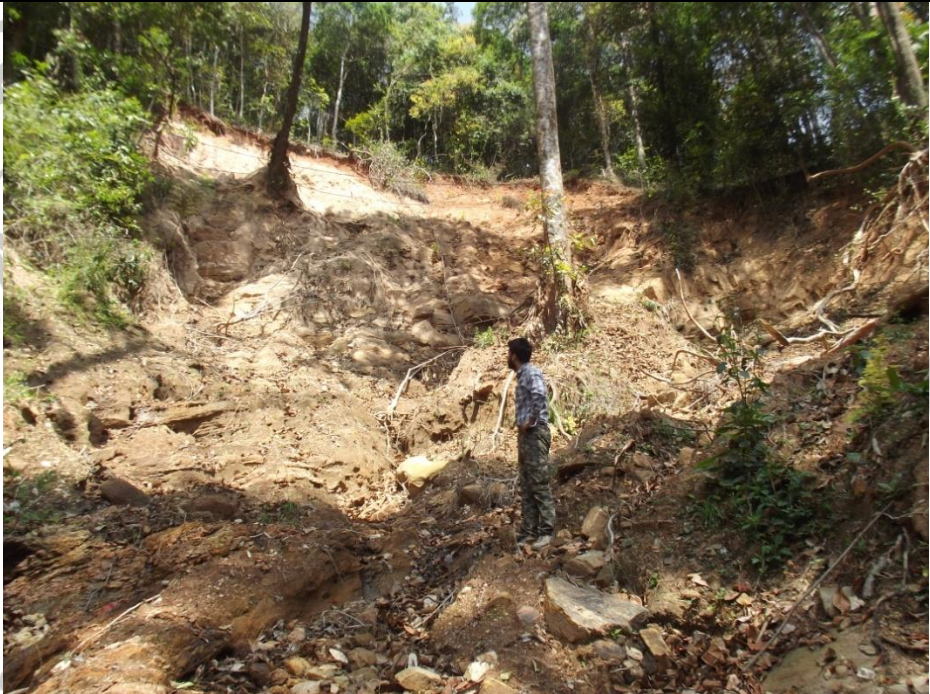
| Geo-scientific Causes | High slope, weathering and erosion of loose material, oversaturation and loss of cohesion. |
| Summary/Abstract | <p><i>Here the rock is crushed and shows some signs of deformation (grain stretch and reorientation). Quartz veins have intruded and there is mica development, water oozing out at the contact of overburden and underlying rock.</i></p> |

| Remedial measures | Steeping of slope, toe support |

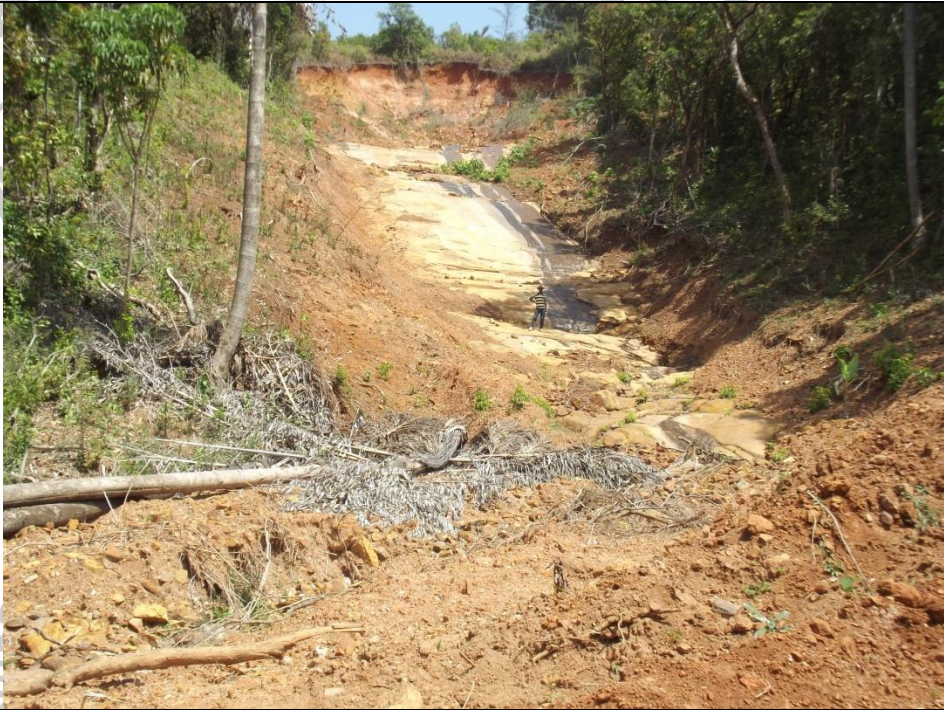
| Geo-scientific Causes | High slope, weathering and erosion of loose material, oversaturation and loss of cohesion. |
| Summary/Abstract | <p><i>Here the slide seems to be the outcome of lubrication along the contact of overburden and underlying rock. A pinkish rock containing mafic layers along foliation planes is susceptible to weathering. The resultant weathered material has flown on hard rock contact.</i></p> |

| Remedial measures | Construction of concrete culvert near road, Nailing. |

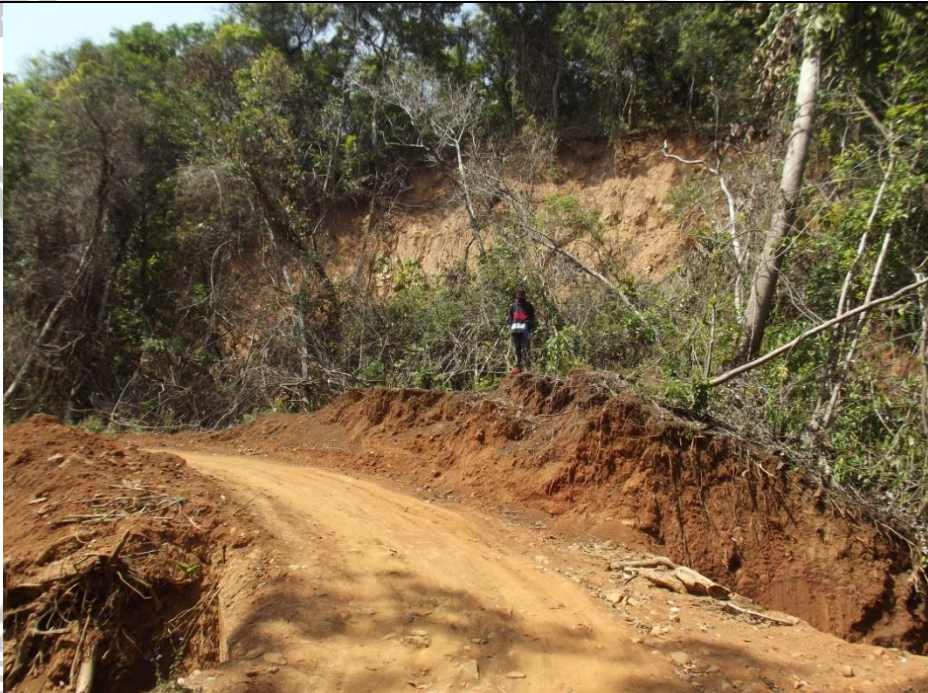
| Geo-scientific Causes | High slope, weathering and erosion of loose material, oversaturation and loss of cohesion. |
| Summary/Abstract | <i>Here a stream is flowing at the base of the slide, so toe cutting cannot be over-ruled. The slide has occurred on a very steep slope.</i> |

| Remedial measures | Concrete culvert of suitable size to accommodate large boulders during high downpour, Slope easing. |

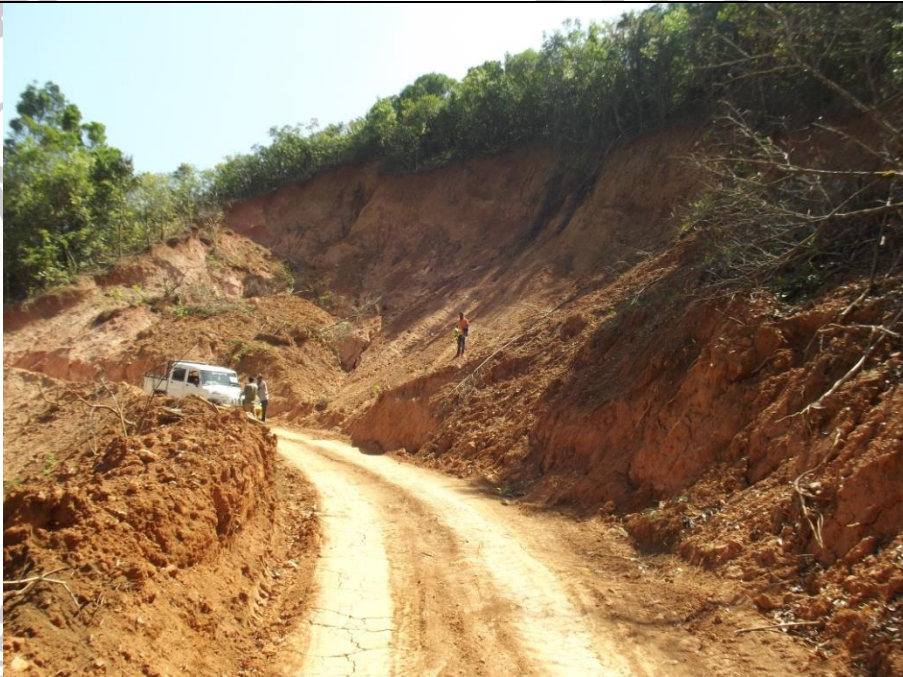
| Geo-scientific Causes | High slope, weathering and erosion of loose material, oversaturation and loss of cohesion. |
| Summary/Abstract | <i>The two main factors responsible here are steep slope and thick overburden. The strength of the overburden material was reduced due to super saturation.</i> |

| Remedial measures | Drainage maintenance, Slope easing |

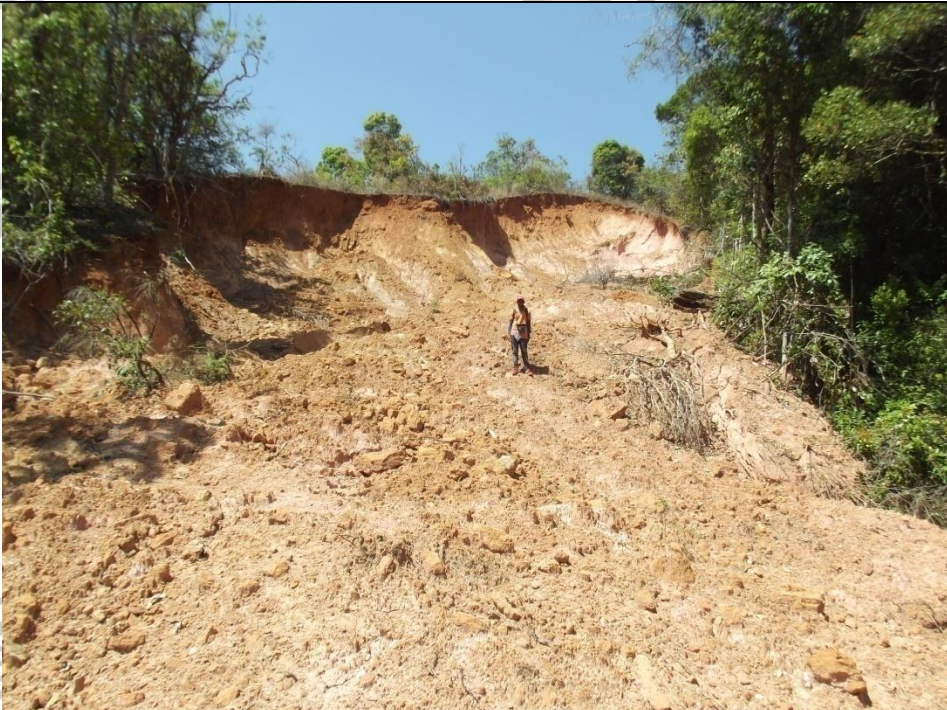
| Geo-scientific Causes | High slope, weathering and erosion of loose material, oversaturation and loss of cohesion. |
| Summary/Abstract | <i>The movement here is confined to insitu overburden soil. The toe cutting during high down pour cannot be ruled out due to the presence of stream at the base of the slide</i> |

| Remedial measures | Drainage maintenance, Slope easing |

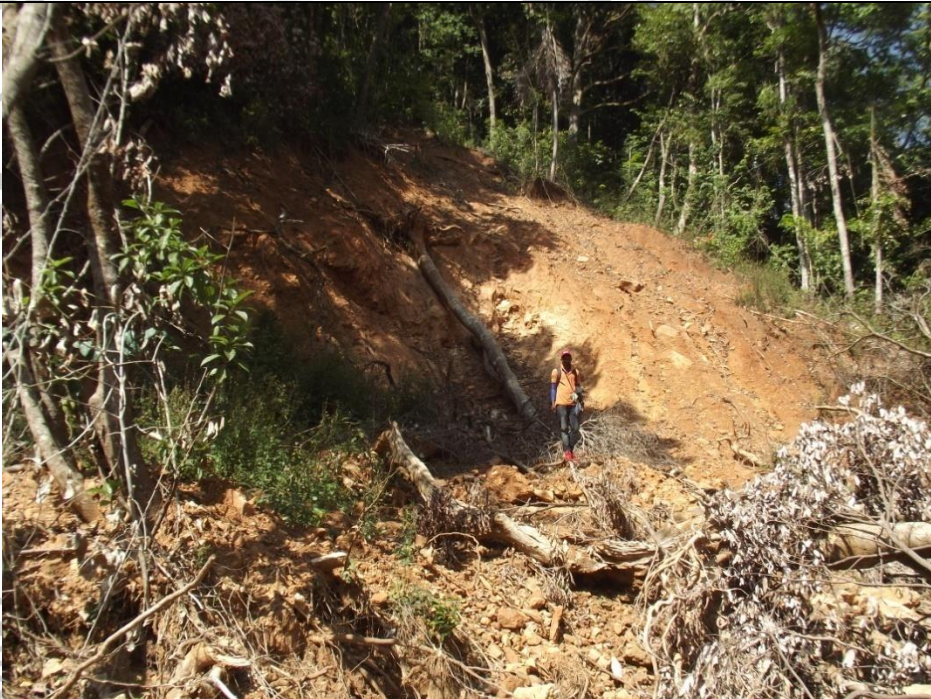
| Geo-scientific Causes | High slope, weathering and erosion of loose material, oversaturation and loss of cohesion. |
| Summary/Abstract | <i>The material on the slide plane is highly crushed indicating shearing. The stream flowing at the base has played a vital role by toe cutting.</i> |

| Remedial measures | Drainage maintenance, Slope easing |

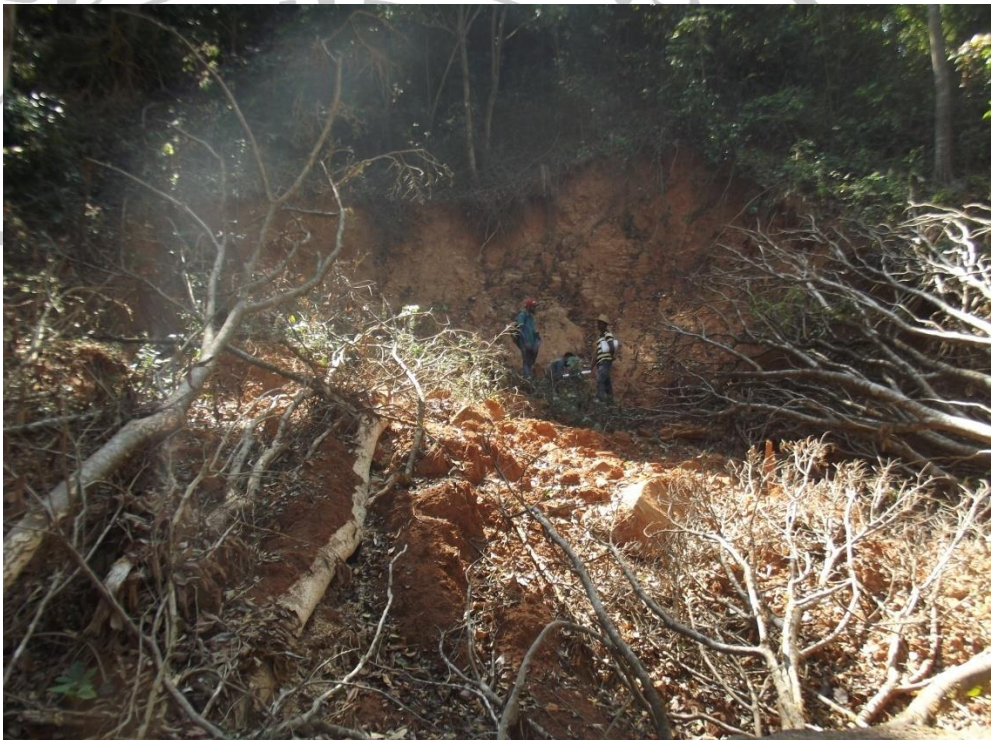
| Geo-scientific Causes | Weathering, Presence of loose pulverized material, Oversaturation and loss of cohesion. |
| Summary/Abstract | <p><i>Here the slide seems to be the combined outcome of rock and overburden. Although the overburden is less than 0.5m but the steep slope and slight depression has favoured the percolation of more water leading to the pore water pressure.</i></p> |

| Remedial measures | Drainage maintenance, Nailing |
