REPORT ON MESO-SCALE LANDSLIDE SUSCEPTIBILITY MAPPING (1:10,000) IN AND  
AROUND NIDUVATTU, MUKKODLU & MEGATTALU AREAS, KODAGU DISTRICTS OF  
KARNATAKA

Item no.: M4LSSM/NC/SR/SU-KG/2018/26601

Final report for field season 2018-19

Aijaz Ahmad Bhat, Senior Geologist & Dr. Zameer Ahmad Shah, Geologist

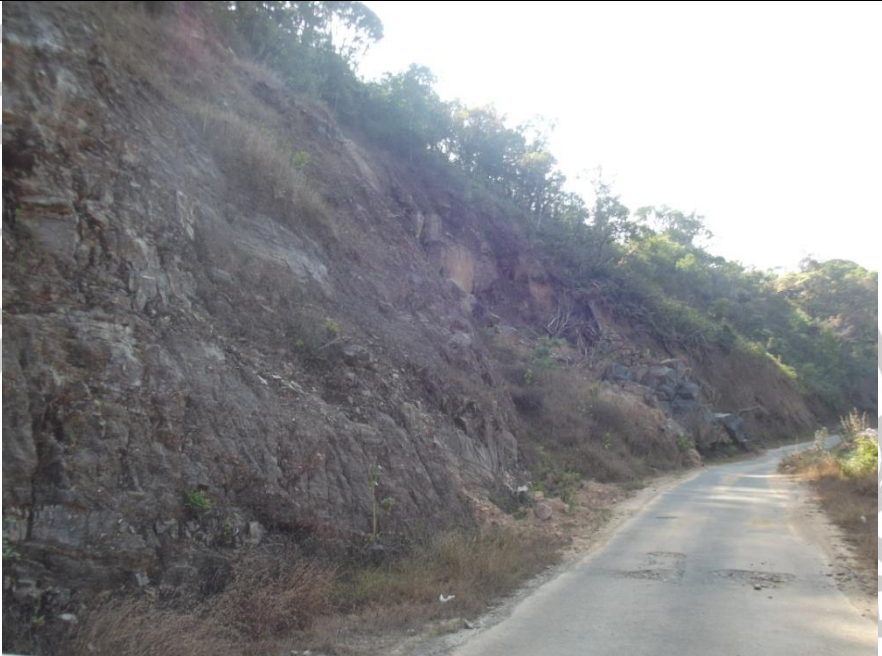
| Summary/Abstract | <p><i>Here the slide is rock slide. The boulders lying on the road (10x07x08m) show some planes which indicate the detachment of these boulders along some planes..</i></p> |

| Geo-parameter | Details |
|---|---|
| Remedial measures | Rock bolting |

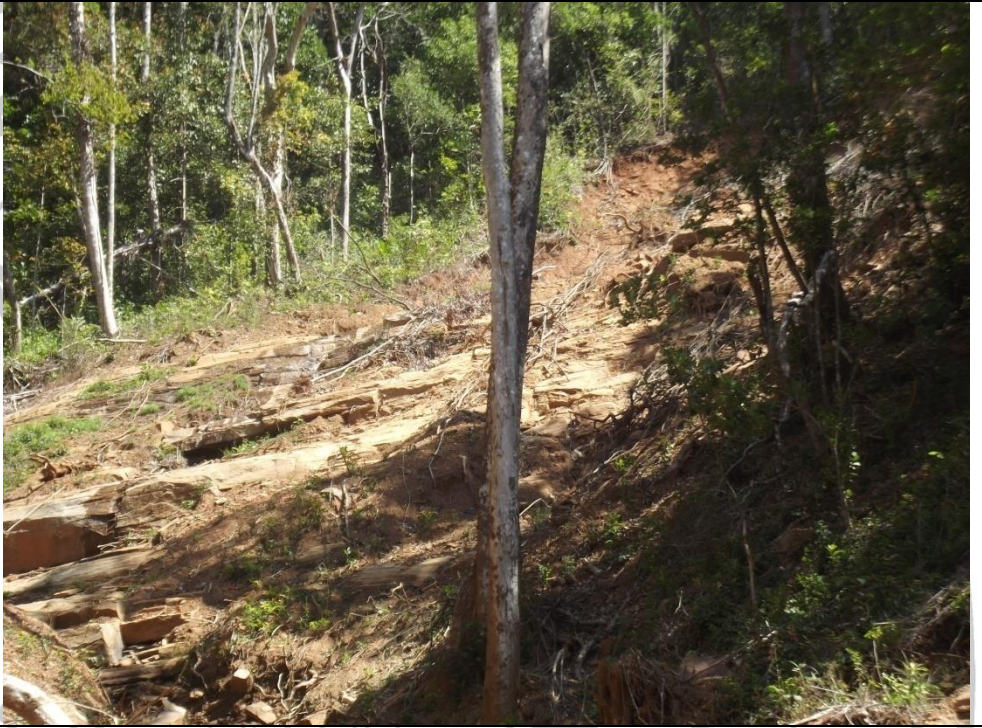
| Summary/Abstract | <i>Here toe cutting very clear at the base of the slide.</i> |

| Geo-parameter | Details |
|---|---|
| Remedial measures | Drainage maintenance |

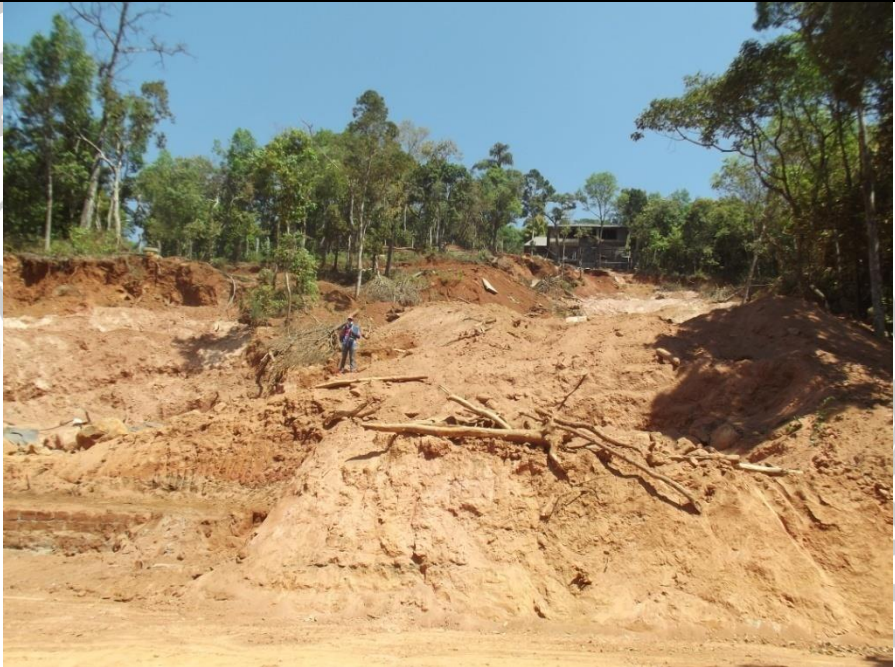
| Geo-parameter | Details |
|---|---|
| Geo-scientific Causes | Toe cutting |

| Summary/Abstract | <p><i>Here the crown of the slide marks a home stay under construction. The movement has mostly occurred here along the first order stream.</i></p> |

| Geo-parameter | Details |
|---|---|
| Remedial measures | Drainage maintenance, Slope easing, Nailing |

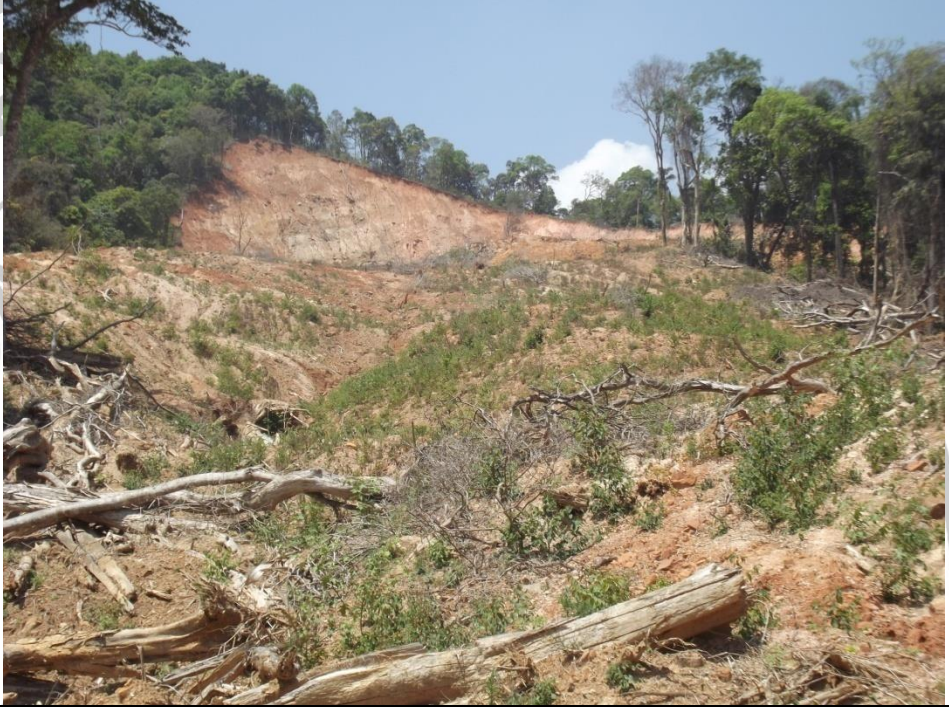
| Geo-parameter | Details |
|---|---|
| Geo-scientific Causes | Reduction of strength on super-saturation, pore water pressure building |

| Summary/Abstract | <i>The material involved in slide contains rock fragments show some shear signatures. The material seems to have been sheared, pulverized before movement along the slope.</i> |

| Remedial measures | Drainage maintenance, Drainage diversion |

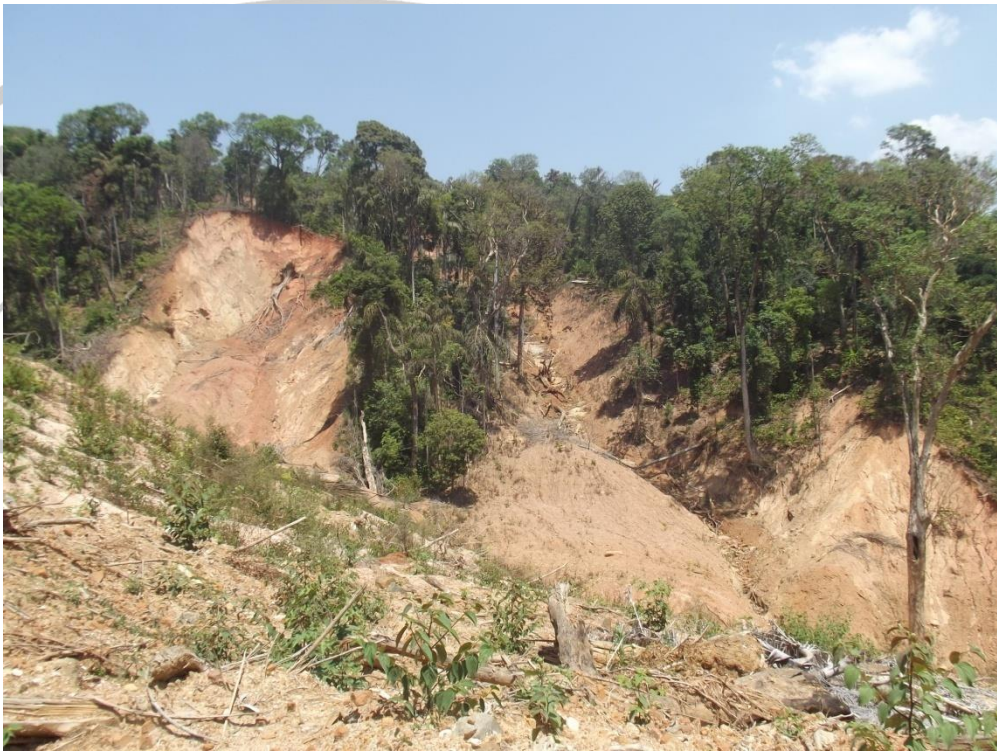
| Geo-parameter | Details |
|---|---|
| Geo-scientific Causes | Reduction of strength on super-saturation, pore water pressure building |

| Summary/Abstract | <i>The material has flown along rock and overburden plane. The material involved is sheared and pulverized</i> |

| Remedial measures | Drainage maintenance, Drainage diversion |

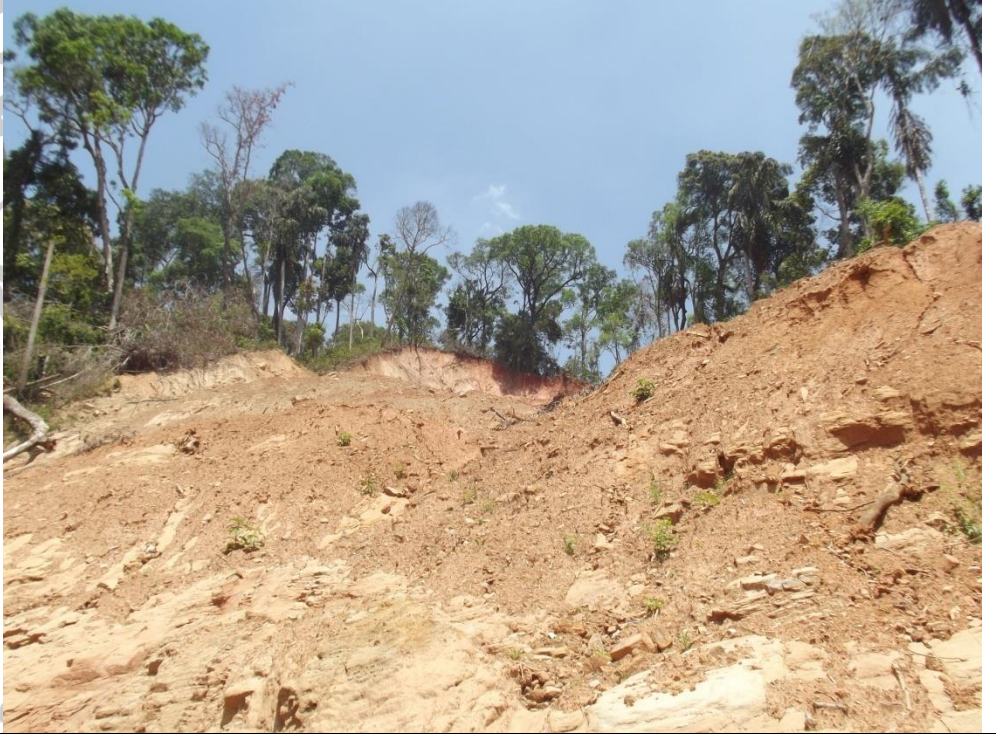
| Geo-parameter | Details |
|---|---|
| Geo-scientific Causes | Reduction of strength on super-saturation, pore water pressure building |

| Summary/Abstract | <i>The material has flown along rock and overburden plane. The material involved is sheared and pulverized</i> |

| Remedial measures | Drainage maintenance, Drainage diversion |

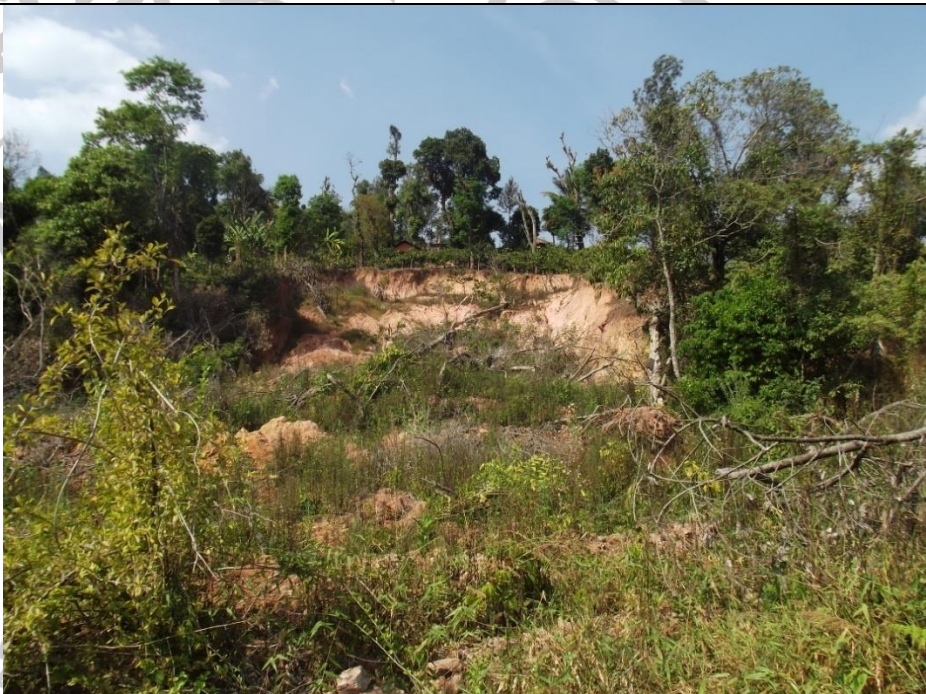
| Geo-scientific Causes | Reduction of strength on super-saturation, pore water pressure building |
| Summary/Abstract | <p><i>The material has been sheared and pulverized. The quartz grains in rocks are stretched and some shear fabric has been developed. The sheared and pulverized material has flown along the rock and overburden contact.</i></p> |

| Remedial measures | Drainage maintenance, Drainage diversion |

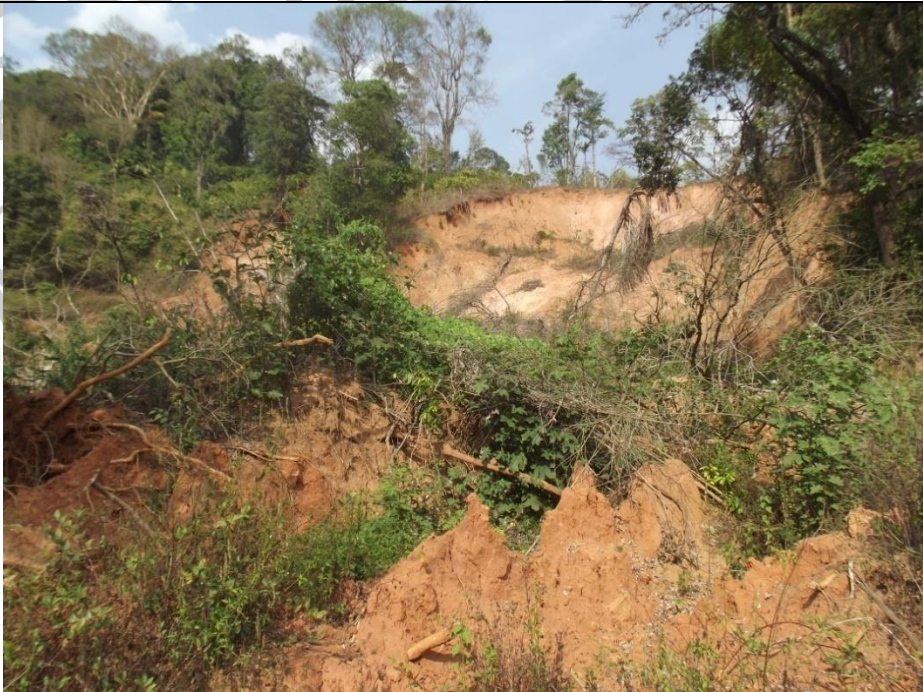
| Geo-parameter | Details |
|---|---|
| Geo-scientific Causes | Reduction of strength on super-saturation, pore water pressure building |

| Summary/Abstract | <p><i>The material has been sheared and pulverized. The fragments show stretched Quartz and feldspar grains. Some rock boulders had cut down along joint planes. Weathered overburden is of moderate thickness and contains pulverized rock fragments.</i></p> |

| Remedial measures | Drainage maintenance, Drainage diversion |

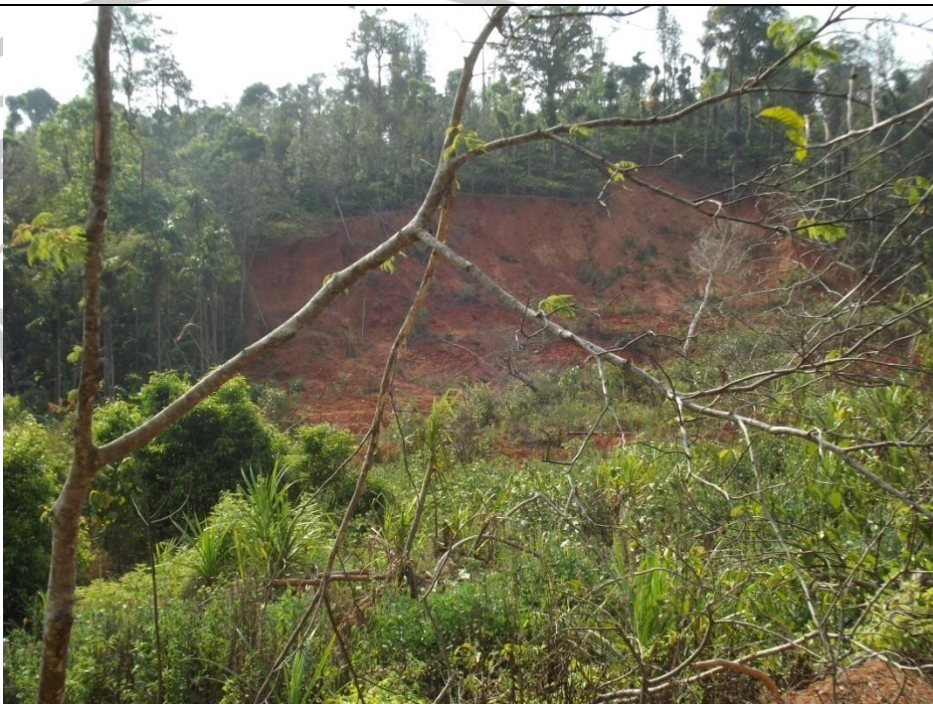
| Geo-parameter | Details |
|---|---|
| Geo-scientific Causes | Reduction of strength on super-saturation, pore water pressure building |

| Summary/Abstract | <p><i>The material has been sheared and pulverized. The fragments show stretched Quartz and feldspar grains. Some rock boulders had cut down along joint planes. Weathered overburden is of moderate thickness and contains pulverized rock fragments.</i></p> |

| Remedial measures | Drainage maintenance, Drainage diversion |

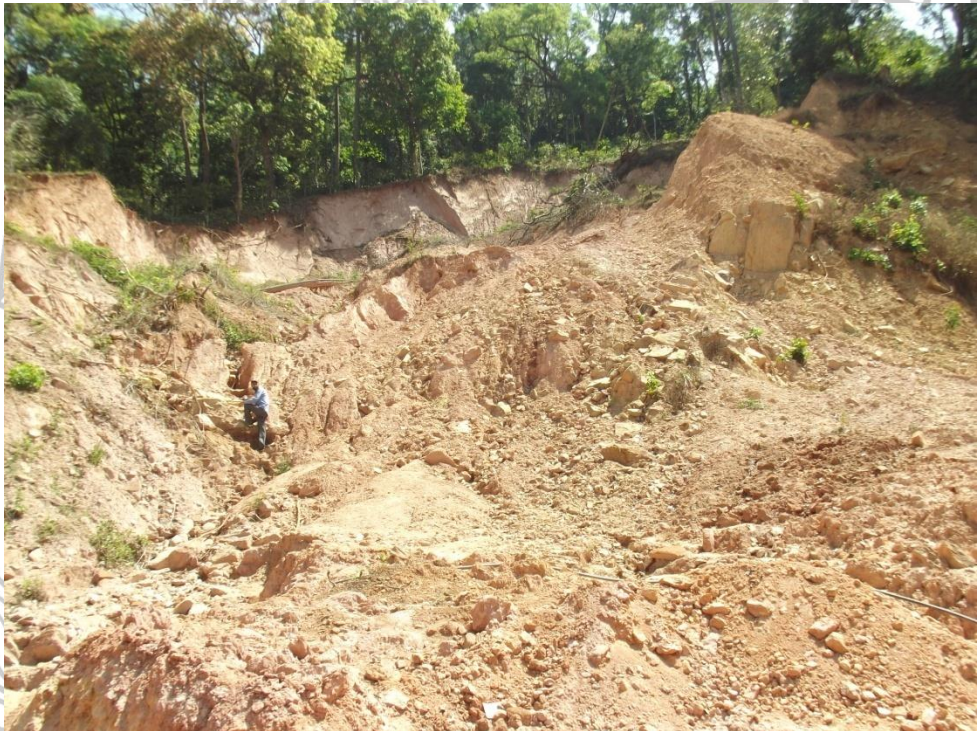
| Remarks, if any | Here the rock exposed on the slide surface highly weathered. The slide seems to be the outcome of disintegration of incompetent rock with some evidences of shear under high shear conditions. Here the anthropogenic role is also visible as the road leading to the house and slide has destabilized the slope. |

| Remedial measures | Drainage maintenance, Drainage diversion |

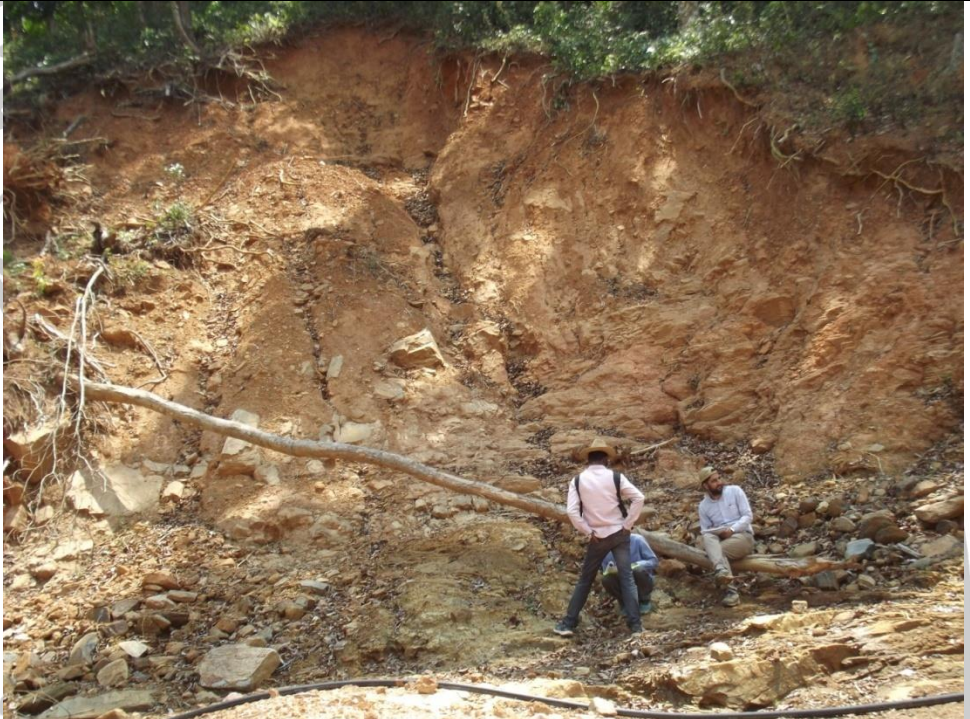
| Geo-parameter | Details |
|---|---|
| Geo-scientific Causes | Oversaturation of overburden, non-cohesion of the material. |

| Remedial measures | Drainage maintenance, |

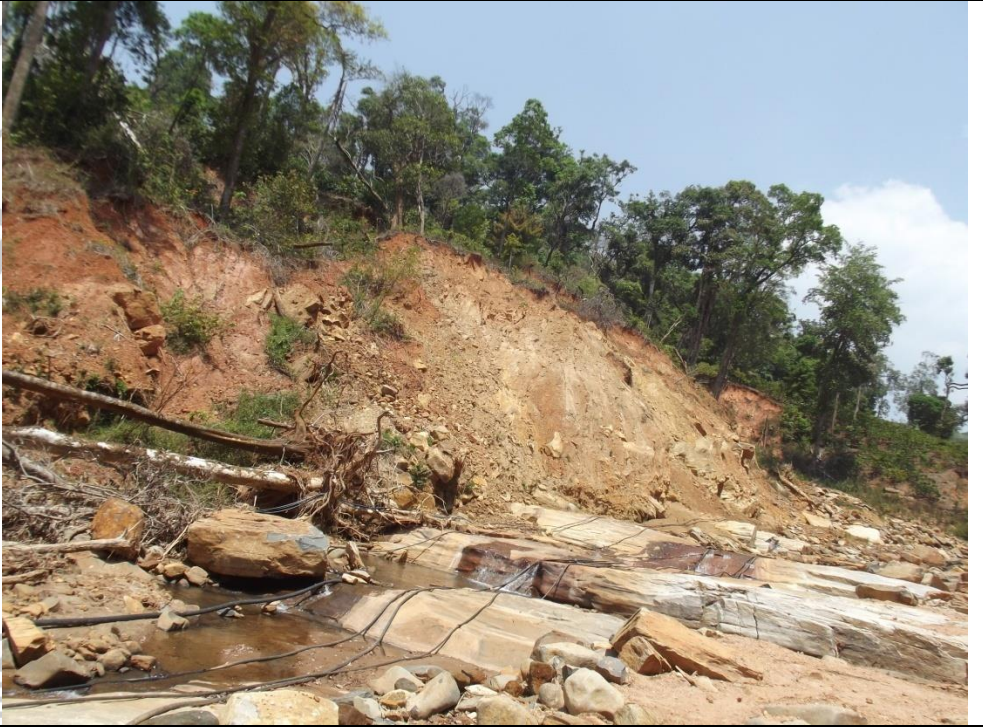
| Geo-parameter | Details |
|---|---|
| Geo-scientific Causes | Oversaturation of overburden, non-cohesion of the material. |

| Remarks, if any | The overburden material has moved along contact along rock and overlying loose material. Some rock boulders lying below the stream seem to have detached along some preferred weak planes. |

| Remedial measures | Drainage maintenance, |

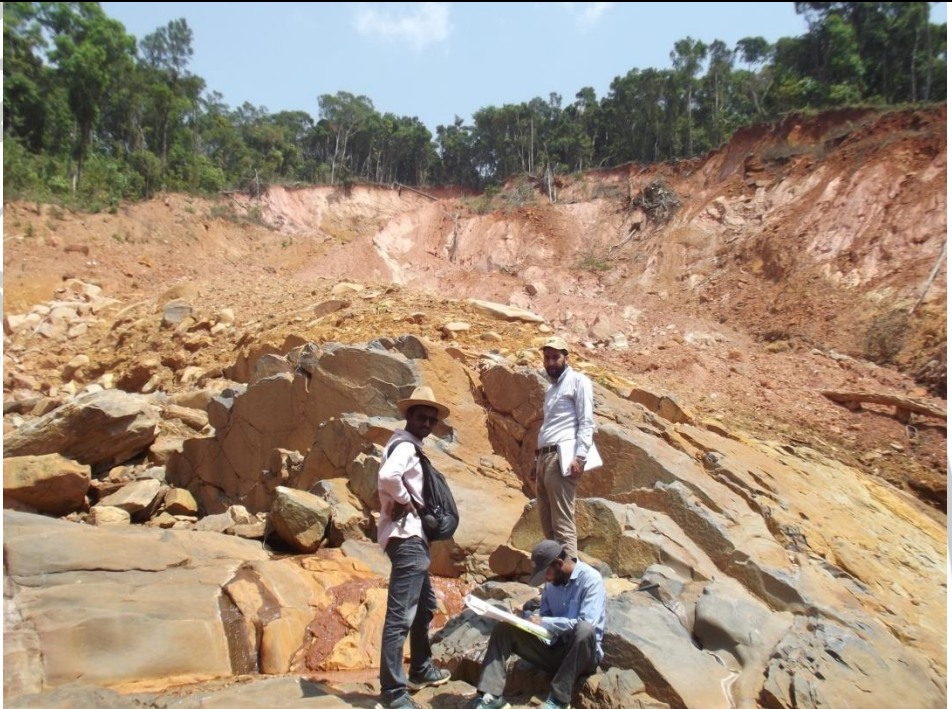
| Geo-parameter | Details |
|---|---|
| Geo-scientific Causes | Oversaturation of overburden, non-cohesion of the material. |

| Remarks, if any | Here the disintegration of the mafic component lead to the movement along contact of Granite gneiss and Amphibolite. |

| Remedial measures | Drainage maintenance, |

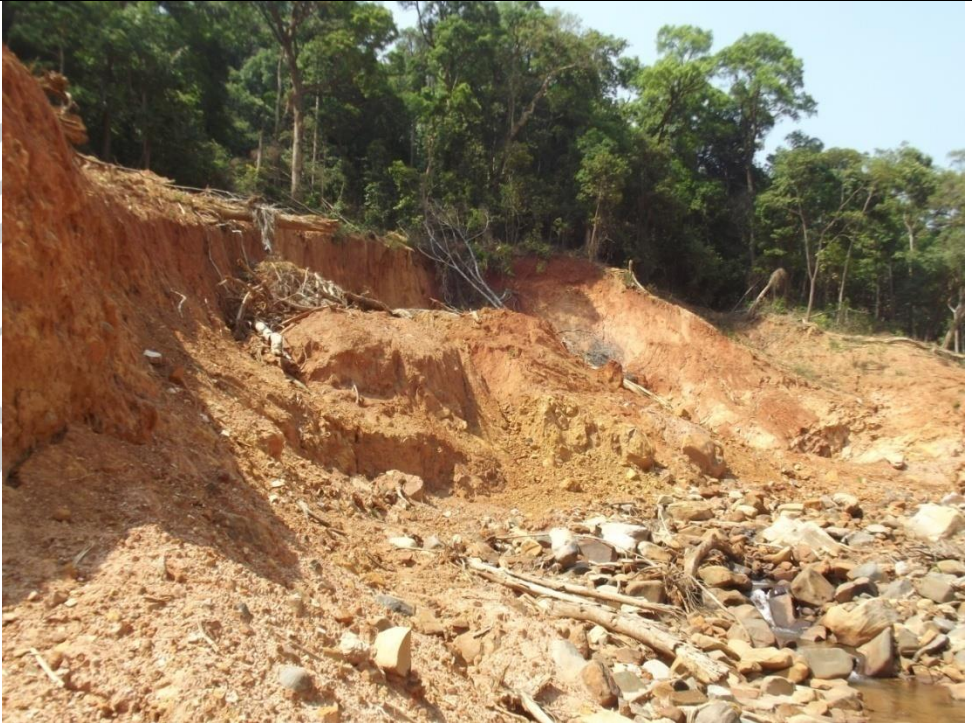
| Geo-parameter | Details |
|---|---|
| Geo-scientific Causes | Toe cutting and over saturation of the overburden material |

| Remedial measures | Drainage maintenance, |

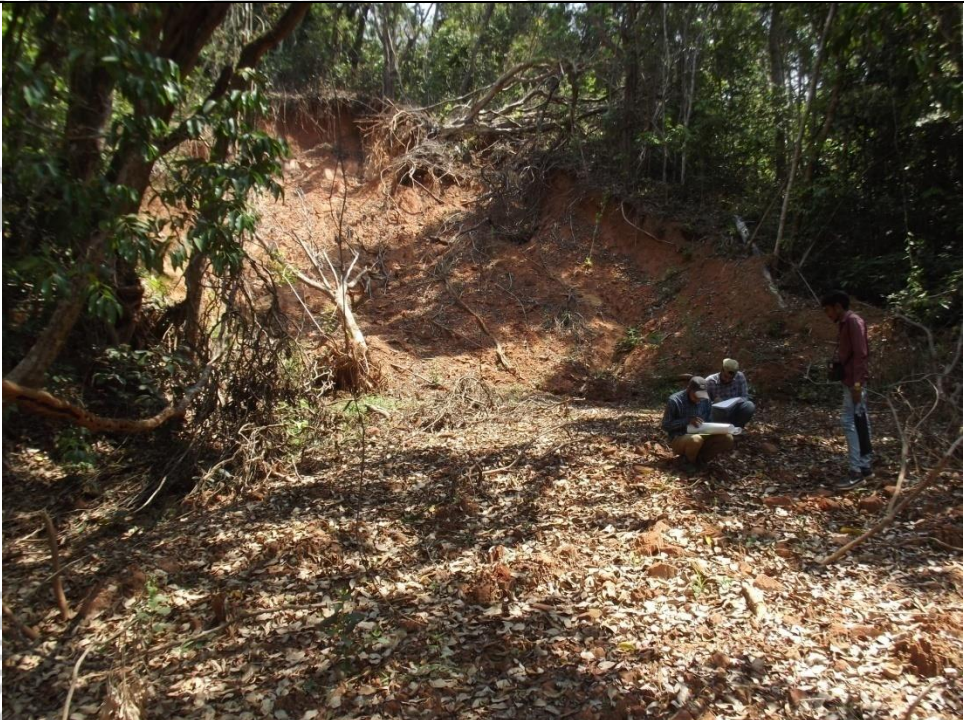
| Geo-scientific Causes | over saturation of the overburden material, Lubrication along contact of overburden and underlying rock. Moreover, weathered material had favoured the percolation of water. |

| Remedial measures | Drainage maintenance, |

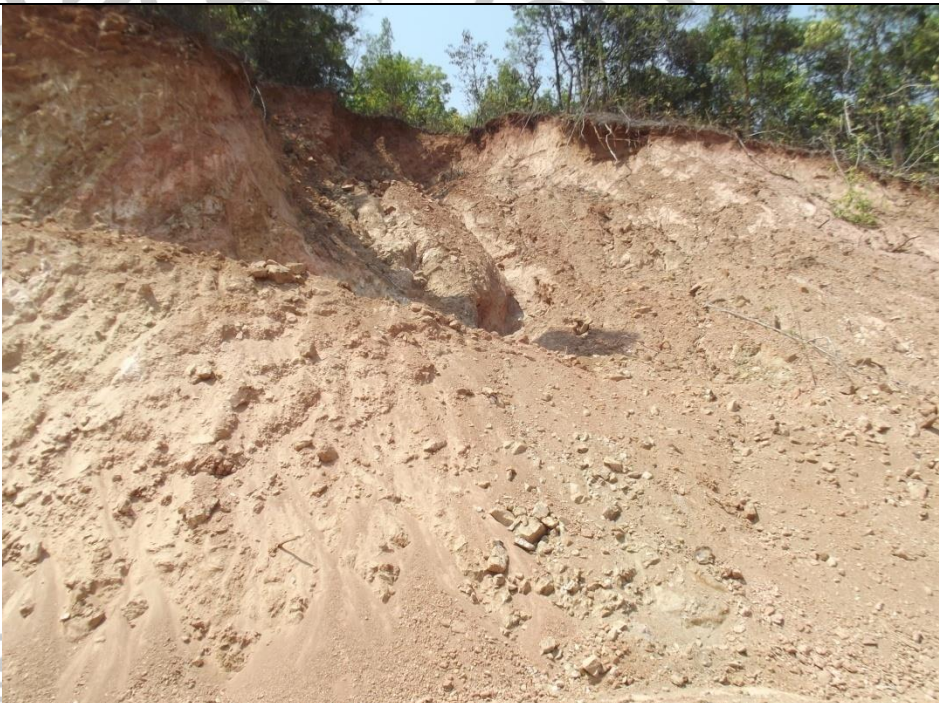
| Geo-parameter | Details |
|---|---|
| Infrastructure | 2 houses were partially damaged. |

| Geo-scientific Causes | Over saturation of the overburden material, Lubrication along contact of overburden and underlying rock. |

| Remedial measures | Slope easing, Drainage maintenance, |

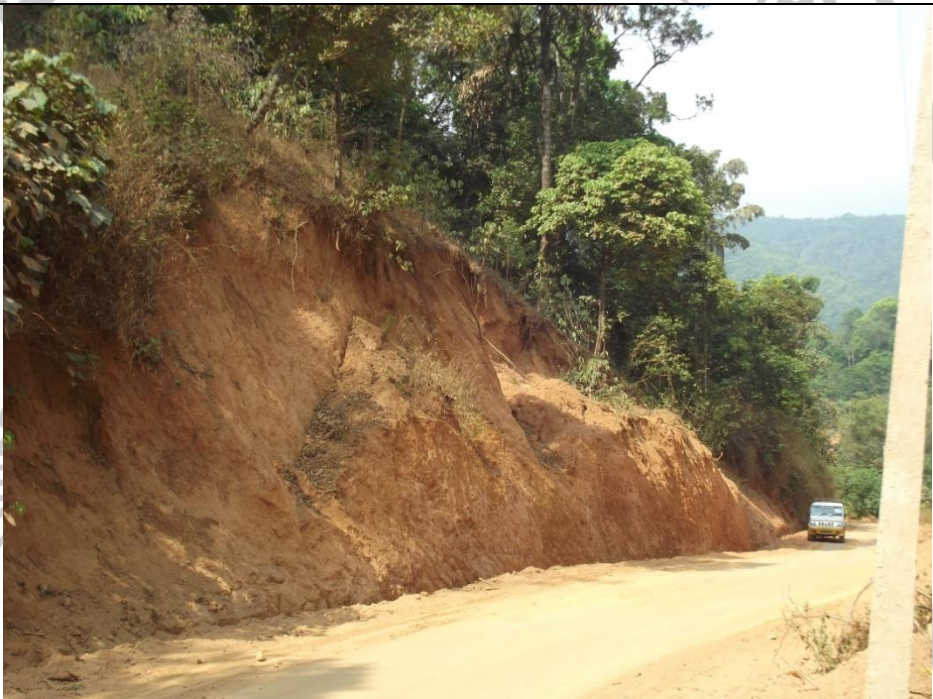
| Geo-scientific Causes | Over saturation of the overburden material, Anthropogenic involvement is quite visible in the form of undammed loose material near the road bend. |
| Remarks, if any | The slide seems to be due to the unplanned road cutting, leaving behind humps of loose material at the bend which has failed in the form of steps during rainy season. |

| Remedial measures | Slope easing, Drainage maintenance, |

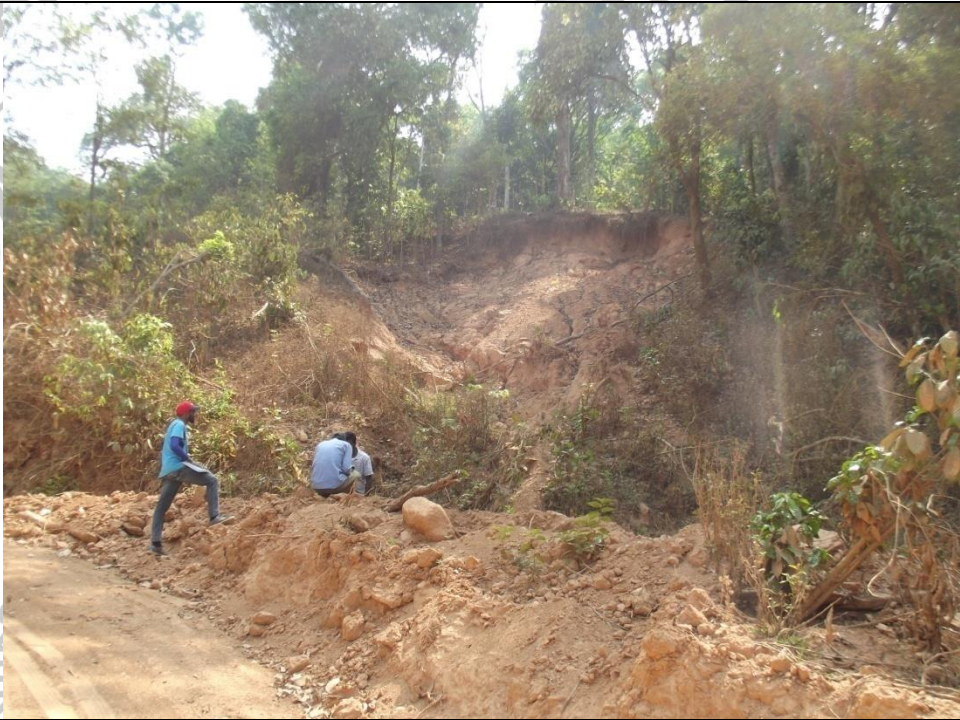
| Geo-scientific Causes | Over saturation of the overburden material, Anthropogenic processes like road cutting and road widening also play some role. |

| Remedial measures | Toe cutting, Drainage coverage and Nailing. |

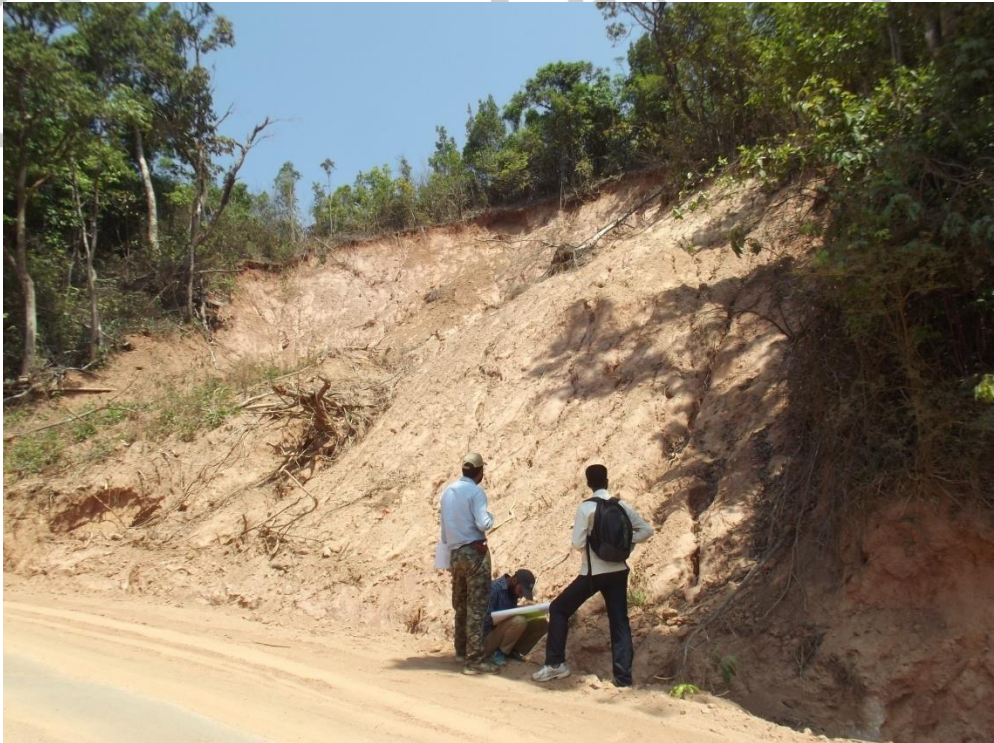
| Geo-scientific Causes | The oversaturation of overburden, toe cutting at base by stream, and deep weathering. |
| Remarks, if any | Here the slope ranges from 35 to 40°. The slide has occurred at road bend where the role of slope cutting for road widening cannot be ruled out. |

| Remedial measures | Drainage maintenance, Nailing |

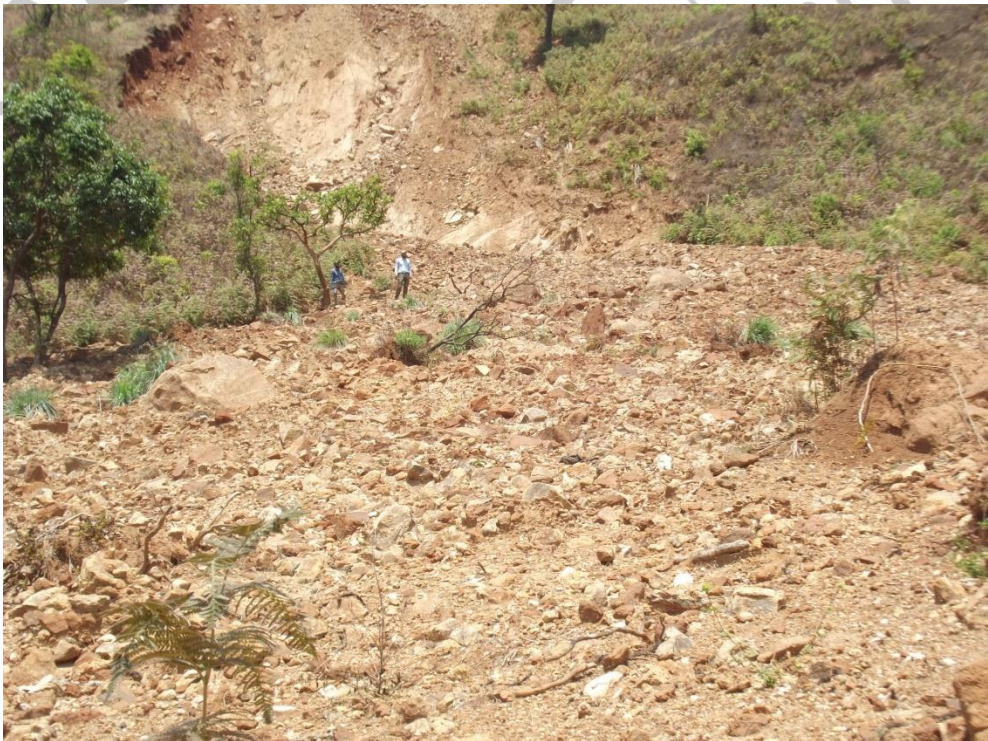
| Geo-scientific Causes | The oversaturation of overburden, more percolation along weak planes and detachment along same planes. |
| Remarks, if any | Here the rock is highly pulverized showing brittle shear conditions. The rock is traversed by prominent joint set trending 25°/vertical causes the fragmentation. |

| Remedial measures | Drainage maintenance, Nailing |

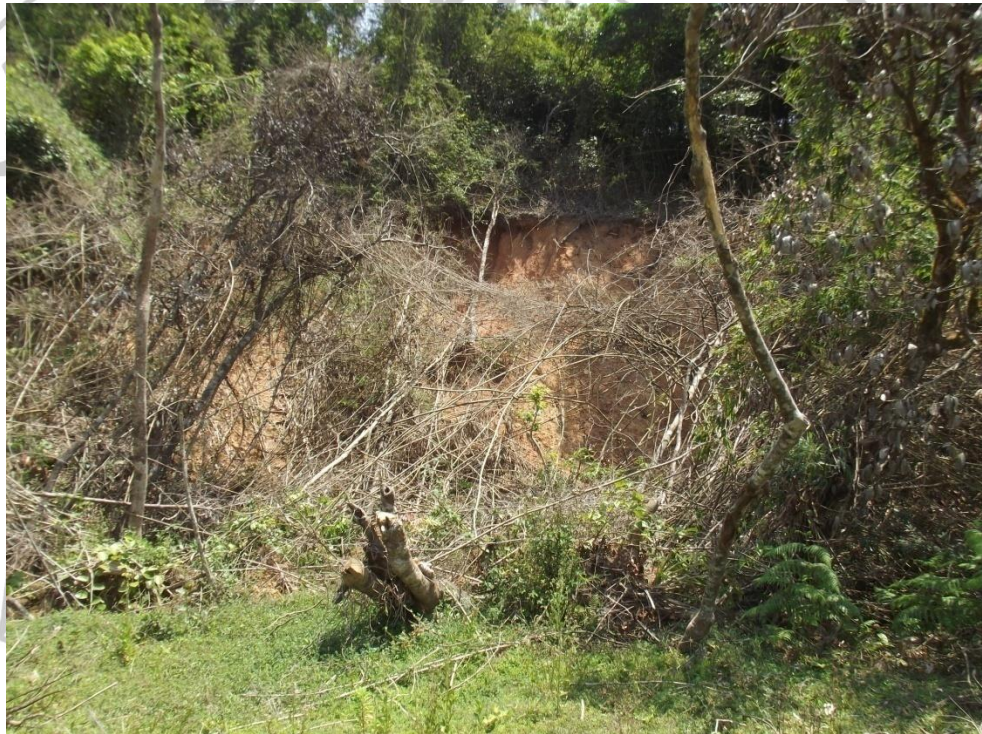
| Geo-scientific Causes | The oversaturation of overburden, more percolation along weak planes and detachment along same planes. |
| Remarks, if any | The slide is the outcome of the toe cutting by a stream at the base including the oversaturation of the material at the top. |

| Remedial measures | Drainage maintenance |

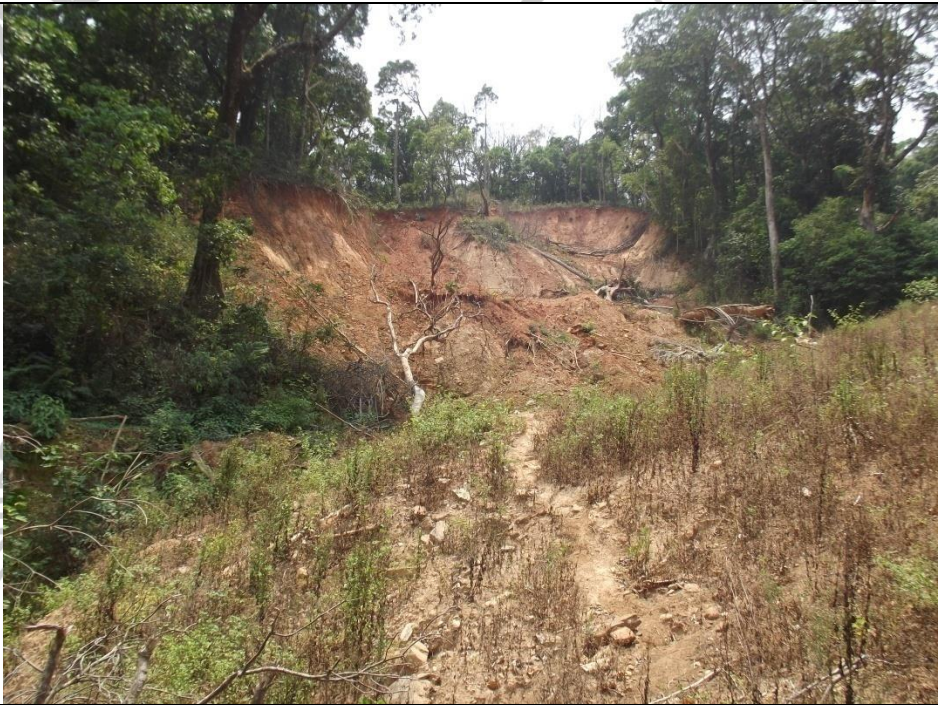
| Geo-scientific Causes | The oversaturation of overburden, more percolation along weak planes and detachment along same planes. |
| Remarks, if any | The main factors responsible here include high slope, over saturation of the overburden and highly weathered nature of the rock. |

| Remedial measures | Drainage maintenance, Nailing, Maintaining free flow of the water. |

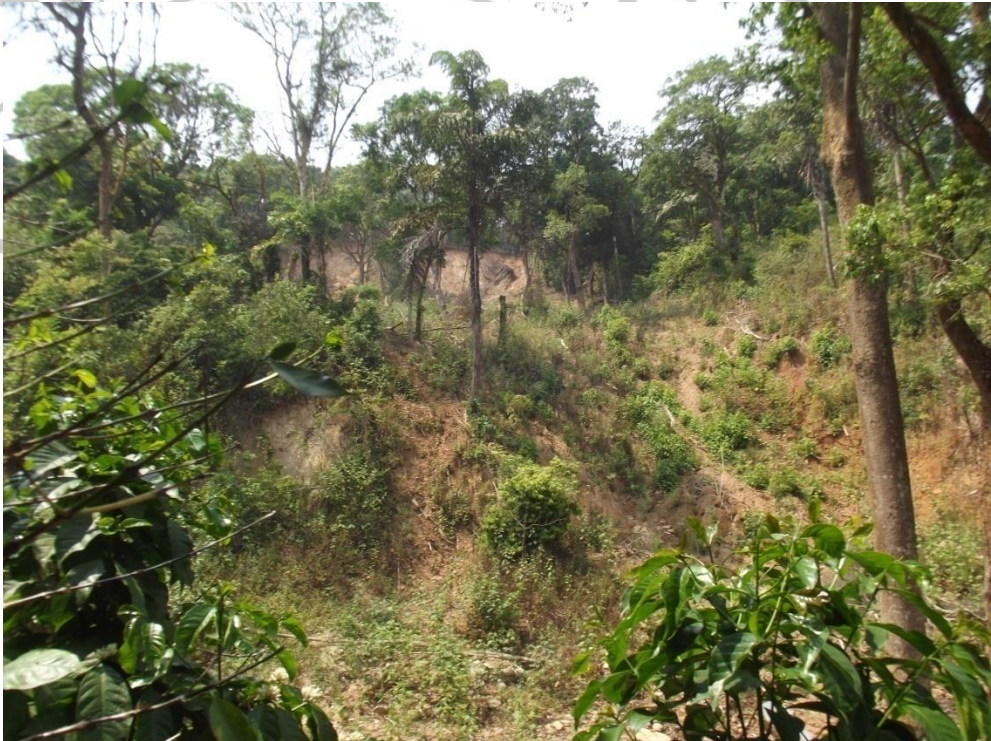
| Geo-parameter | Details |
|---|---|
| Geo-scientific Causes | The oversaturation of overburden, non-cohesion of the material. |

| Remarks, if any | The main factors responsible here include high slope, over saturation of the overburden and highly weathered nature of the rock. |

| Remedial measures | Drainage maintenance, Nailing, Maintaining free flow of the water. |

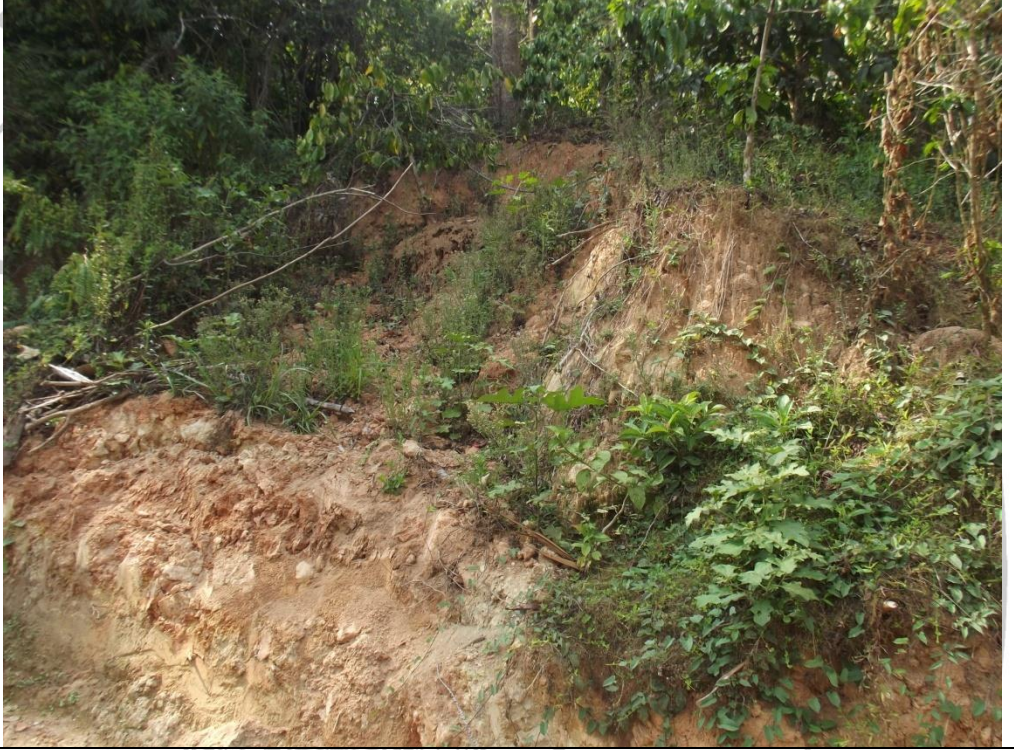
| Geo-scientific Causes | Removal of toe support during road construction, Increase of soil mass due to oversaturation |

| Remedial measures | Drainage maintenance, Nailing, Maintaining free flow of the water. |

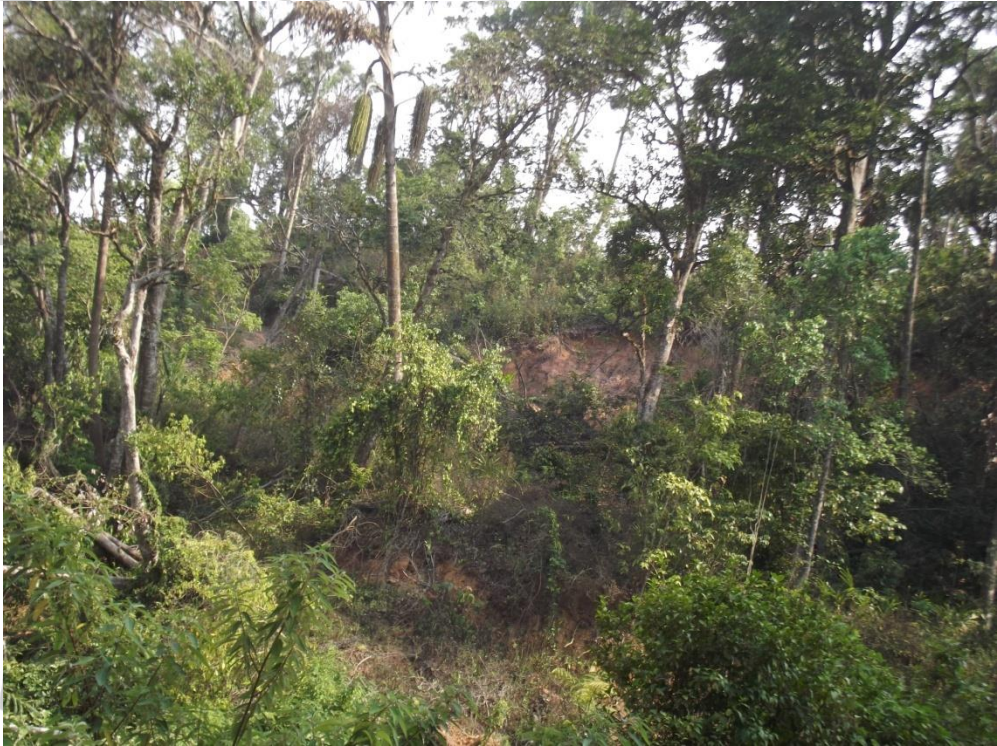
| Geo-scientific Causes | Slip along contact between overburden and underlying rock, Increase in soil mass weight. |

| Remedial measures | Drainage maintenance, Nailing, Maintaining free flow of the water. |

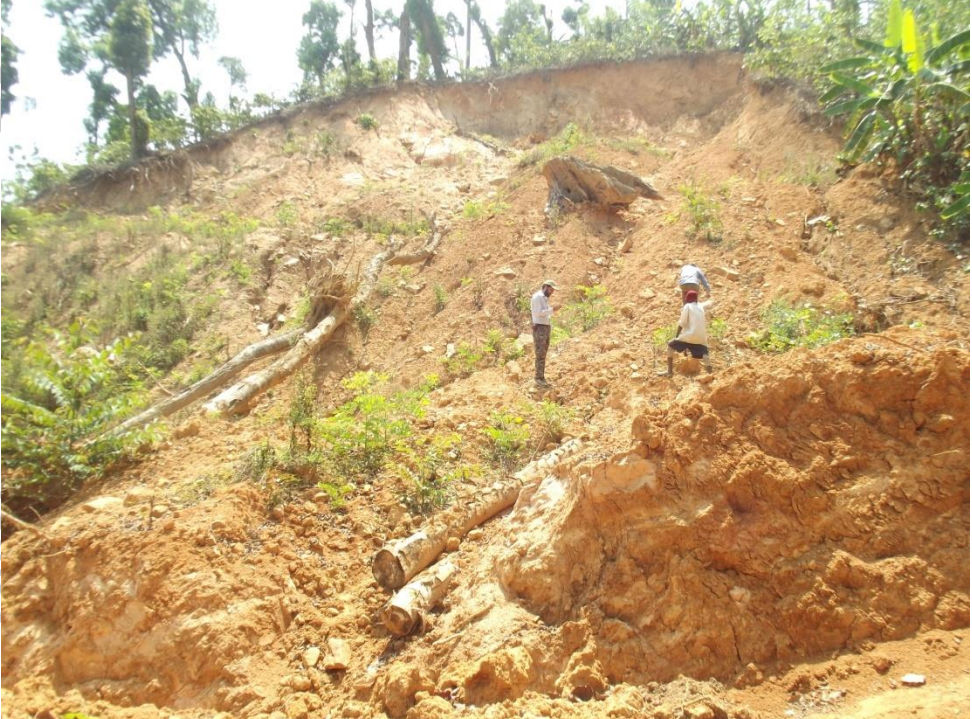
| Geo-scientific Causes | Weathered rock and thick overburden, Saturation of overburden during rains, Slip along bed rock plane, Steep slope, High stretching of mineral grains under ductile conditions and initiation of shear planes. |

| Remedial measures | Drainage maintenance, Nailing, Maintaining free flow of the water. |

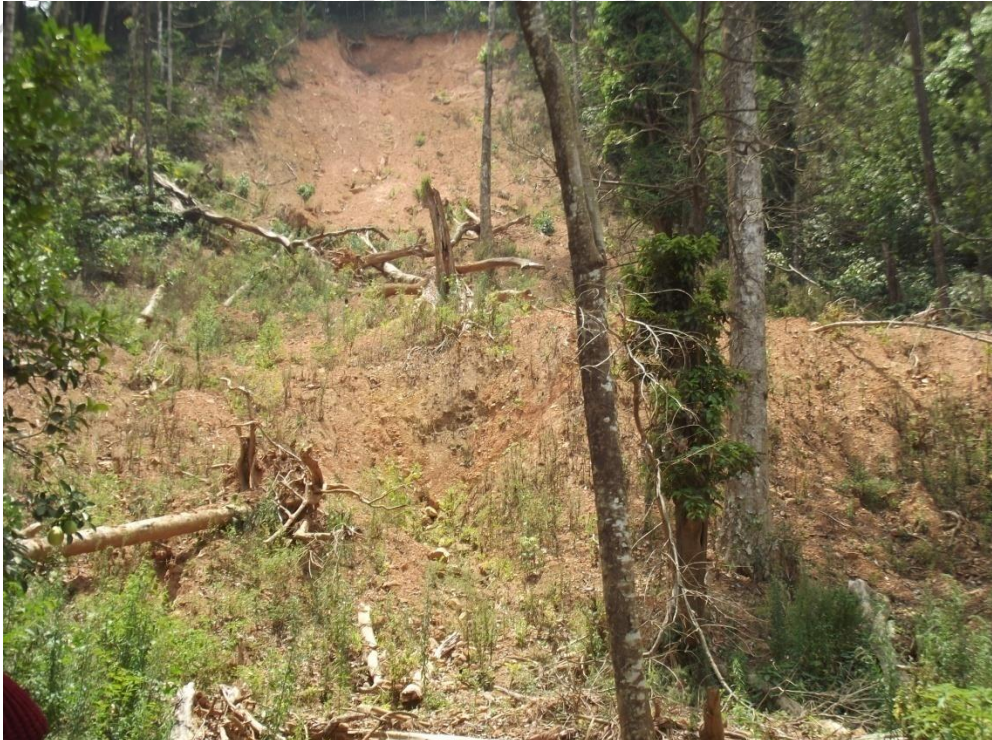
| Geo-scientific Causes | Saturation of overburden, Exposure of rock along nalla with frequent discontinuities favoured the detachment during high down pour and loose material lying on the flanks of the stream. |

| Remedial measures | Drainage maintenance, Nailing, Maintaining free flow of the water. |

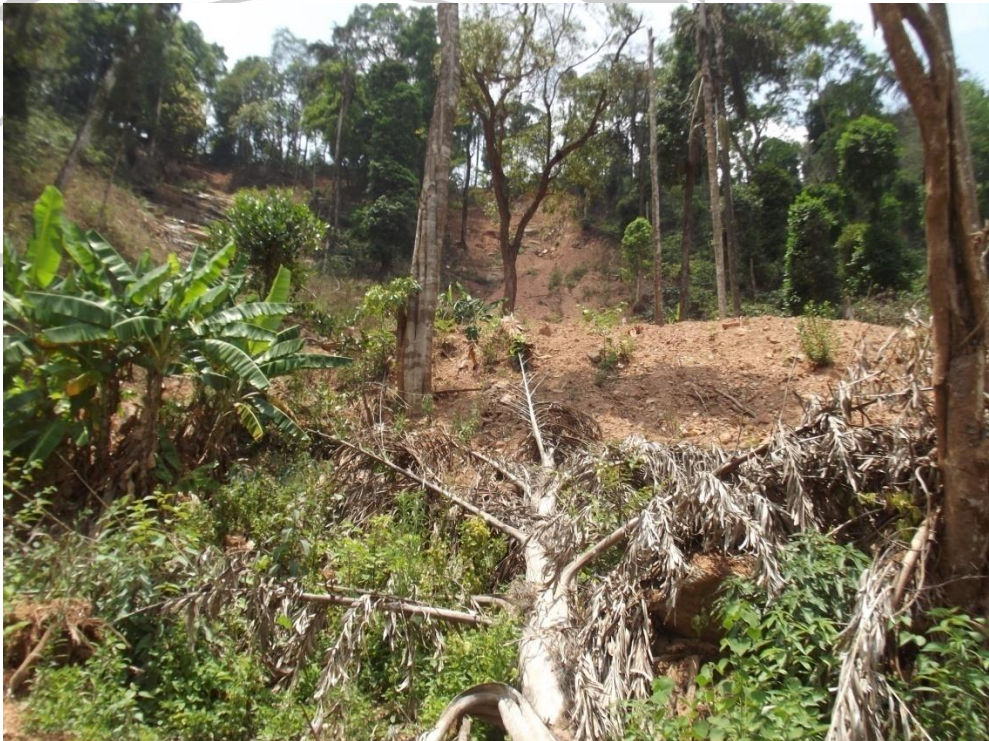
| Geo-scientific Causes | Over saturation of the overburden, lubrication of the loose overburden material along contact between rock and overlying material |

| Remedial measures | Drainage maintenance, Nailing, Maintaining free flow of the water. |

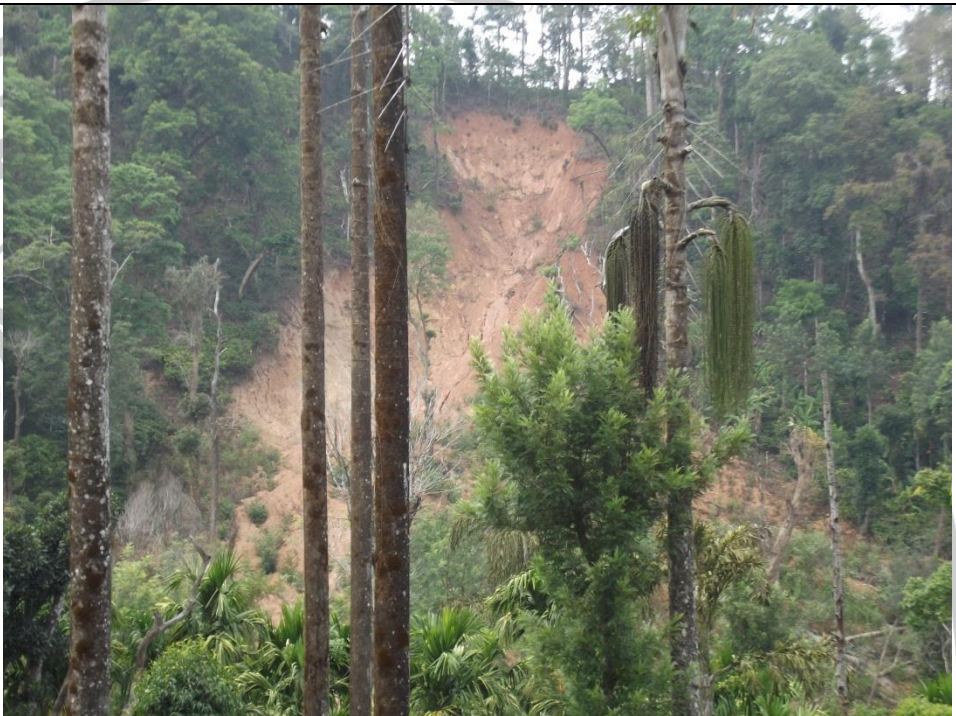
| Geo-parameter | Details |
|---|---|
| Geo-scientific Causes | High slope and over saturation of overburden material |

| Remedial measures | Drainage maintenance, Nailing, Slope easing, Maintaining free flow of the water. |
