REPORT ON MESO-SCALE LANDSLIDE SUSCEPTIBILITY MAPPING (1:10,000) IN AND  
AROUND NIDUVATTU, MUKKODLU & MEGATTALU AREAS, KODAGU DISTRICTS OF  
KARNATAKA

Item no.: M4LSSM/NC/SR/SU-KG/2018/26601

Final report for field season 2018-19

Aijaz Ahmad Bhat, Senior Geologist & Dr. Zameer Ahmad Shah, Geologist

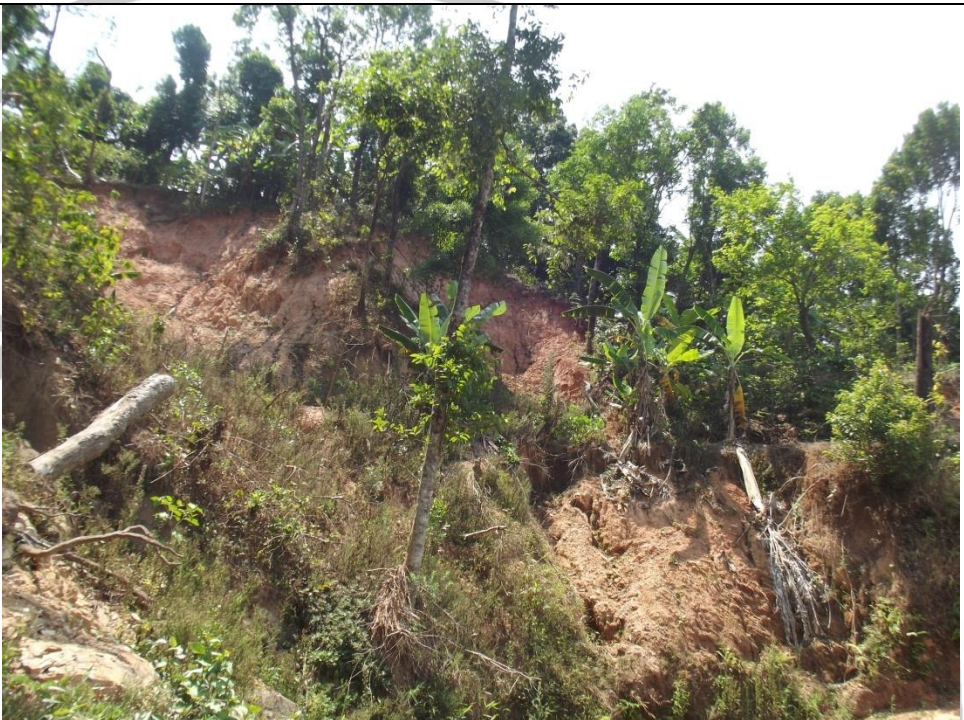
| Geo-parameter | Details |
|---|---|
| Geo-scientific Causes | Oversaturation of the overburden, lubrication of overburden along contact between overburden and underlying rock. |

| Remedial measures | Drainage maintenance, Nailing, Slope easing, Maintaining free flow of the water. |

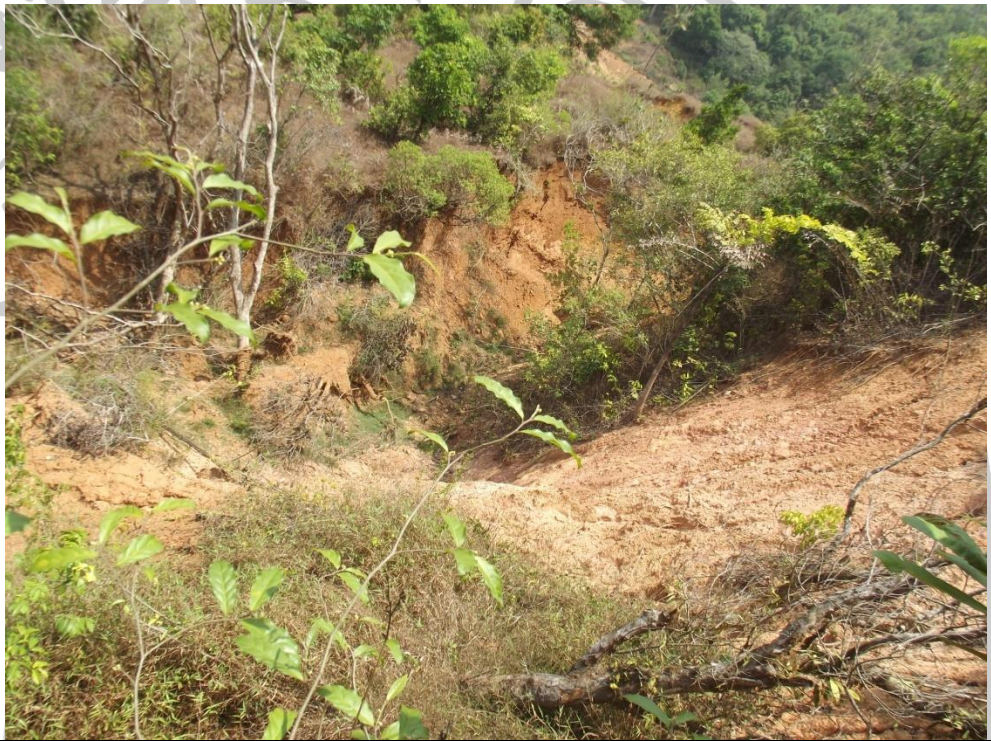
| Geo-parameter | Details |
|---|---|
| Geo-scientific Causes | Very steep slope (80 to 85°), Saturation of overburden. |

| Remedial measures | Drainage maintenance, Nailing, Slope easing, Maintaining free flow of the water. |

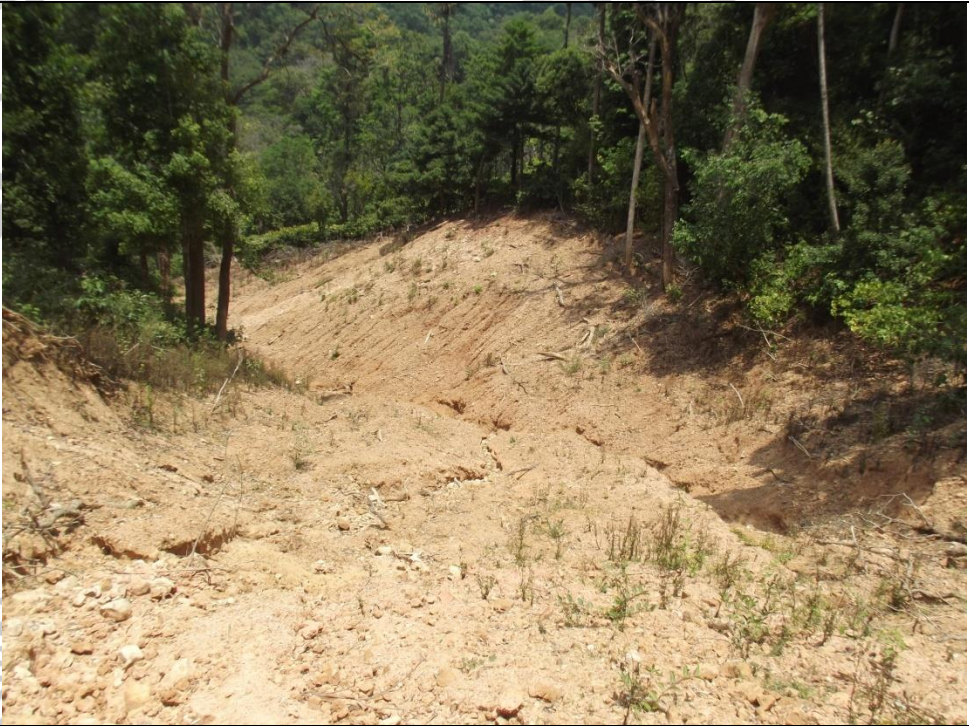
| Geo-scientific Causes | Partially weathered underlying rock Saturation of overburden and high slope |

| Remedial measures | Drainage maintenance, Nailing, Slope easing, Maintaining free flow of the water. |
