**भारत सरकार**  
**Government of India**  
**भारतीय भूवैज्ञानिक सर्वेक्षण**  
**Geological Survey of India**

**Meso-scale (1:10,000) Landslide Susceptibility Mapping in and around Virajpet area,  
Kodagu district of Karnataka**  
टोपोशीट सं: 48 P/16; Toposheet No.: 48 P/16

एम4एलएसएसएम/एनसी/एसआर/एसयू-केजी/2020/32460  
Item no.: M4LSSM/NC/SR/SU-KG/2020/32460

कार्य सत्र 2020-21 का प्रतिवेदन  
**Report for field season 2020-21**

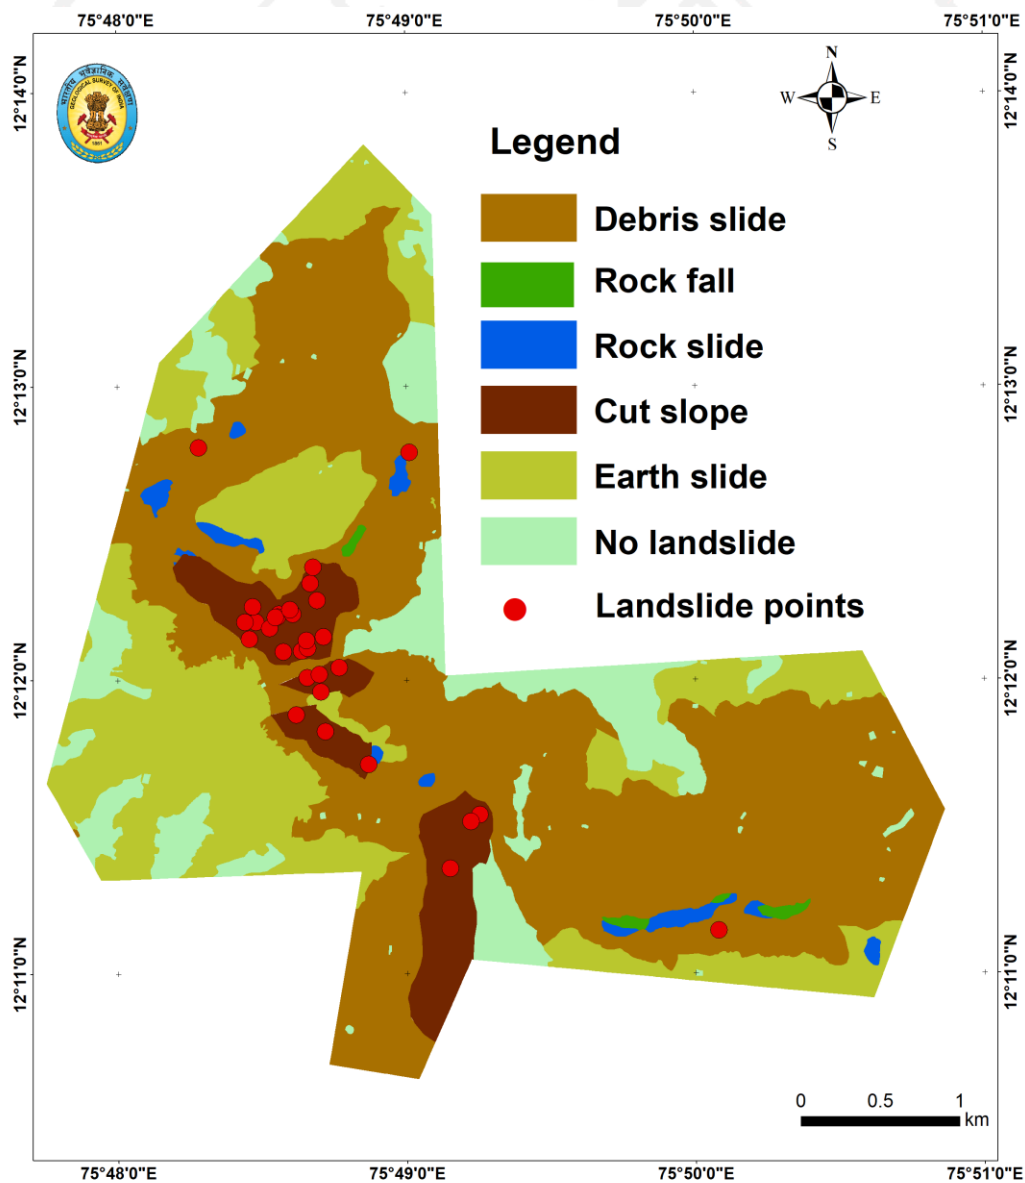
Fig. 4.1 Landslide distribution on the domain map

In the process of updating the landslide inventory (*Annexure-III*) in the field, 31 number landslides of varying dimensions were documented within the localities of Virajpet following Varnes' classification (Varnes, D. J., 1978) of landslides. There are 24 debris slides and 7 earth slides while no rock slide is documented in the area. Out of the 31 landslides in

the database, 28 are shallow rotational earth or debris slides while 3 are shallow translational slides with a depth less than 4 m. The landslides are of varied dimension and wholly confined within the cut slope domain (Fig. 4.1). These parts of the hillslopes have undergone substantial slope profile modification primarily because of the increased construction of settlements. Several small dimension landslides are observed here due to toe cutting for building construction. The average length the landslides is 15 m with no run out distance. The maximum length of the landslide documented is about 45 m with approximately 50 m run out distance in the north facing Magulla hillslope (KG/KOD/48P16/2020-21/11, Annexure III). A few localized transverse cracks are observed on parts of these slopes which indicate a varying level of instability.

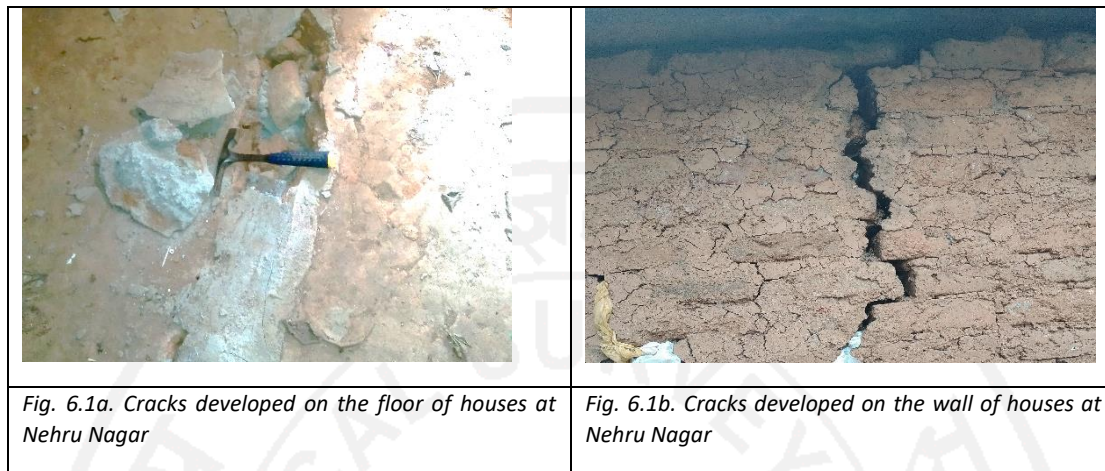
In Nehru Nagar, above Polling Station number 8, the settlements and buildings are located on the mid-slopes of southwestern facing slope up to an elevation of 1007m above mean sea level. A localized surface crack ( $12^{\circ}11'42.57''\text{N}$ ,  $75^{\circ}48'51.84''\text{E}$ ) has developed at the mid-slope above the topmost settlement or building at Nehru Nagar, Virajpet (Fig. 6.1a,b). The crack is about 30 m long with an opening varying from 5-10 cm while the depth varies from 10-30 cm. The shape of the crack is curvilinear and is currently sealed using impervious

- vi) Several cut sections without structural toe buttress are observed at the western part of Nehru Nagar (Lat/Long: 12.197102°/ 75.811939°). In addition, a settlement is constructed right on the path of the ephemeral stream without the provision of a drainage system and is currently abandoned due to slope instability. The site is characterized by a preponderance of slope wash and assorted debris and represents concave slope morphometry or hollow landform unit which has a high potential for water accumulation. Therefore, a proper drainage system with adequate lining must be provided along the hillside of the cut sections.

vii) In the event of any indicators of landslide incidence within the slope Nehru Nagar, a feasible immediate escape route is towards the southeast of Polling Station number 8 where a temporary safe shelter can be arranged (Fig 6.1c).

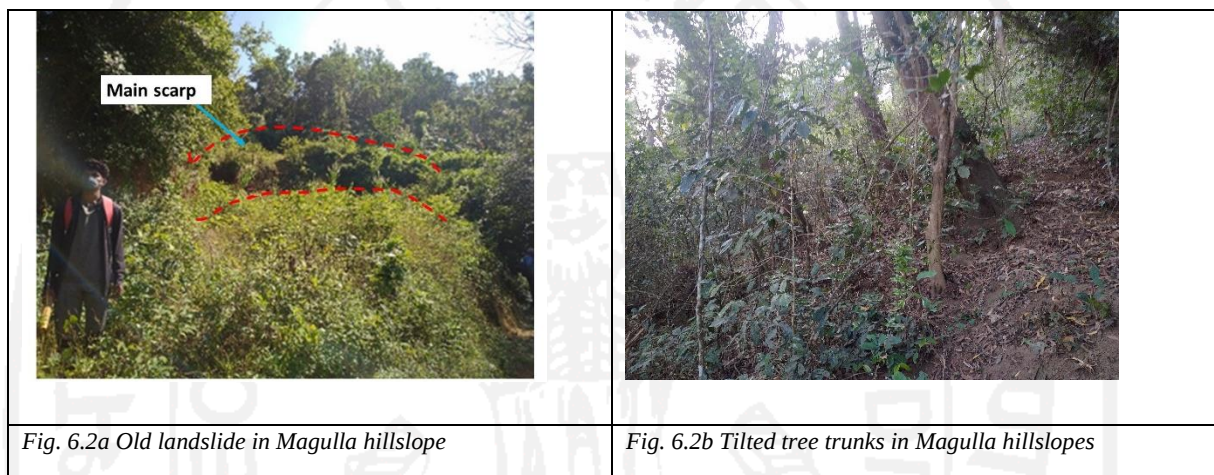
In Magulla, a landslide was reported in the 2018 Monsoon, wherein a house was partially damaged (Fig. 6.2a). The landslide was initiated above the excavated steep slope where the extensive slope cut was kept unsupported at the toe. The thickness of the immature soil characterizing the slope is about 3-4m. No transverse cracks are observed on the flanks or above the landslide however a few tilted tree trunks are observed on the upslopes (Fig. 6.2b). If re-activation of the old landslide is triggered through retrogression, given the steep slope of

about 35°-45° coupled with thick overburden under adverse hydrological conditions, the Magulla foot slope falls in the probable high-risk zone. The elements at risk (EatR) identified include 5 residential buildings that fall in a possible impact zone along the material movement direction. Based on the dimension of the old landslide, the possible volume of the material that can be mobilized is 3000 m<sup>3</sup> (Length-20m, width-50m, and thickness-3m).

As a part of the mitigative measure, it is recommended to erect a breast wall of sufficient height and weep holes at the slope cut sections. In the event of a prolonged adverse meteoric event that may aggravate instability within the slope, a feasible immediate escape route is towards the north where a temporary safe shelter can be arranged above the closest State-Highway road tri-junction about 90m away at the foot slope of Ayyappa Hill (Fig.6.2c)

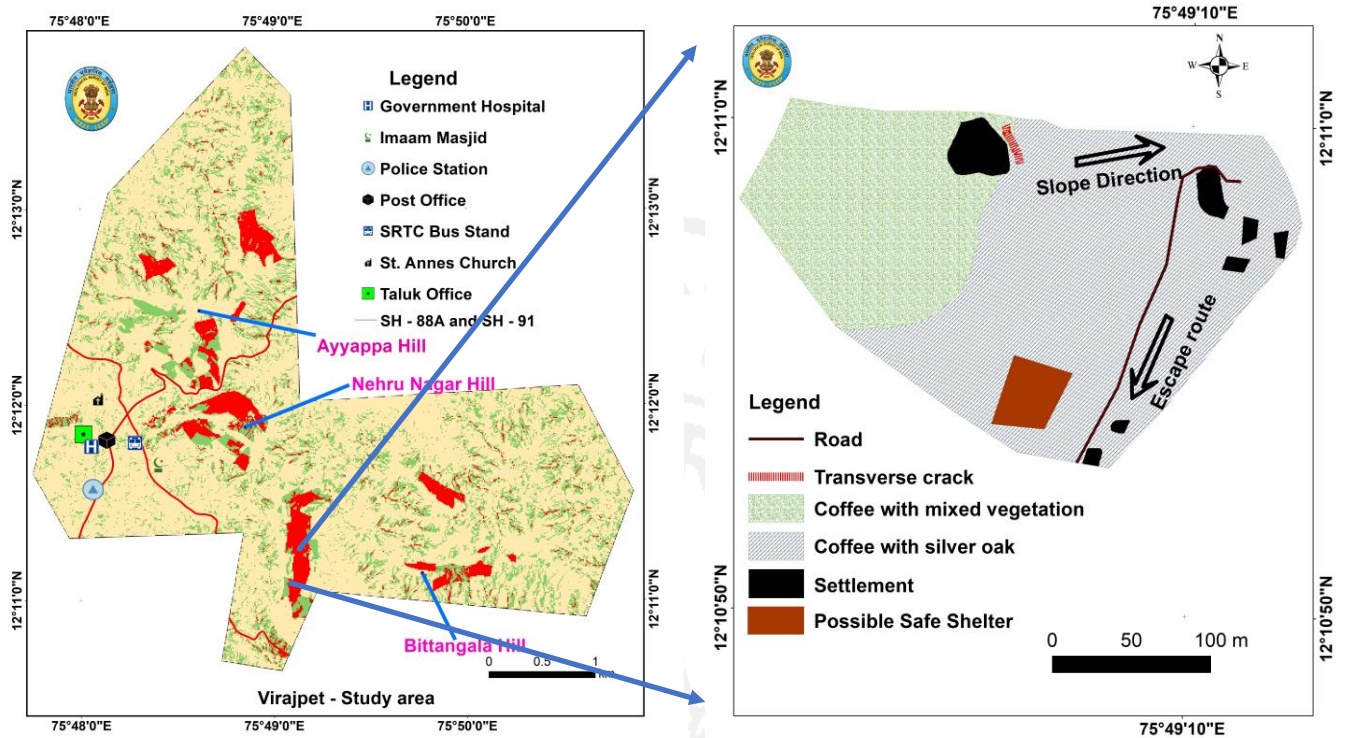
Fig. 6.3c. Location map of Ambatty, Virajpet along with Elements at Risk (EatR) and possible escape route

The probable high risk (PhR) area is a qualitative assessment that is driven by the presence of elements at risk (EatR) near the distressed slopes. The possible volume of material that can be mobilized is an approximate conservative estimation based on the observations of site characteristics. The proposed temporary safe shelter and escape route identified are of neighbouring houses representing relatively stable locations in the event of adverse incidence.
