मेसो-स्केल (1:10,000) कलासा क्षेत्र के एनएनई में और एसएच-66 रोड कॉरिडोर के साथ,  
चिकमंगलूर जिला, कर्नाटक में भूस्खलन संवेदनशीलता मानचित्रण।  
**Meso-scale (1:10,000) Landslide Susceptibility Mapping in NNE of Kalasa area and  
along SH-66 road corridor, Chikmangalur District, Karnataka.**  
टोपोशीट सं: 48 O/8; Toposheet No.: 48 O/8

एम4एलएसएसएम/एनसी/एसआर/एसयू-केजी/2021/33518  
**Item no.: M4LSSM/NC/SR/SU-KG/2021/33518**

**कार्य सत्र 2021-22 का प्रतिवेदन**  
**Report for field season 2021-22**

इंजीनियरिंग भूविज्ञान तथा भूस्खलन विभाग/Engineering Geology and Landslide Division  
राज्य इकाई: कर्नाटक एवं गोवा/State Unit: Karnataka & Goa  
बेंगलूरु/Bengaluru-560078

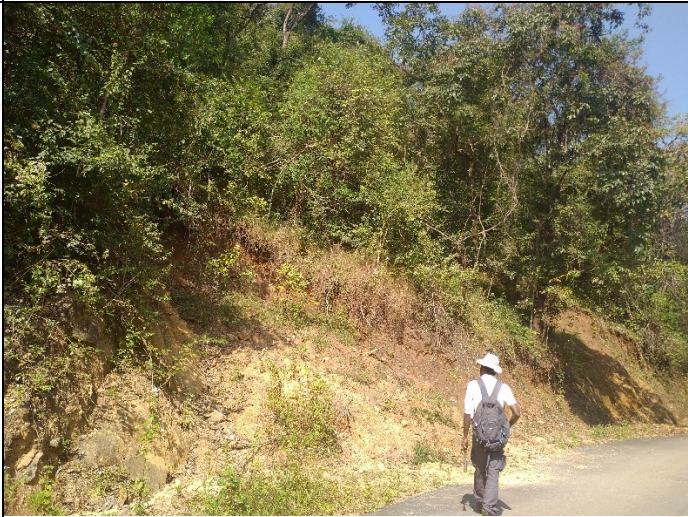
| 40 | Summary/Abstract | Shallow rotational slide along the steep slope with the presence of thick overburden in between the rocky flanks and drainage above the crown flowing over the slope face and saturating the overburden. |

| 37 | Remedial measures | - A breastwall with proper drainage system should be erected at the toe. |

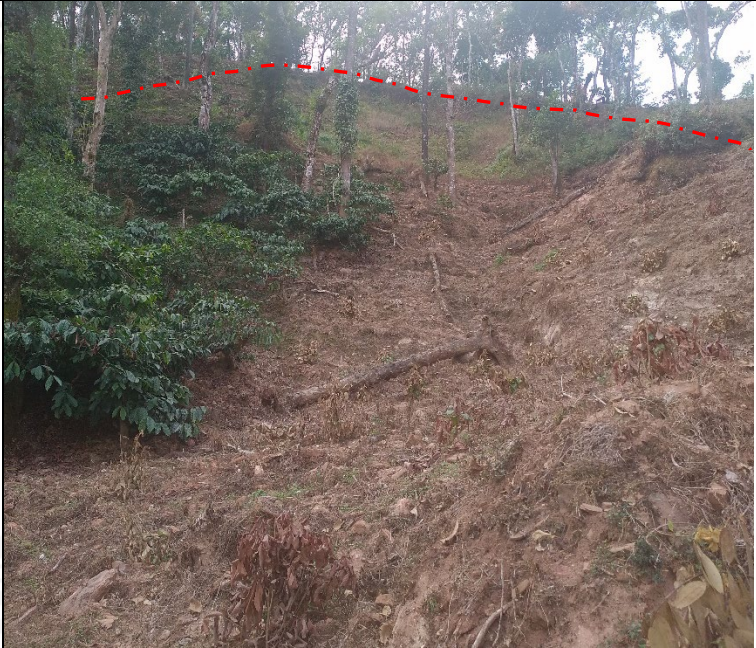
| 40 | Summary/Abstract | The slide is inventoried within the coffee plantation where highly weathered rock with about 1 m thick overburden/residual soil. In addition slope morphometry is concave augmenting water flow accumulation on the slope. |

| 37 | Remedial measures | -Construction of drainage to be provided on the hillside along with chute drain on the flanks to prevent possible widening through erosion. |

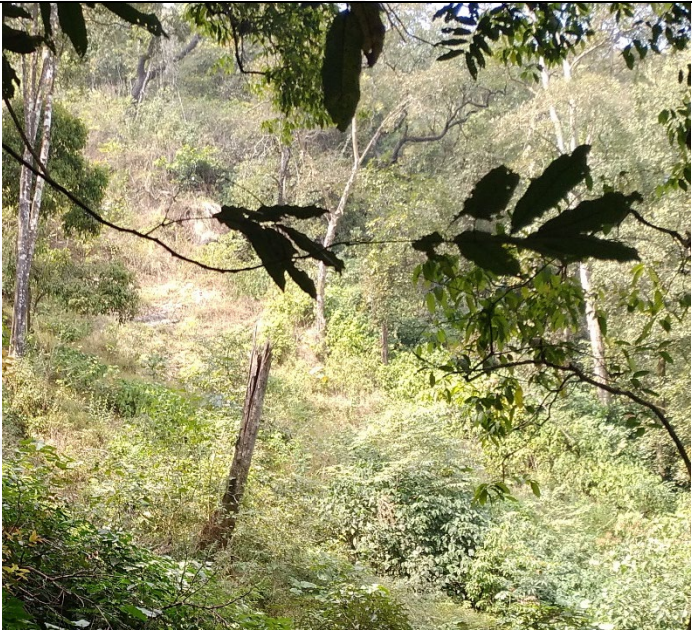
| 40 | Summary/Abstract | -It is observed that the slope here is characterized 1-2 m of colluvium and thickly forested. It is recommended that proper lining of drainage and pre-cast pipe of adequate diameter be provided at the downslope where the Hemmaki road is intersected by the drainage. |

| 37 | Remedial measures | - It is recommended that proper lining of drainage and pre-cast pipe of adequate diameter may be provided at the downslope where the Hemmaki road and other plantation area is intersected by the drainage in the event of debris flow. |

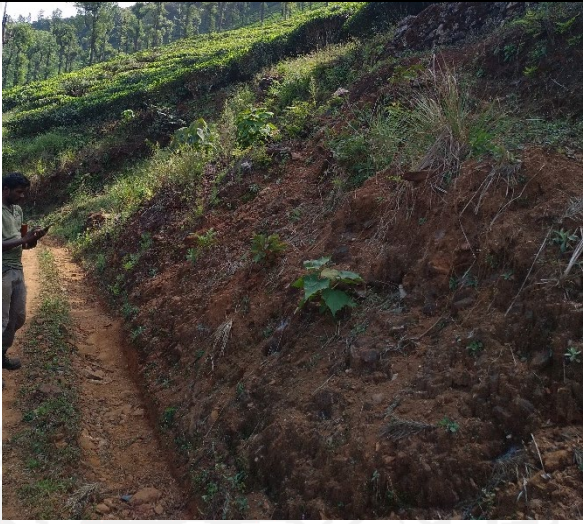
| 40 | Summary/Abstract | - The slide is inventoried at Goomankhan tea estate where the slope is characterized 1-2 m of immature soil and the steep slope cutting was observed at the site compared to adjacent slope without any structural support system at the toe. It is recommended that a breastwall be constructed with proper lining of drainage. |

| 37 | Remedial measures | -It is recommended that a breastwall be constructed with proper lining of drainage. |

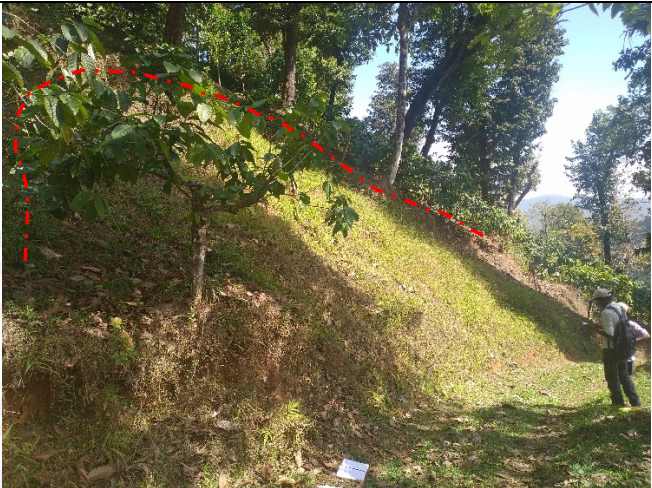
| 40 | Summary/Abstract | -The slide is inventoried within the coffee plantation at Yelandur where the slope is characterized 1-2 m of mature soil and steeply dipping. The approach road to coffee plantation was constructed without any structural support drainage system. It is recommended to construct a lined hillside drainage system to arrest toe erosion and further reactivation of the slide. |

| 37 | Remedial measures | -It is recommended to construct a lined hillside drainage system to arrest toe erosion and further reactivation of the slide. |

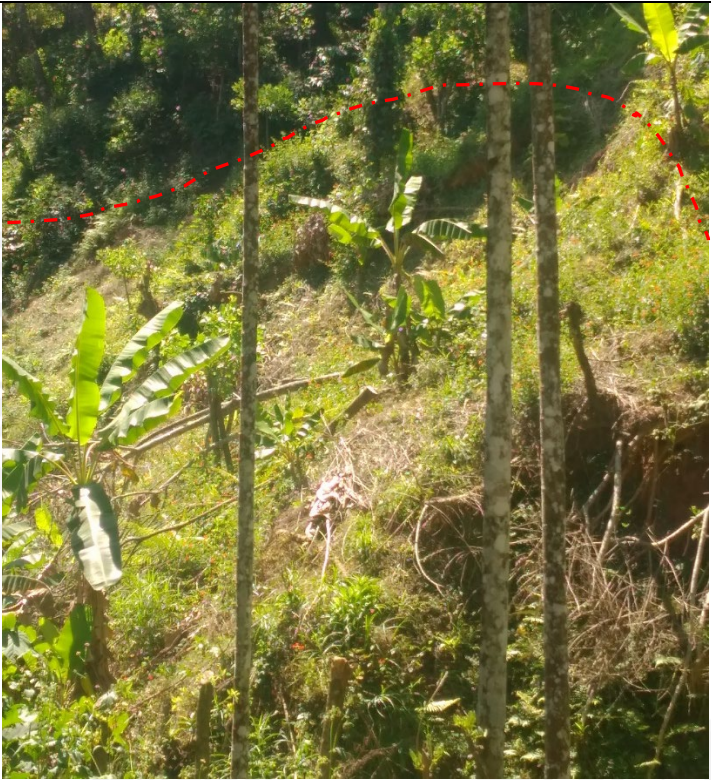
| 40 | Summary/Abstract | -The slide is inventoried at Hemmaki area where the slope is characterized 1-2 m of colluvium soil and the slope has been subjected to sustained toe erosion by the 2 <sup>nd</sup> order stream at the left flank which aggravated the landslide. It is recommended to construct a gabion wall or drystone wall to arrest the toe erosion by the stream. |

| 37 | Remedial measures | -It is recommended to construct a gabion wall or drystone wall to arrest the toe erosion by the stream. |

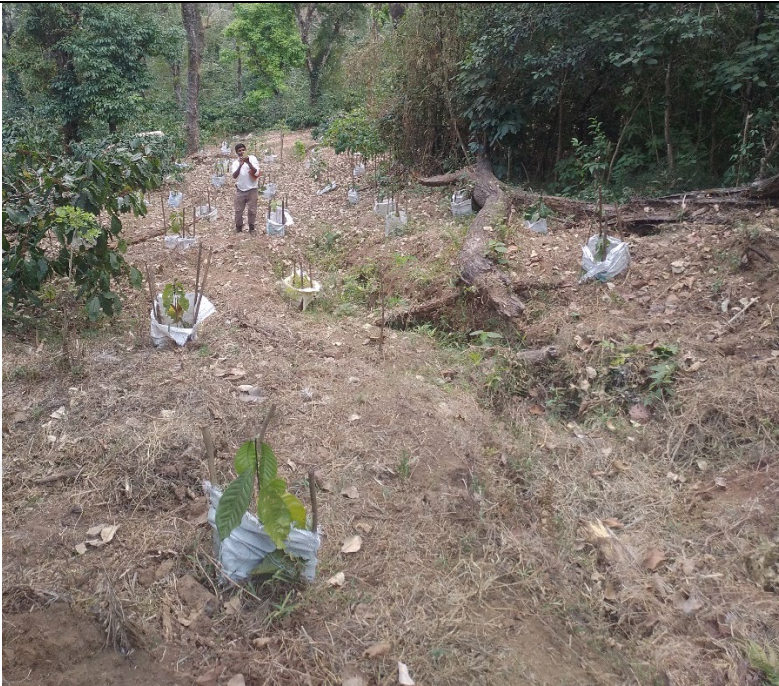
| 40 | Summary/Abstract | -The slide is inventoried in Bilagali where the slope is characterized 1-2 m of immature soil and colluvium and steeply dipping. First order stream was seen to have active erosion on the slope. It is recommended to monitor and observe for any indicators of slope instability such as cracks on the upslope because there is a settlement 60m on the upslope. It is recommended to construct proper drainage system and drystone walls to arrest the toe erosion by the stream. |

| 37 | Remedial measures | -It is recommended to monitor and observe for any indicators of slope instability such as cracks on the upslope because there is a settlement 60m on the upslope. It is recommended to construct proper drainage system and drystone walls to arrest the toe erosion by the stream. |

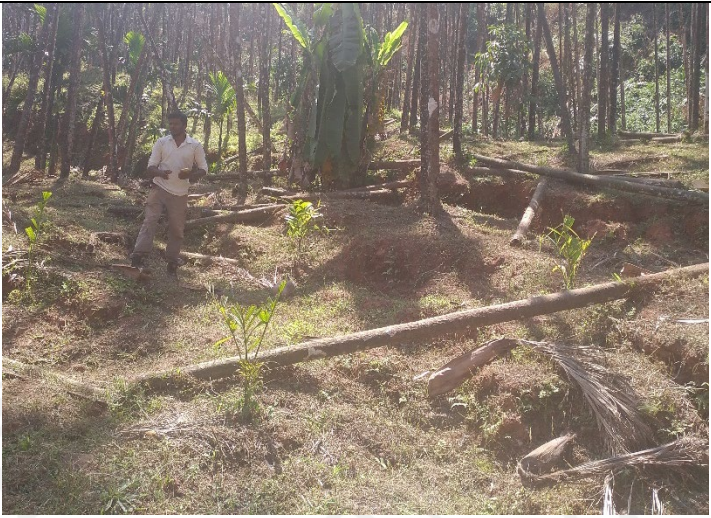
| 40 | Summary/Abstract | -The slide is inventoried in Bilagali where the slope is characterized by about 2 m mature residual soil. Third order stream was also observed where active bank erosion can be seen. It is recommended to construct proper drainage system and drystone walls to arrest the toe erosion by the stream. In addition, concrete retaining wall may be constructed near the adjacent bridge to arrest erosion of the bridge abutment area. |

| 37 | Remedial measures | -It is recommended to construct proper drainage system and drystone walls to arrest the toe erosion by the stream. In addition, concrete retaining wall may be constructed near the adjacent bridge to arrest erosion of the bridge abutment area. |
