**Note on the preliminary Assessment of Landslides at Dakshin Kannada Districts, Karnataka, 2023.**

M4LS/NC/SR/SU-KG/2023/47552

Field season 2023-24

Senthilkumar K  
Senior Geologist

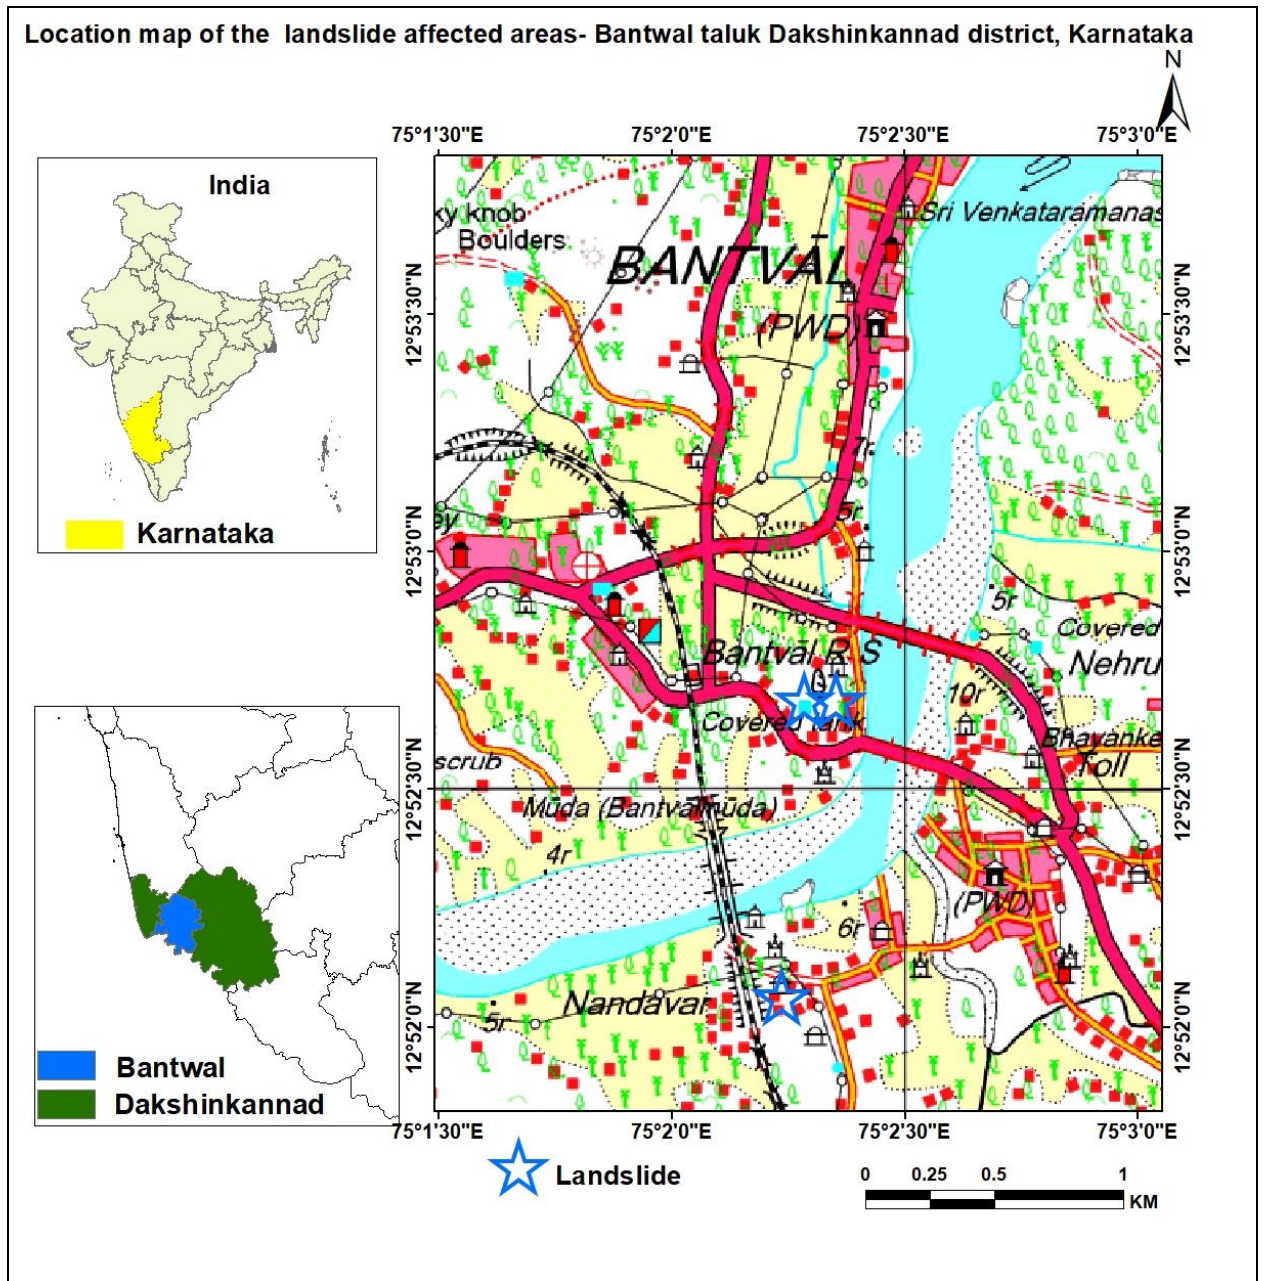
Fig.1 Location of the landslide-affected areas in Dakshin Kannada district of Karnataka

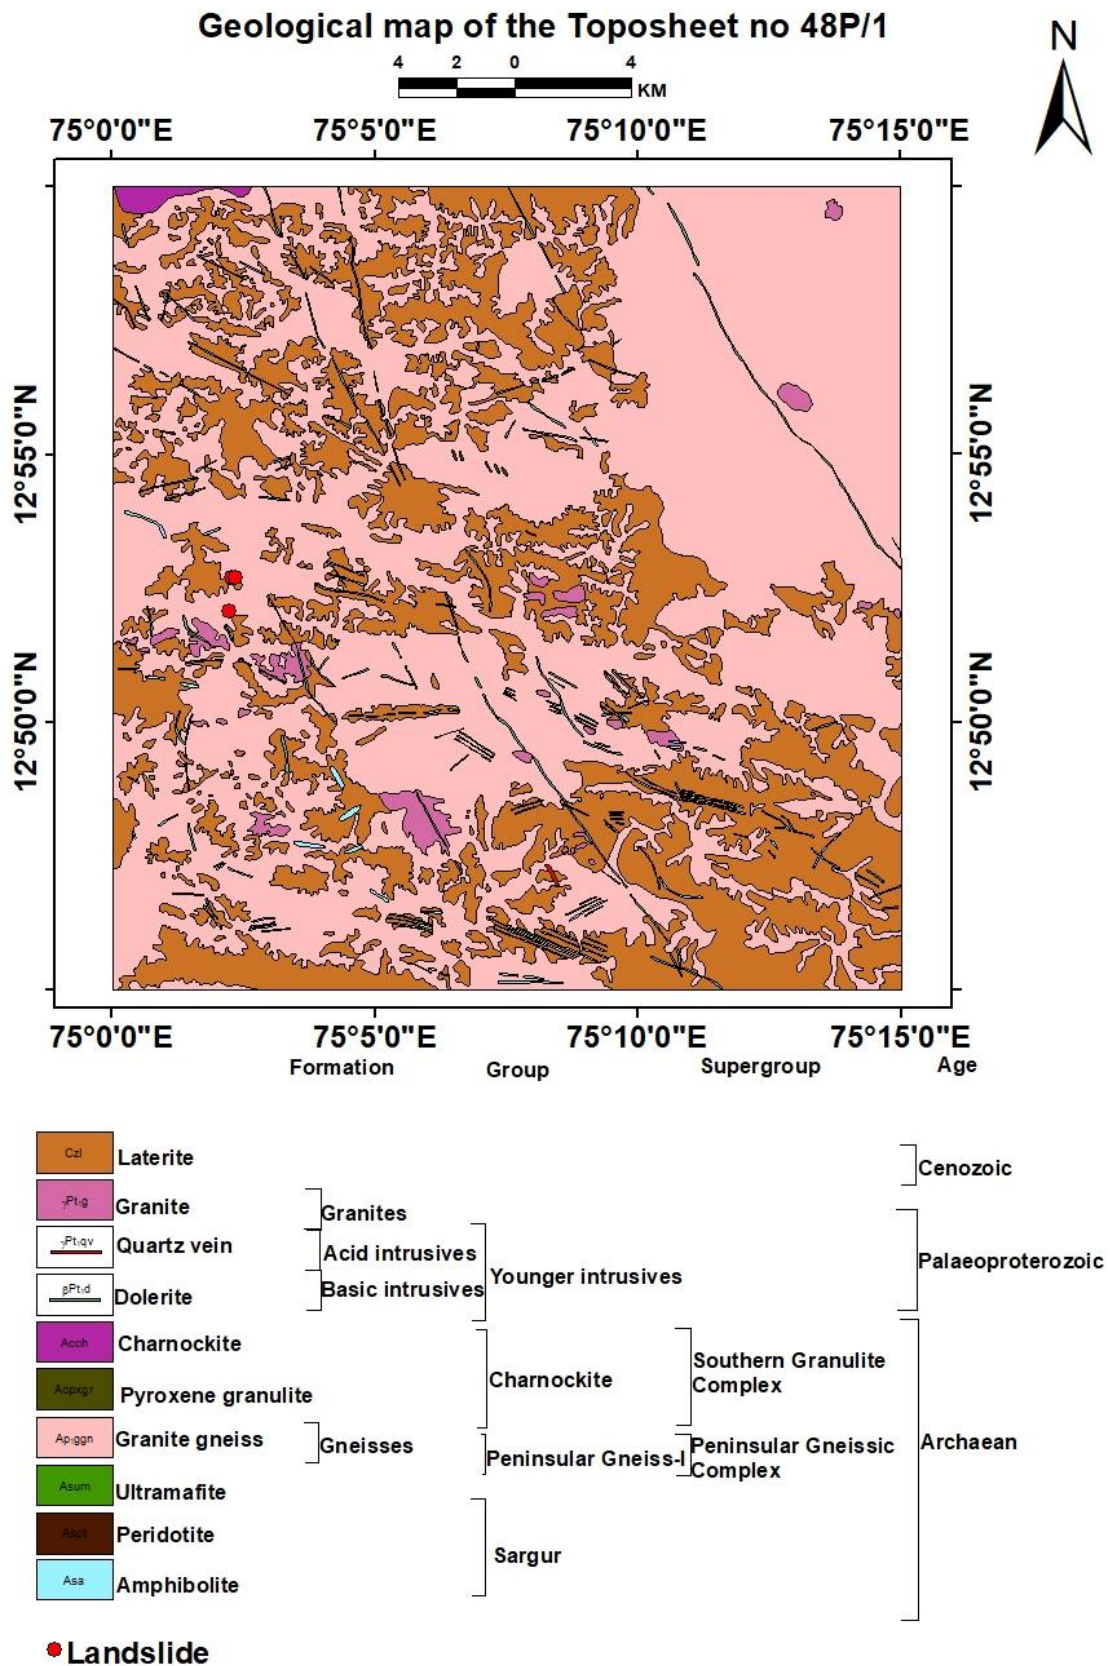
Fig. 2 Geological map of Toposheet no 48P/1  
(Source: GSI, 1:50k Geological map)

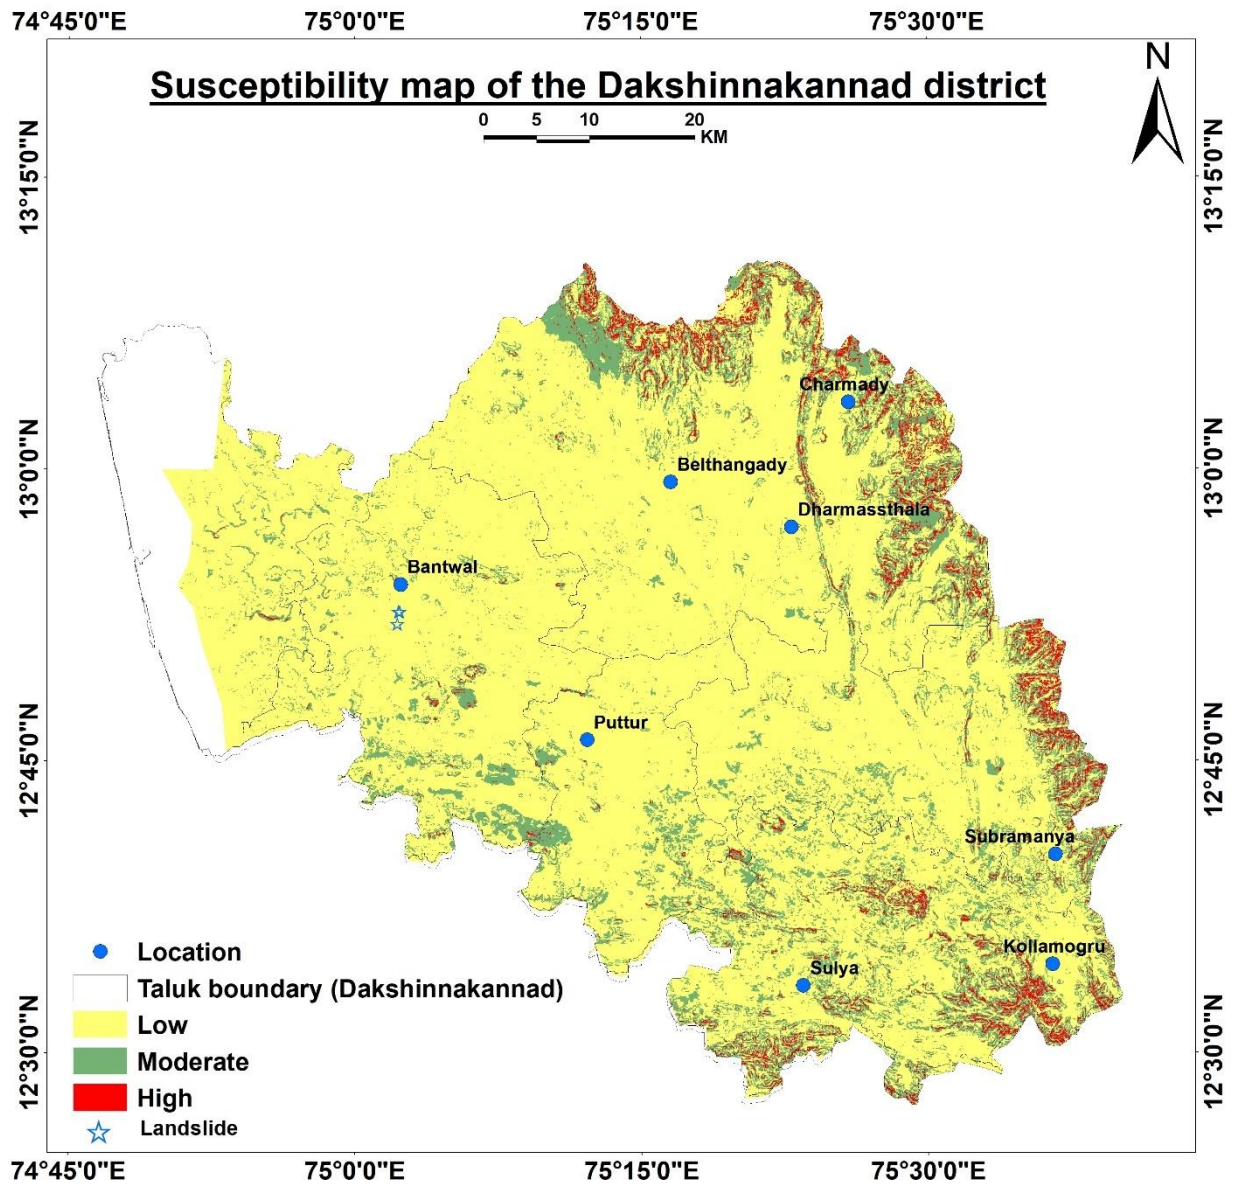
Approximately 19% of the region covered by the National Landslide Susceptibility Mapping (NLSM) in Dakshin Kannada, equivalent to 818 square kilometers, exhibits a combined moderate and high susceptibility to landslides. These vulnerable areas are primarily concentrated within the Kadaba, Sulya, and Beltangadi taluks. In Bantwal taluk, specifically in the Sajipamunnur village, the topography is characterized by gently undulating landforms situated at an elevation of approximately 45 meters above sea level. The landslide incident took place in an area characterized by cut slopes.

Fig.3 Landslide locations on the national landslide susceptibility map (NLSM) of the Dakshin Kannada districts (GSI, 1:50k NLSM map)

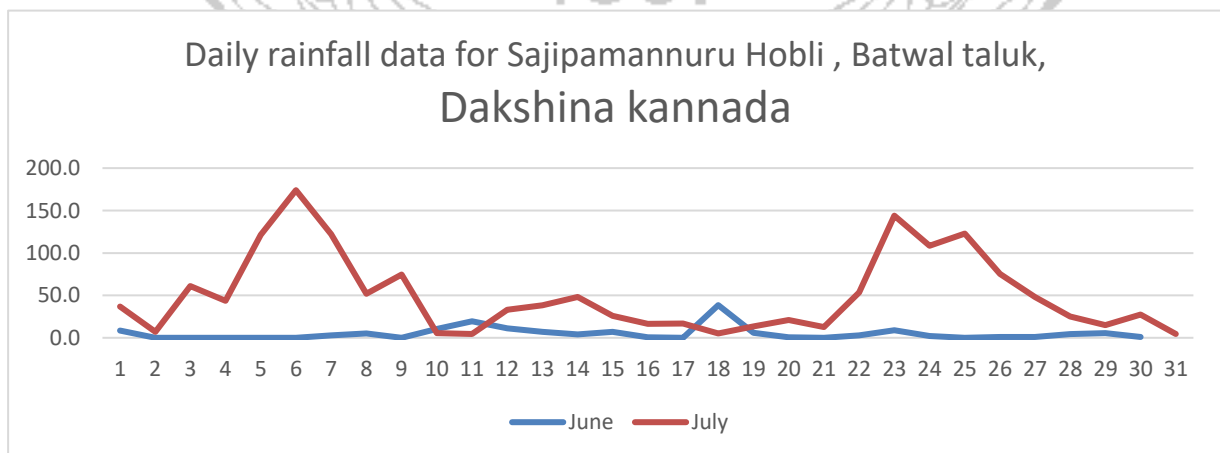
The primary catalyst for the landslide in Sajipamunnur village was heavy rainfall, which occurred on 7th July 2023. The analysis of rainfall data reveals a significant spike in precipitation (as depicted in Figure 4) from the 5th to the 7th of July 2023, and it was this particular rainfall event that triggered the Sajipamunnur landslide. Furthermore, an examination of cumulative rainfall data from 2018 to 2023 illustrates that Sajipamunnur Hobli consistently experiences its highest levels of rainfall during July (as shown in Figure 5).

**Fig. 4. Daily rainfall data for June to July from Sajipamunnur Hobli, Batwal taluks (KSNDMC)**
