**A REPORT ON LANDSLIDE INVENTORY ALONG NH & SH  
OF GHAT ROADS IN KARNATAKA**

**(Progress Report for the Field Season 2007-08)**

**Code No.: LHZ/SR/KG/2007/044**

**Project: ENGINEERING GEOLOGY**

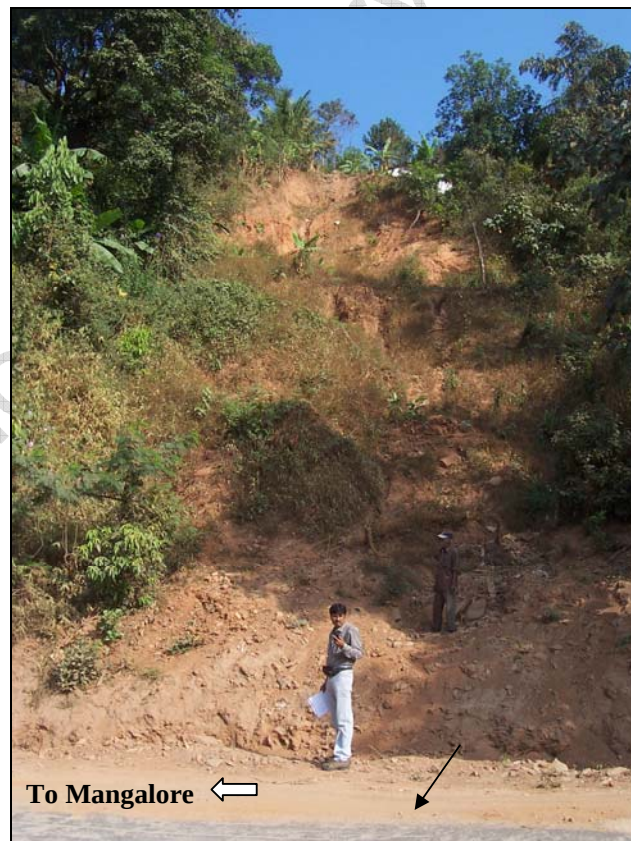
**NATURE OF DAMAGE:** The Madikere-Mangalore state highway (SH 88) was blocked due to the heaped debris material on the road.

**Photo-4:** The SH88 was blocked (arrow) and the slided debris was heaped up on the road

- i). The loose material at the crown is to be removed.
- ii). The natural stream is to be restored for free flow.
- iii). No construction should be allowed along the flanks of the stream.
- iv). Small retaining wall of 2m height may be constructed at the base.

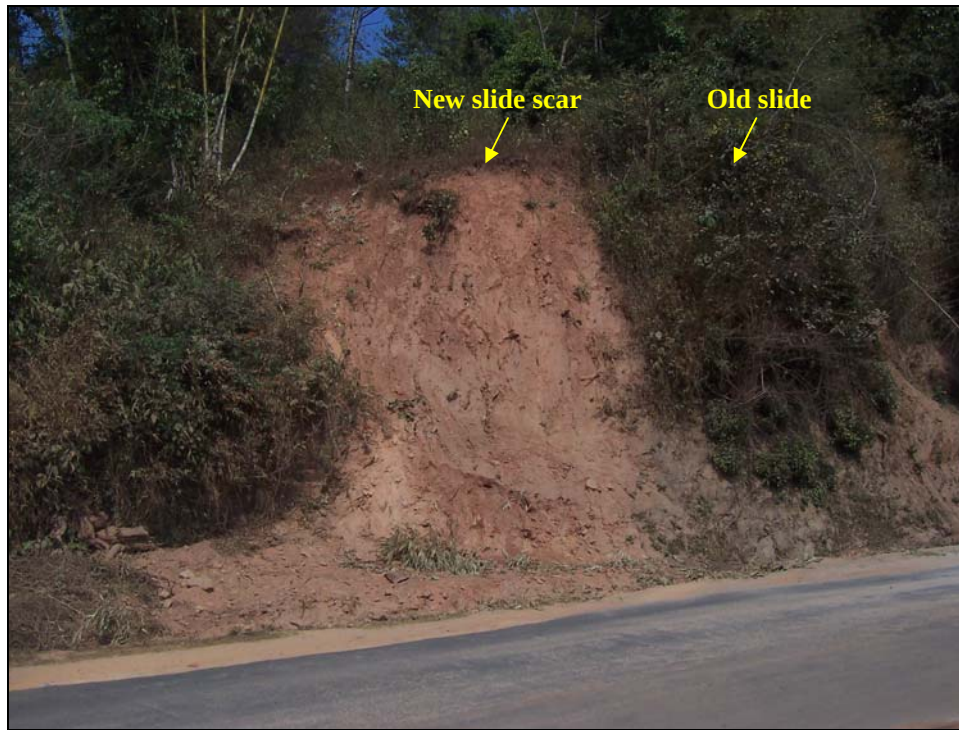
***Photo 13: Lateral progradation of the slide along SH88 cut slopes***

- i) The relative height of the slope is low hence benching of the slope with a average slope angle of 45° will ensure its stability in long run.
- ii) Deep rooted plants/shrubs with high tensile strength is to be planted in the benched slope to increase its stability.

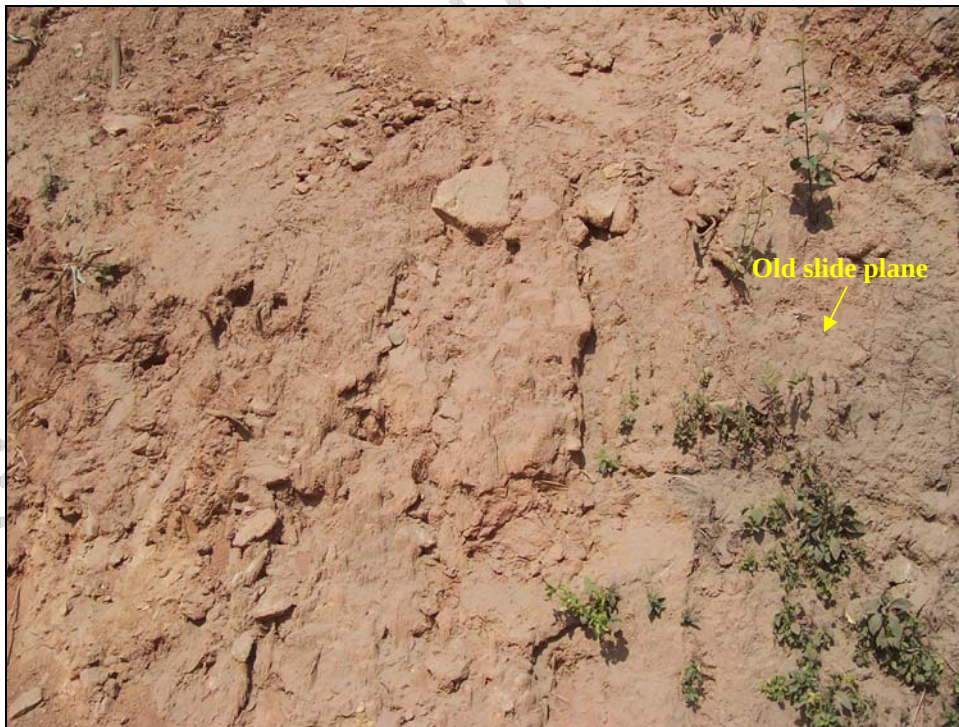
***Photo 14: Deeply weathered granite exposed in the slide plane with old slide plane***

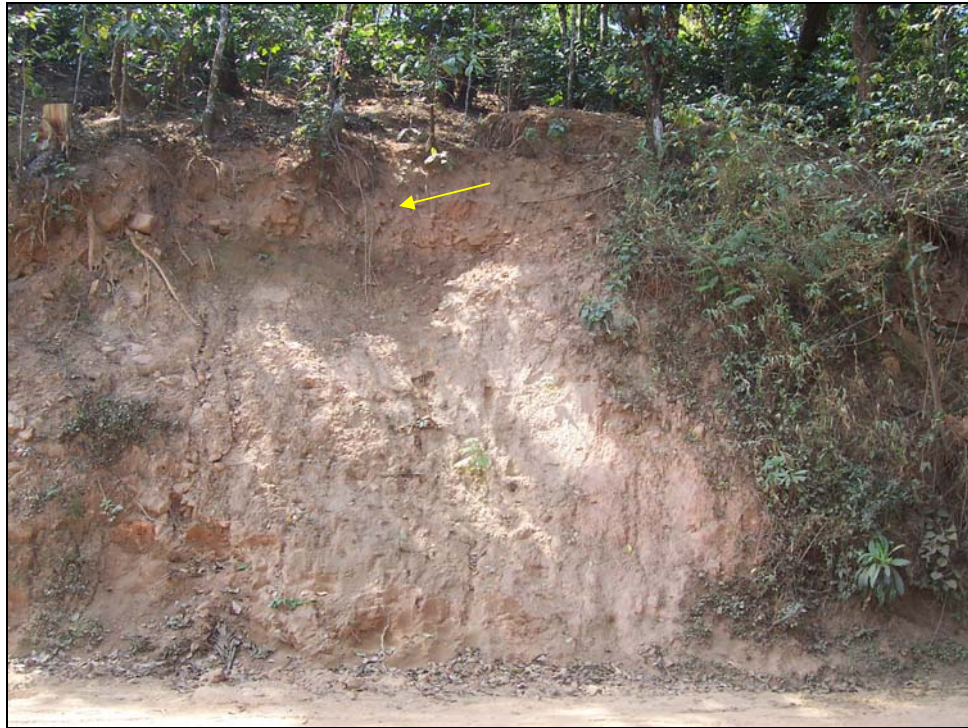
***Photo 19: View of the landslide along the cut slope of SH88***

- i) The relative height of the slope is low hence benching of the slope with an average slope angle of 45° will ensure its stability in long run.
- ii) As the slide is shallow with depth of sliding less than 2m, deep rooted plants/shrubs with high tensile strength is to be planted in the benched slope to increase its stability.

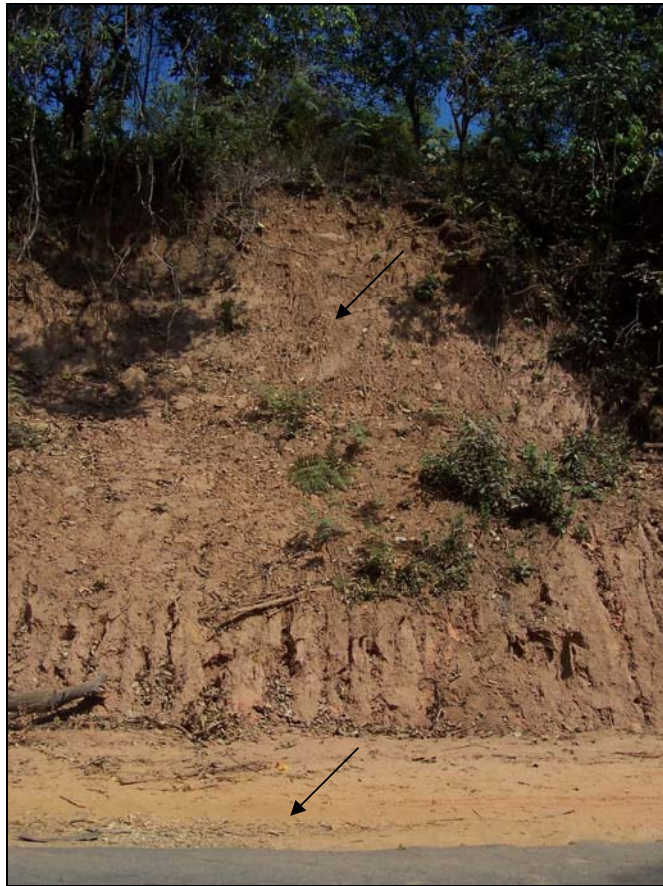
***Photo 21: View of the slide plane and the accumulation zone***

- i) The relative height of the slope is low hence benching of the slope with an average slope angle of 45° will ensure its stability in long run.
- ii) As the slide is shallow with depth of sliding less than 2m, deep rooted plants/shrubs with high tensile strength is to be planted in the benched slope to increase its stability.

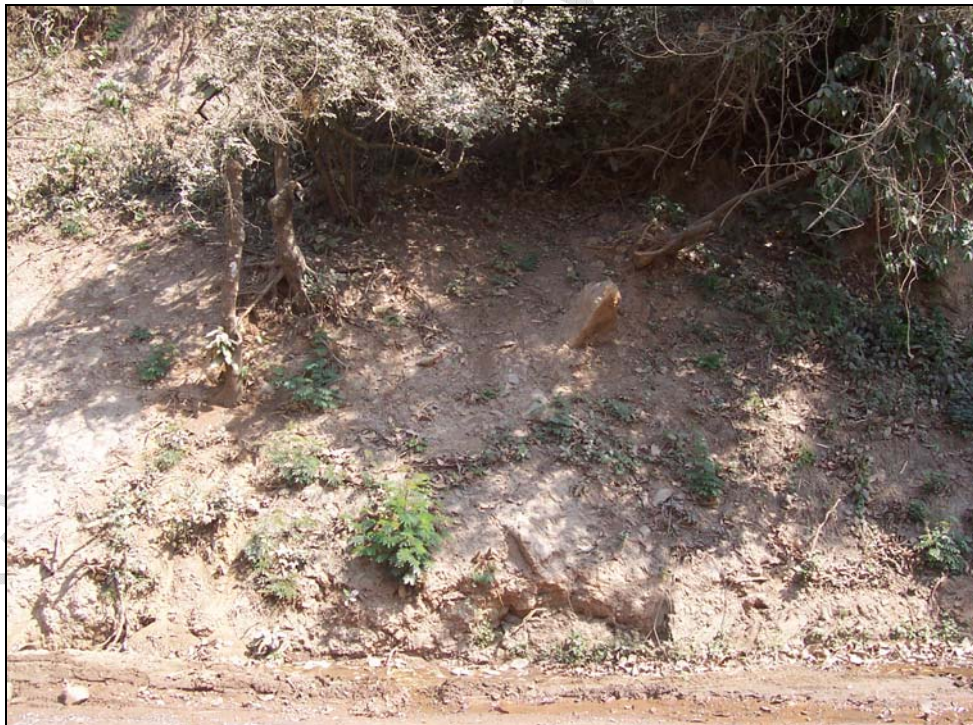
**Photo 24:** *The plan view of the debris slide with exposed bed rock.*

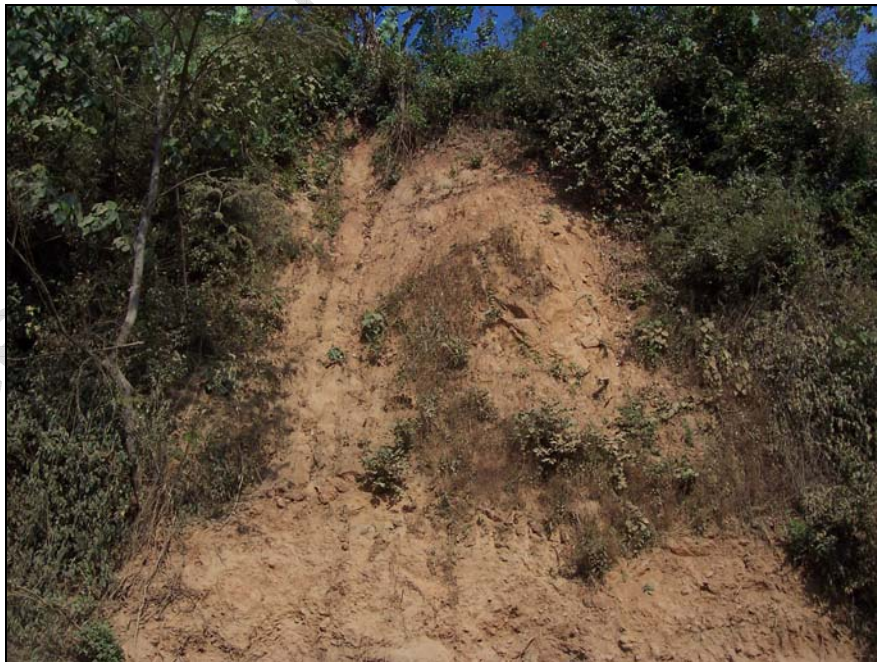
***Photo 31: The plan view of the debris slump***

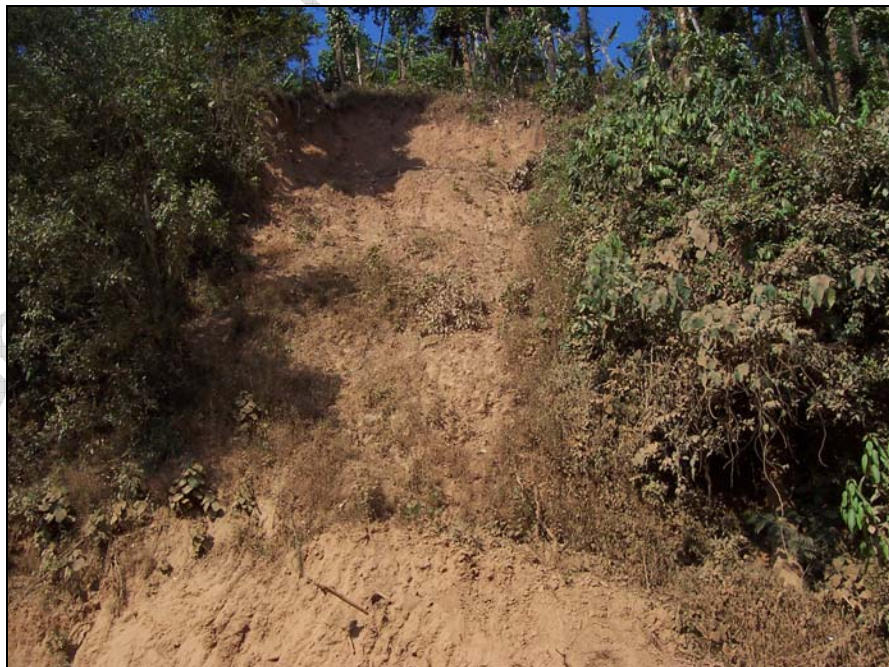
**Photo 33:** *The plan view of the debris slide with unstable crown*

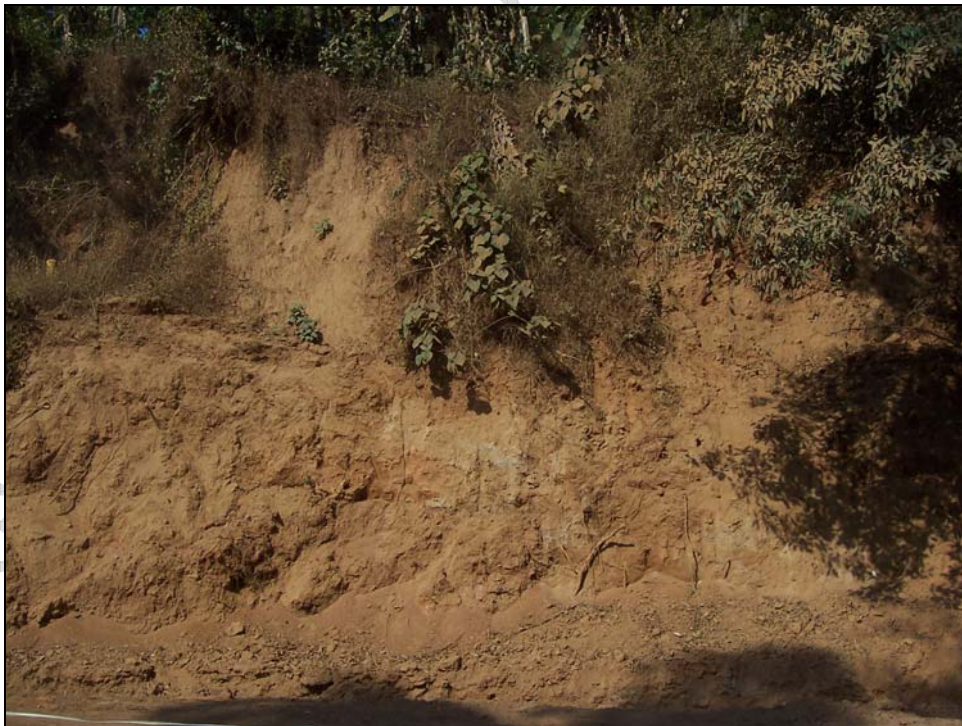
**Photo 35:** *The plan view of the debris slide with unstable crown*

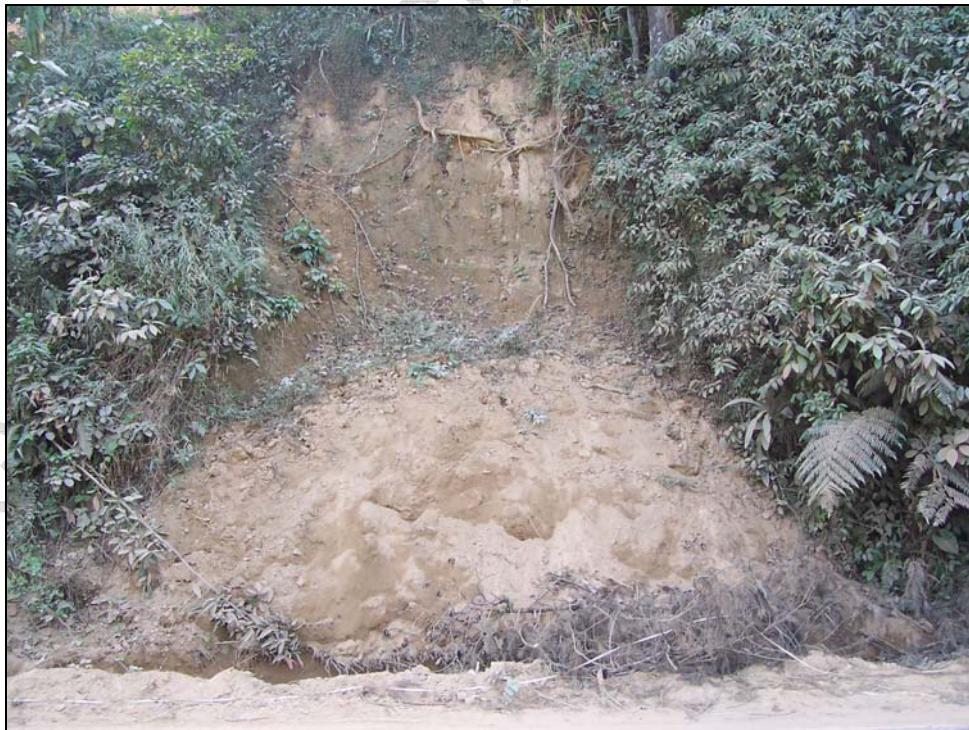
**Photo 39:** *The plan view of the debris slide with zone of accumulation*

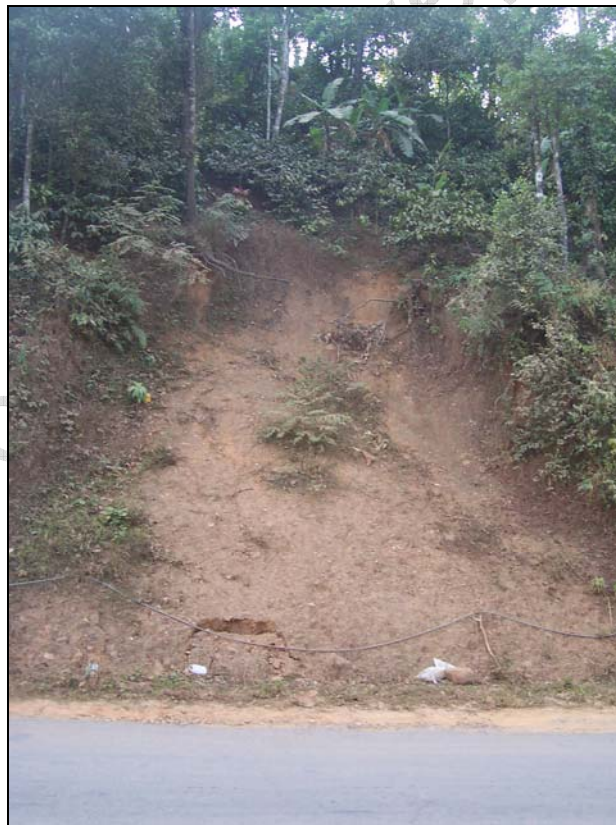
**Photo 42:** *The plan view of the debris slide with huge trees standing on the crown*

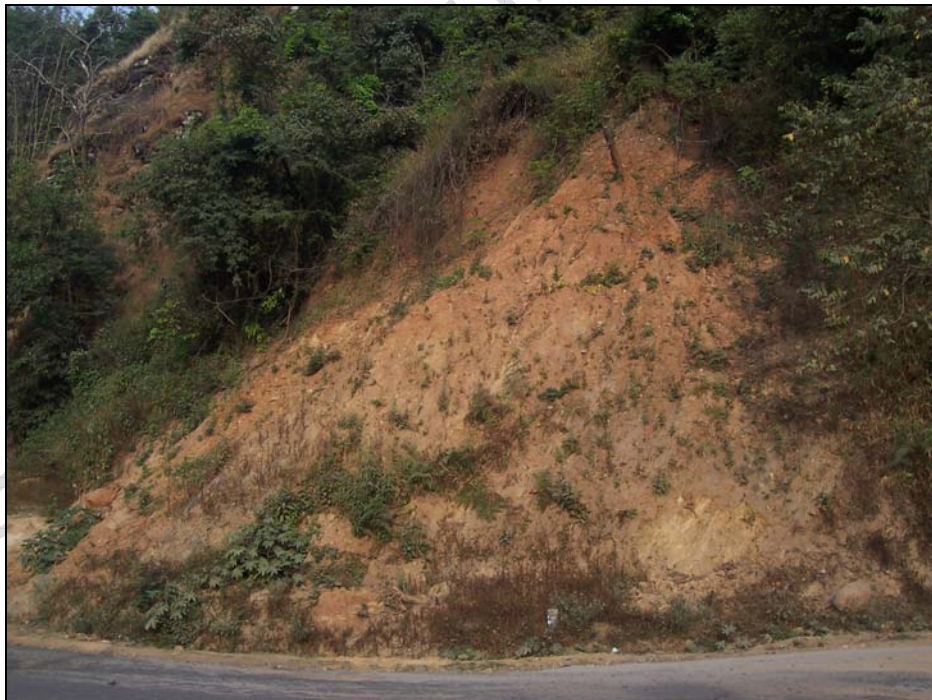
**Photo 44:** Side view of the reactivated slide with exposed weathered granite

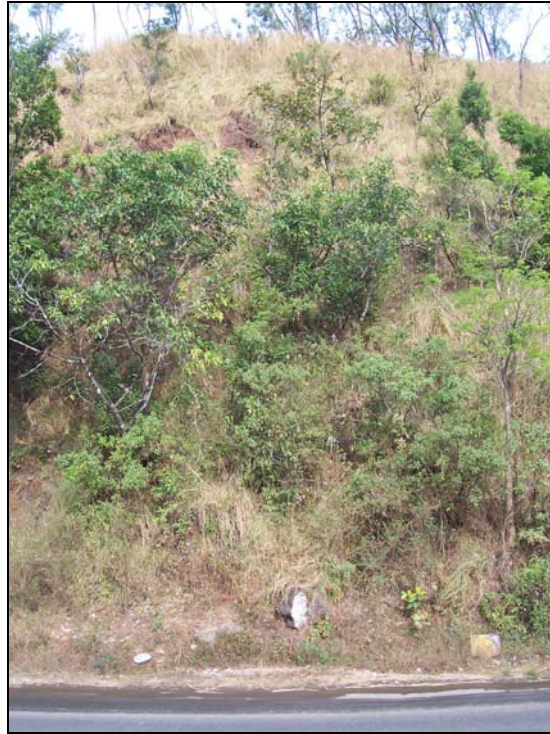
**Photo 45:** Plan view of the debris slide with exposed weathered granite

- i) The protective measures proposed at the site include removal of slide material and unstable from the slope
- ii) Grading of the slope with benches
- iii) Plantation on the slope to increase the soil strength.

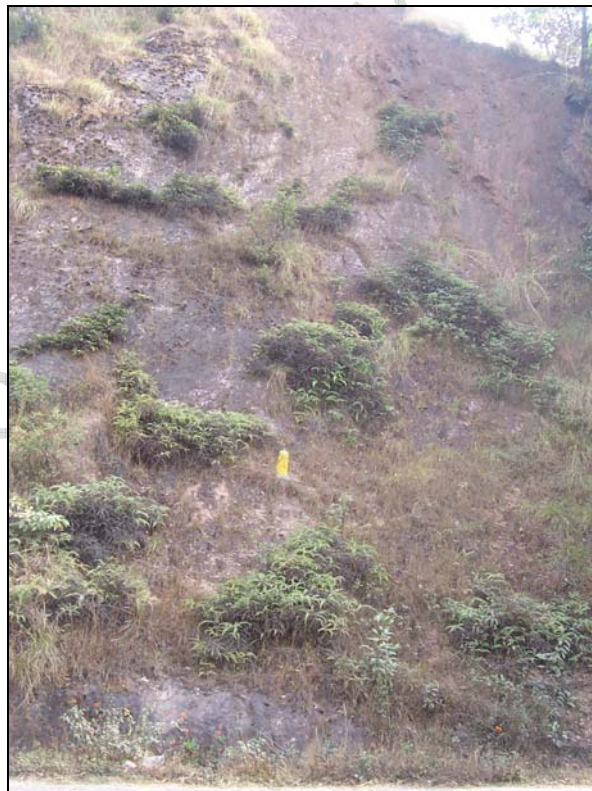
**Photo 50:** View of the debris slump exposing the bed rock over which it has moved.

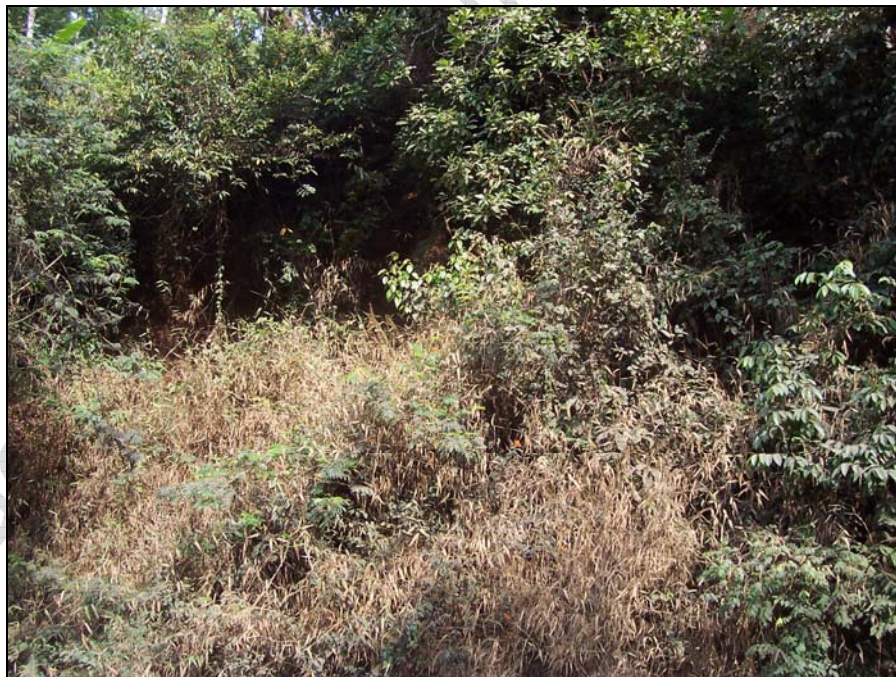
**Photo 52:** *View of the debris slump which is covered by small trees*

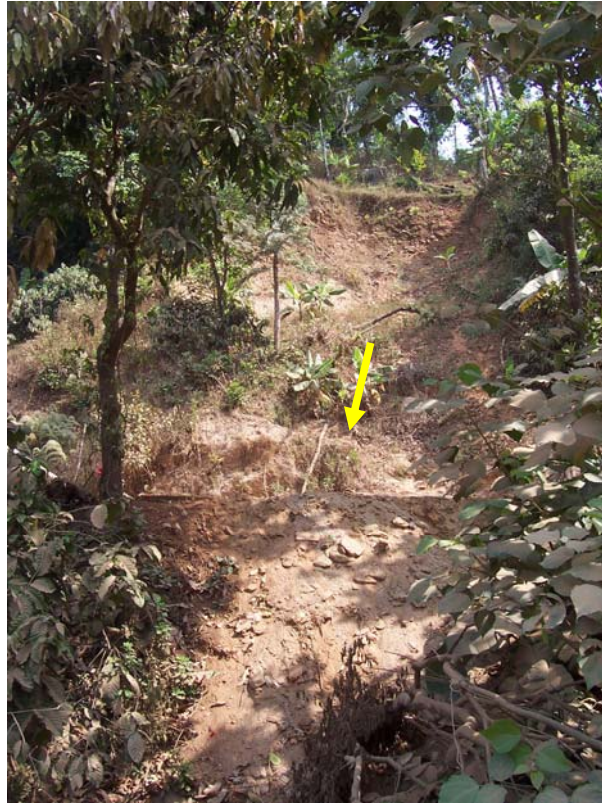
**Photo53:** Plan view of the reactivated debris slide which has length of 17m

- i) Removal of slide material from the slope and unstable material from the crown
- ii) Reducing the slope angle by making benches or grading of the slope
- iii) Providing retaining wall or gabion wall to strengthen the toe part of the slide.

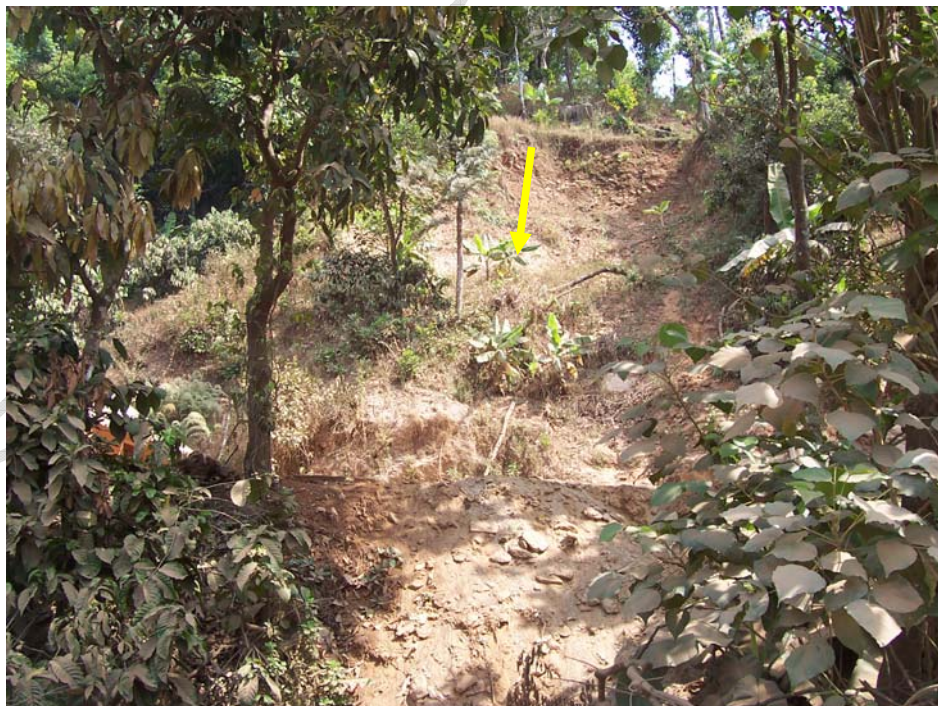
**Photo 54:** Plan view of the reactivated debris slide which has crown height of 2m.

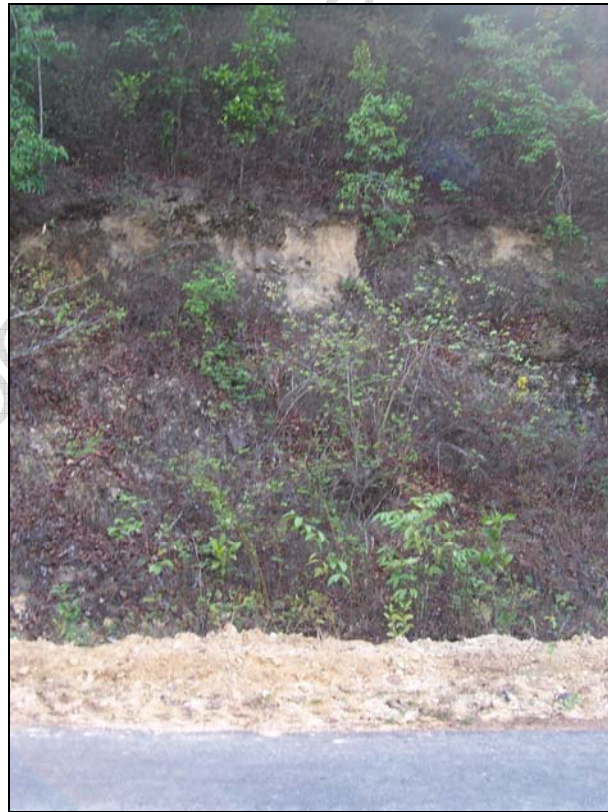
**Photo 63:** *The plan view of the reactivated rock slide along day lighted plane.*

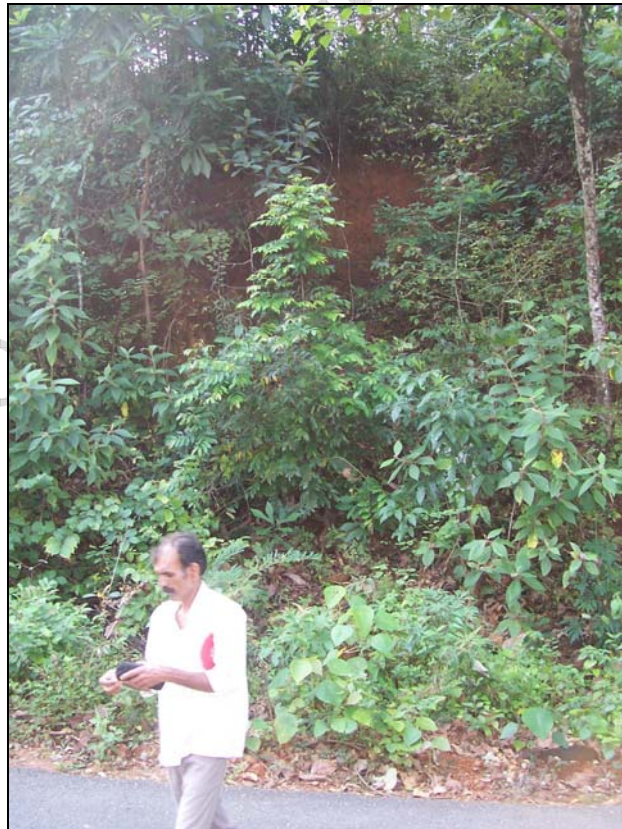
**Photo 67:** *The plan view of the debris slide with exposed bed rock*

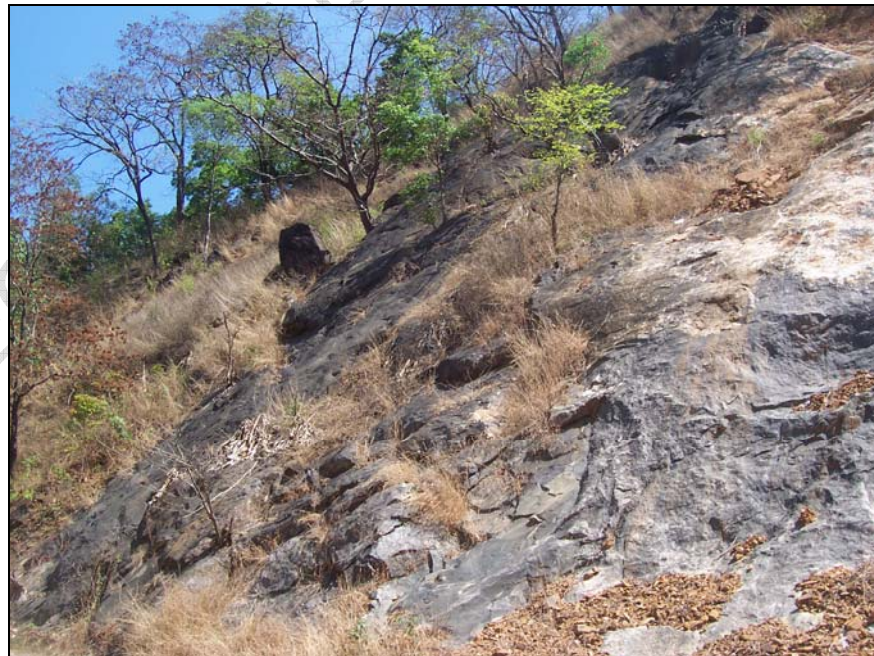
**Photo 75:** The side view of the rock slide

- i) The protective measures proposed at the site include removal of weathered and loose material from the crown.
- ii) Soil nailing and rock bolting is suggested to protect the vulnerable planes from sliding.
- iii) Horizontal drainage is suggested to remove the infiltrated water.

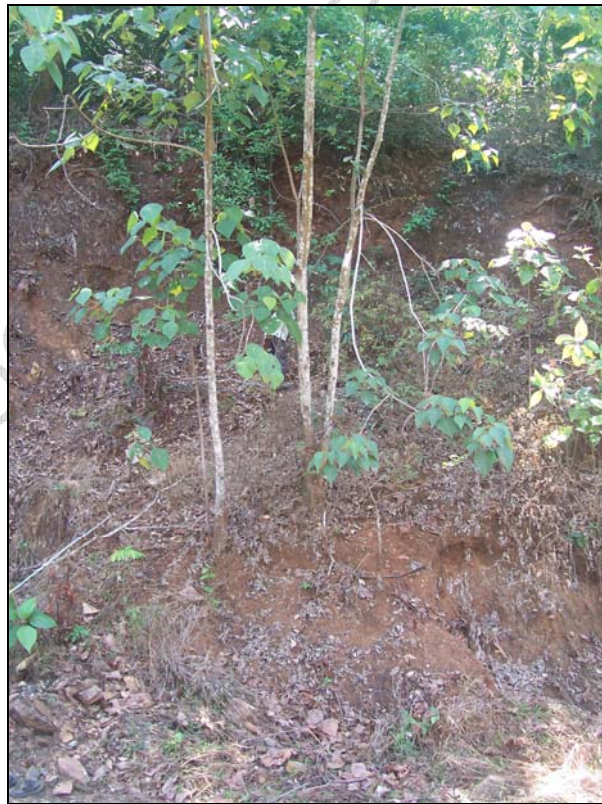
**Photo 77:** *The view of the unstable crown portion of debris slide*

- i) As the slide is shallow with depth of sliding less than 2m, deep rooted plants/shrubs with high tensile strength is to be planted in the benched slope to increase its stability.
- ii) Unstable loose material and trees from the crown should be removed.
- iii) Proper drainage is to be provided for discharge of water away from unstable slopes.

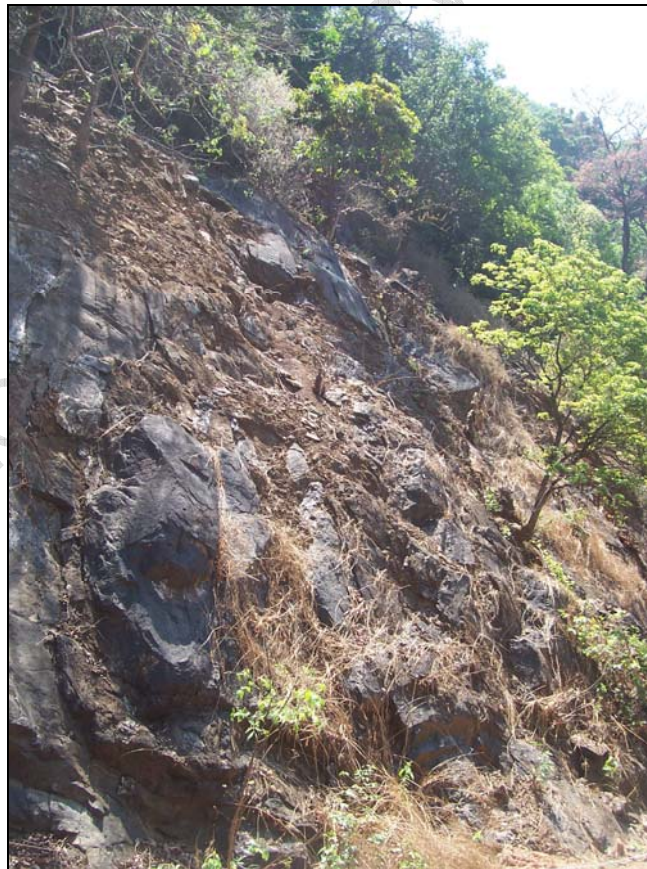
**Photo 79:** *The view of the slide plane of rock slide.*

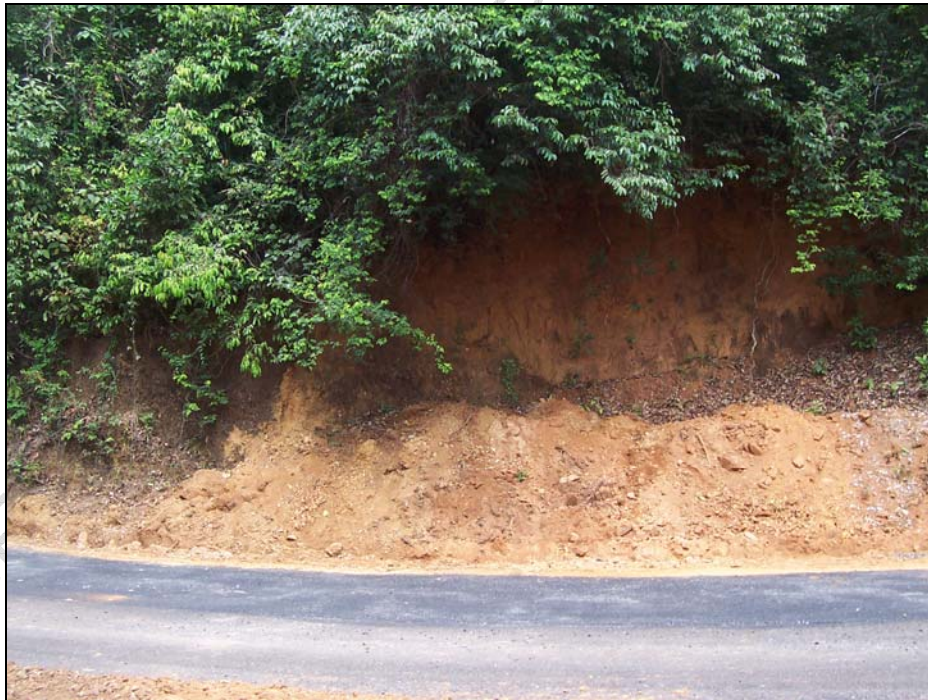
**Photo 81:** *The view of the debris slump with unstable crown.*

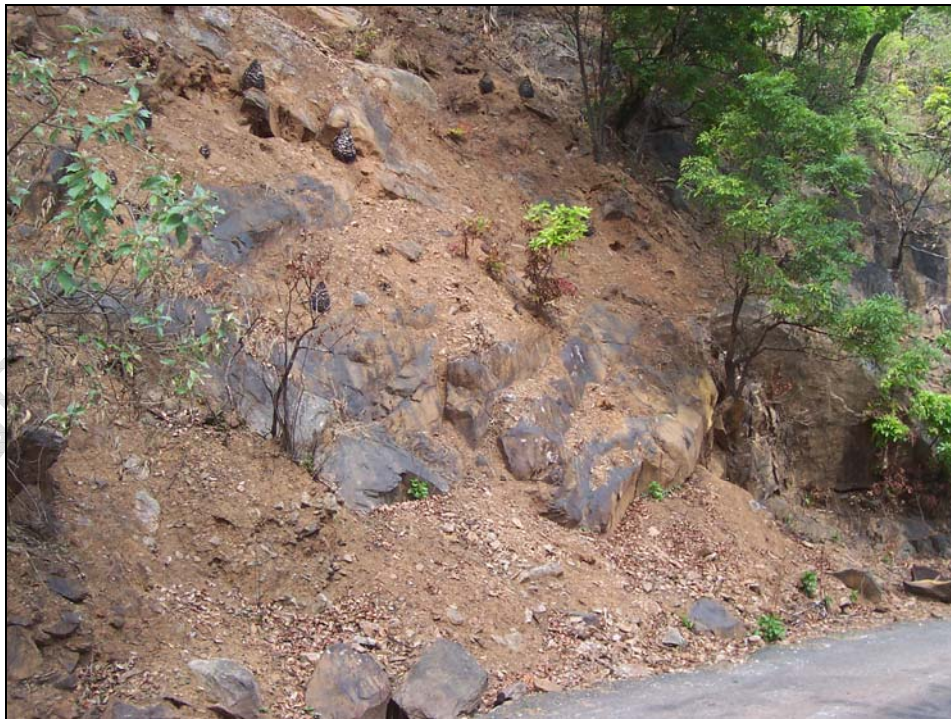
Photo 83: The view of the rock slide.

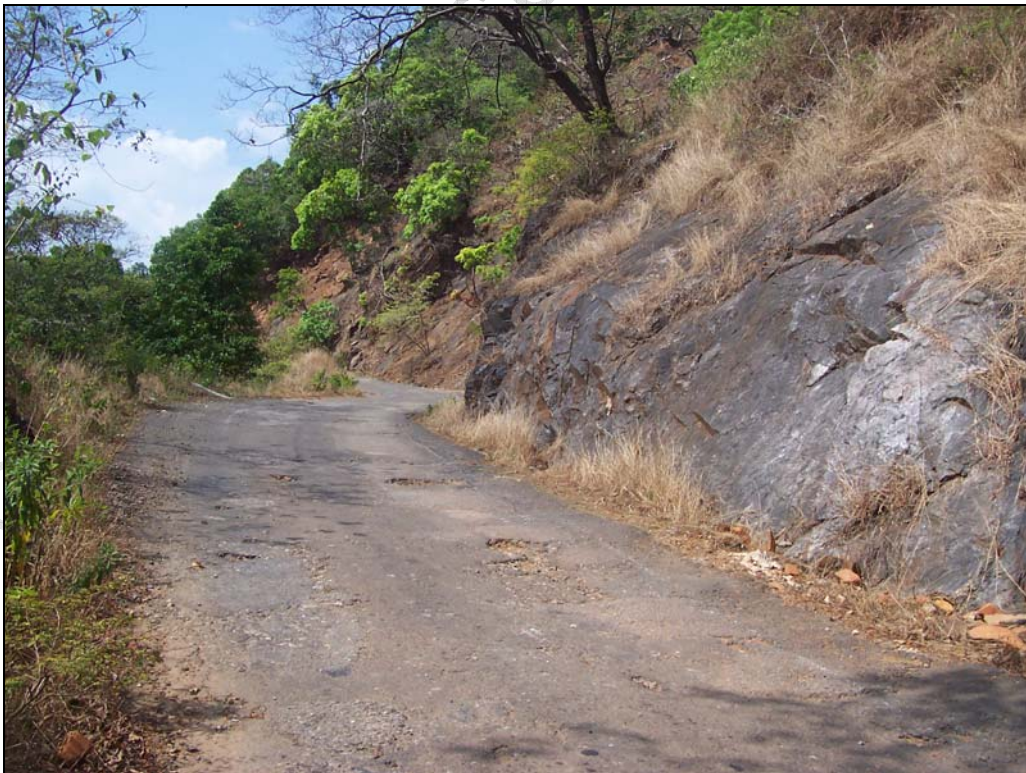
Photo 85: The side view of the rock slide.

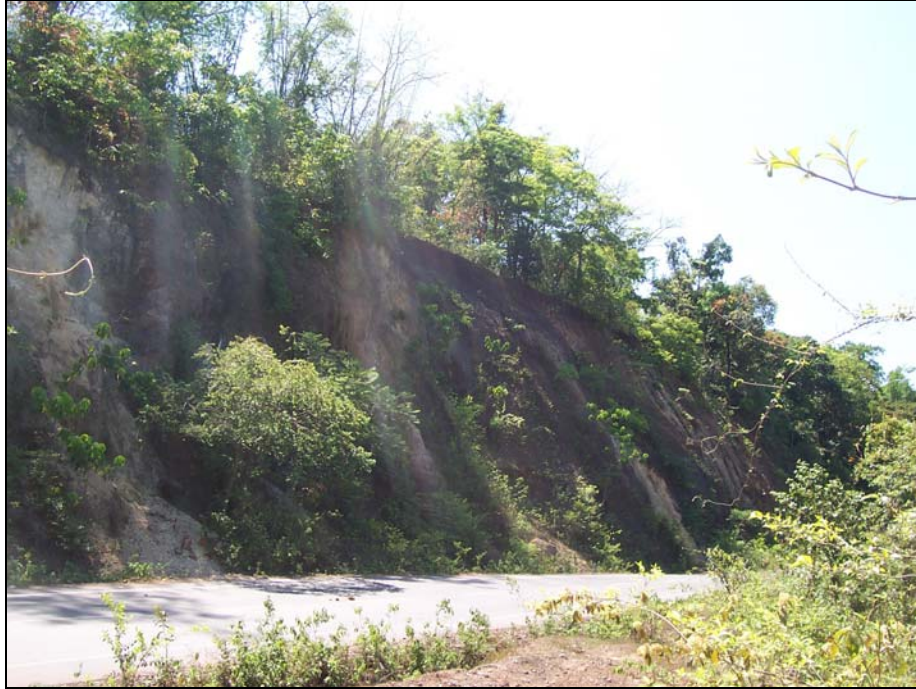
Photo 92: The side view of the debris slide

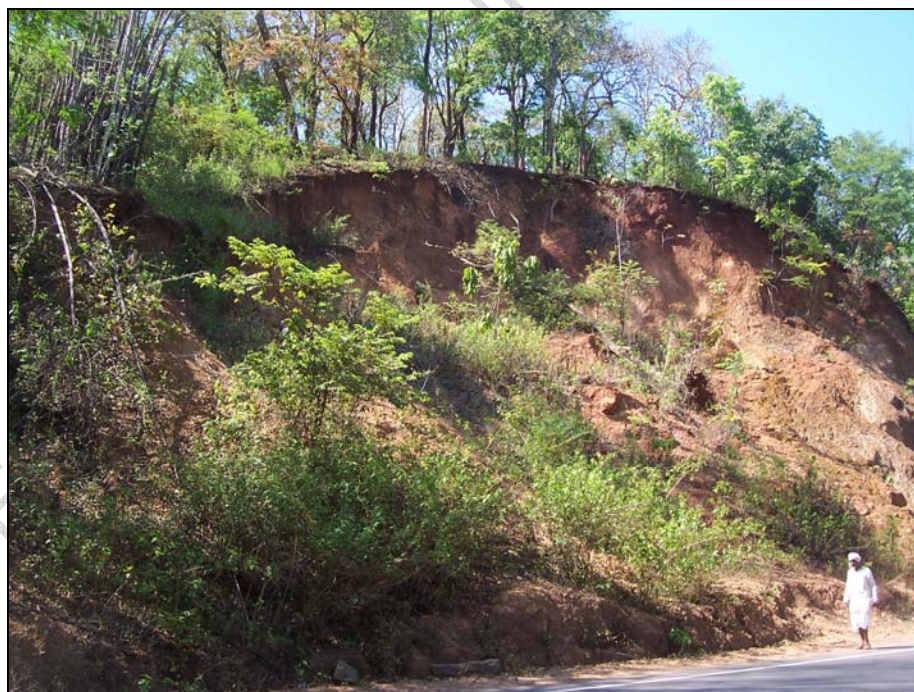
Photo 97: The side view of the debris slide

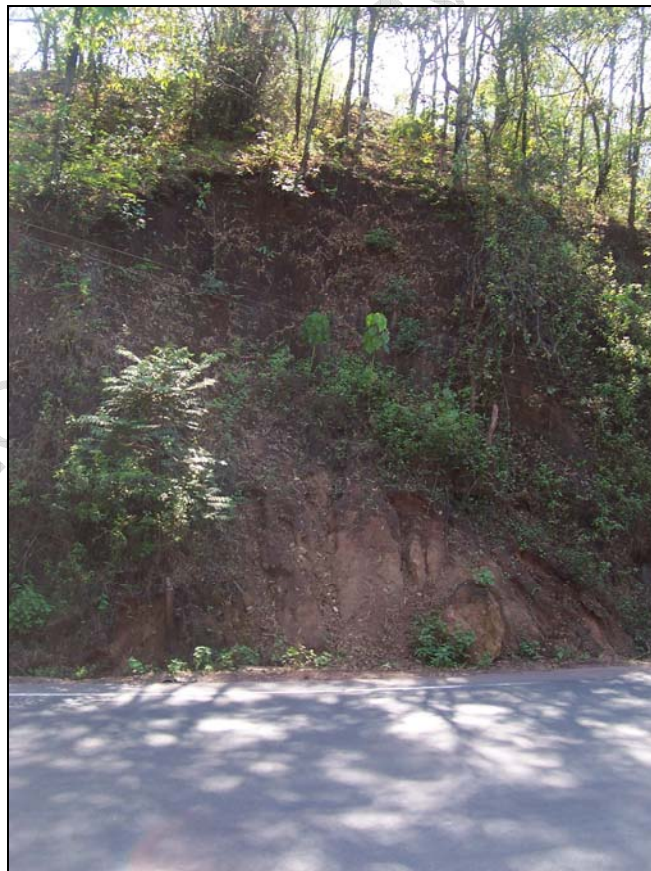
**CAUSES:** The increase in the gradient of the slope due to the vertical cut slope for making road decreased the slope stability. The remedial measures were not provided for the earlier slide, so the slide prograded laterally. The heavy precipitation during monsoon increased the pore water pressure, the loose overburden and the weather granite in the slope failed due to saturation.

**NATURE OF DAMAGE:** Yellapur –Arbail road in NH-63 was blocked due to the heaped debris material on the road.

Photo 99: The view of the debris slide with unstable crown

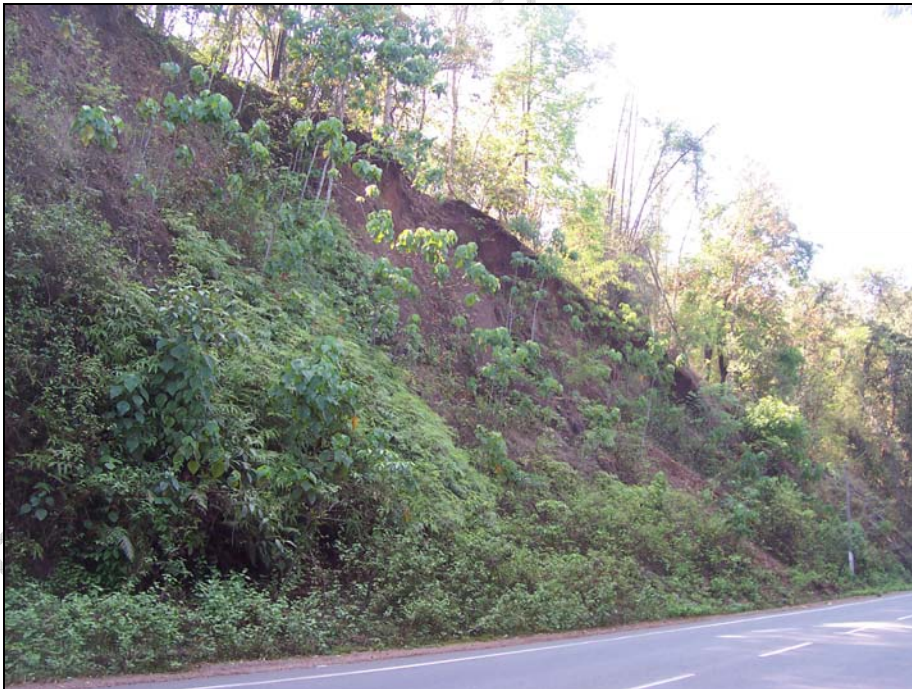
**CAUSES:** The increase in the gradient of the slope due to unscientific cutting of hills for making road resulting in greater instability of hill slopes. Proper remedial measures were not provided for the earlier slide, so the slide prograded laterally. The slope forming materials in the slided area tend to be loose and non-cohesive due to prolonged weathering. The heavy and intensive period of precipitation during monsoon increased the pore water pressure, the loose overburden and the weather granite in the slope failed due to saturation.

**NATURE OF DAMAGE:** Yellapur –Arbail road in NH-63 was affected due to slided material.

Photo 103: The side view of the reactivated debris slide.

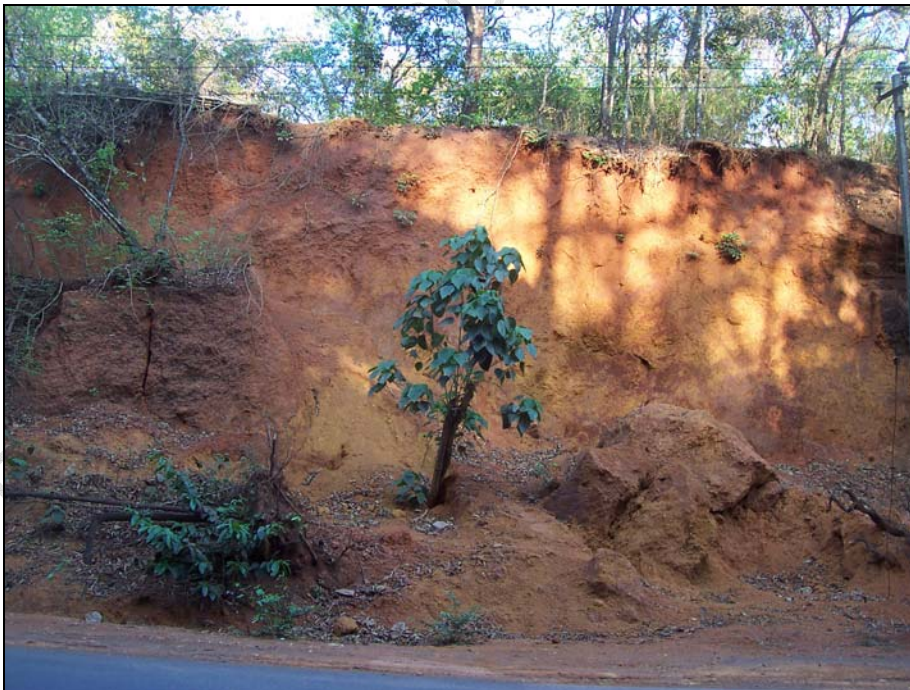
Photo 107: The side view of the debris slide showing steep slope angle.

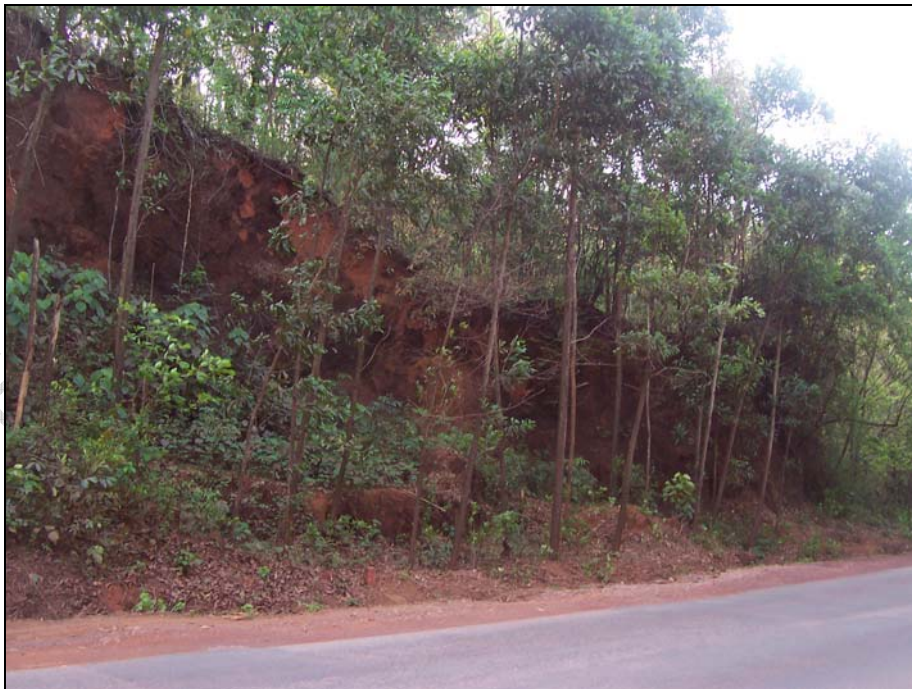
Photo 109: The side view of the debris slide showing steep slope angle.

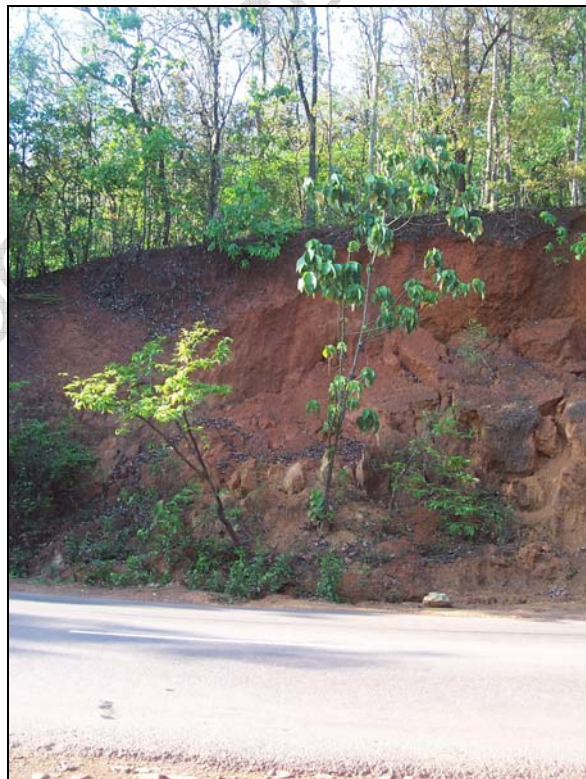
Photo 111: The side view of the debris slide with slided material at the toe.

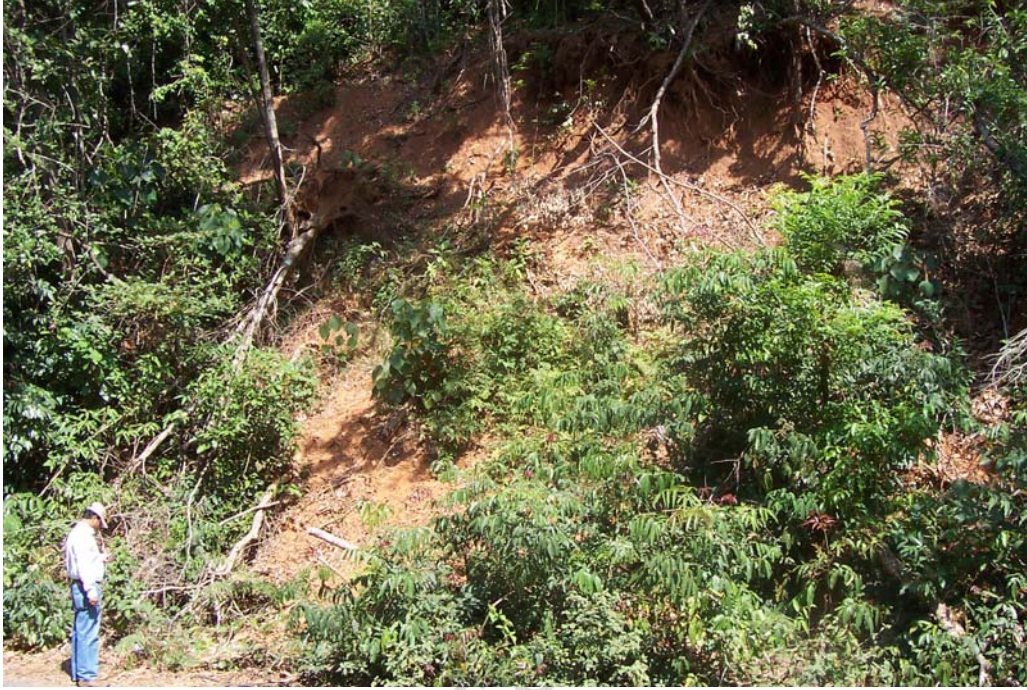
Photo-112: View of the debris slide with slided material

- i) Removal of unstable crown and debris present at the slid area.
- ii) The slope angle needs to be trimmed to 40-45° to increase the stability.
- iii) Bio-engineering, plantation of deep rooted plant/shrub on the slope is suggested to reduce erosion and increase slope stability.
- iv) Making contour drainage at the top of the slopes for decreasing infiltration and sub-surface horizontal drainage i.e. inserting horizontal perforated pipes in to the slopes will act as weep holes in the vertical slopes and thus reducing the pore pressure by draining out the excess water. Retaining wall with weep holes is suggested at the toe of the slope.

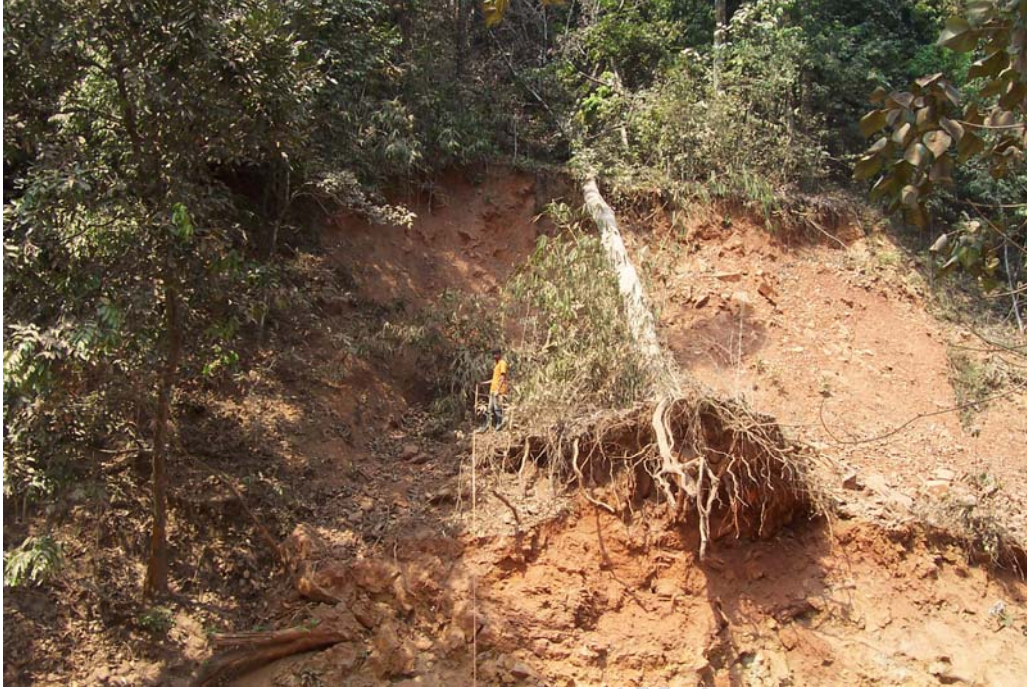
Photo-113: view of the debris slide with slided material

- i) Removal of unstable crown and debris from the slide area.
- ii) Geometrical modification of the slope by grading of the slope or benches, the slope angle should be reduced to <40° to increase the stability.
- iii) Bio-engineering and plantation of deep rooted plant/shrub on the slope is suggested to reduce erosion and increase slope stability.
- iv) Making contour drainage at the top of the slopes for decreasing infiltration and sub-surface horizontal drainage i.e. inserting horizontal perforated pipes in to the slopes will act as weep holes in the vertical slopes and thus reducing the pore pressure by draining out the excess water.
