**A REPORT ON LANDSLIDE INVENTORY ALONG NH & SH  
OF GHAT ROADS IN KARNATAKA**

**(Progress Report for the Field Season 2007-08)**

**Code No.: LHZ/SR/KG/2007/044**

**Project: ENGINEERING GEOLOGY**

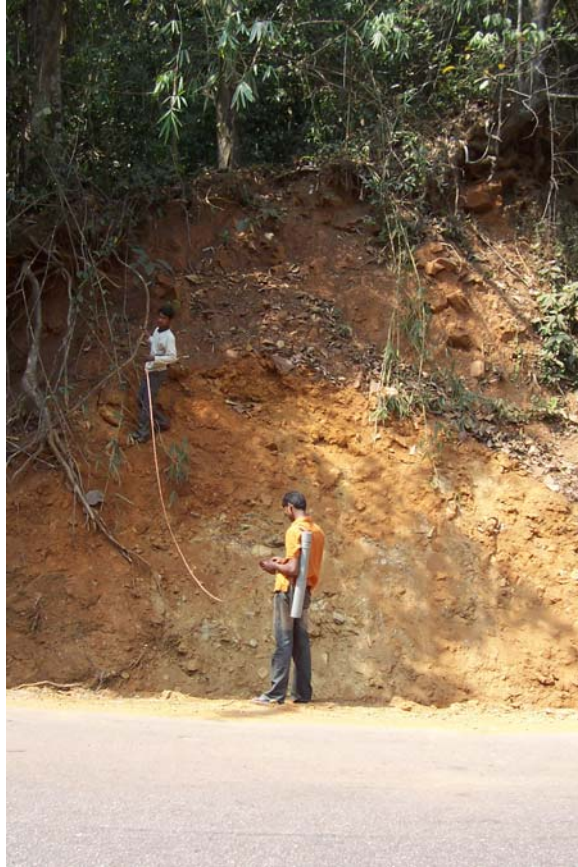
Photo-114: view of the debris slide with slided material

- i) Removal of unstable crown and debris from the slide area.
- ii) Geometrical modification of the slope by grading or benches, the slope angle should be reduced to <40° to increase the stability.
- iii) Bio-engineering and plantation of deep rooted plant/shrub on the slope is suggested to reduce erosion and increase slope stability.
- iv) Making contour drainage at the top of the slopes for decreasing infiltration and sub-surface horizontal drainage i.e. inserting horizontal perforated pipes in to the slopes will act as weep holes in the vertical slopes and thus reducing the pore pressure by draining out the excess water.

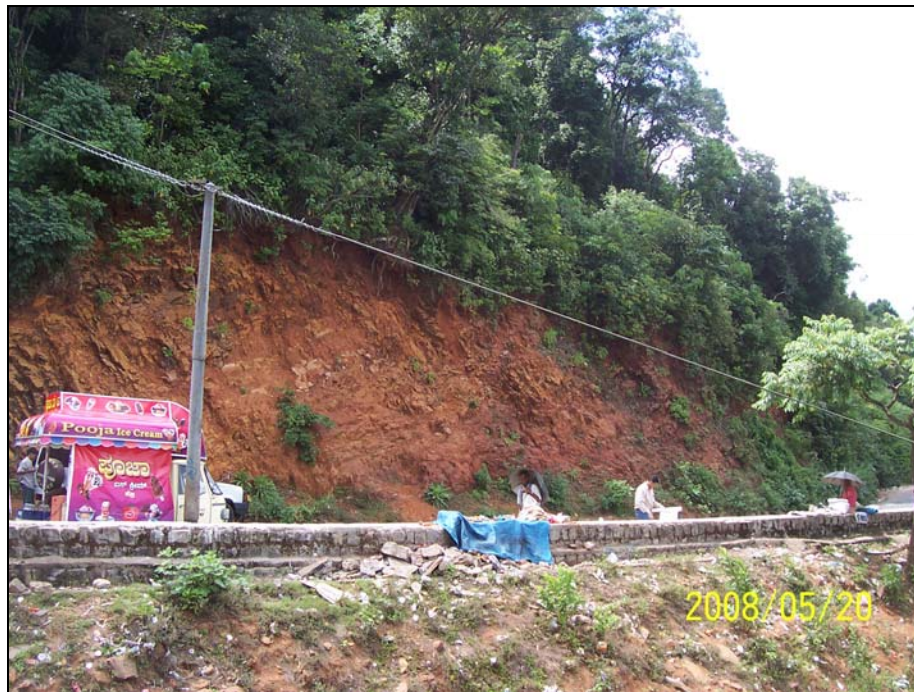
Photo 115: The side view of the debris slump

- i) Removal of unstable crown and huge trees standing on the crown to decrease the load.
- ii) The slope angle should be reduced to <40° to increase the stability.
- iii) Bio-engineering and plantation of deep rooted plant/shrub on the slope is suggested to reduce erosion and increase slope stability.
- iv) Retaining wall with weep holes is suggested at the toe of the slide.

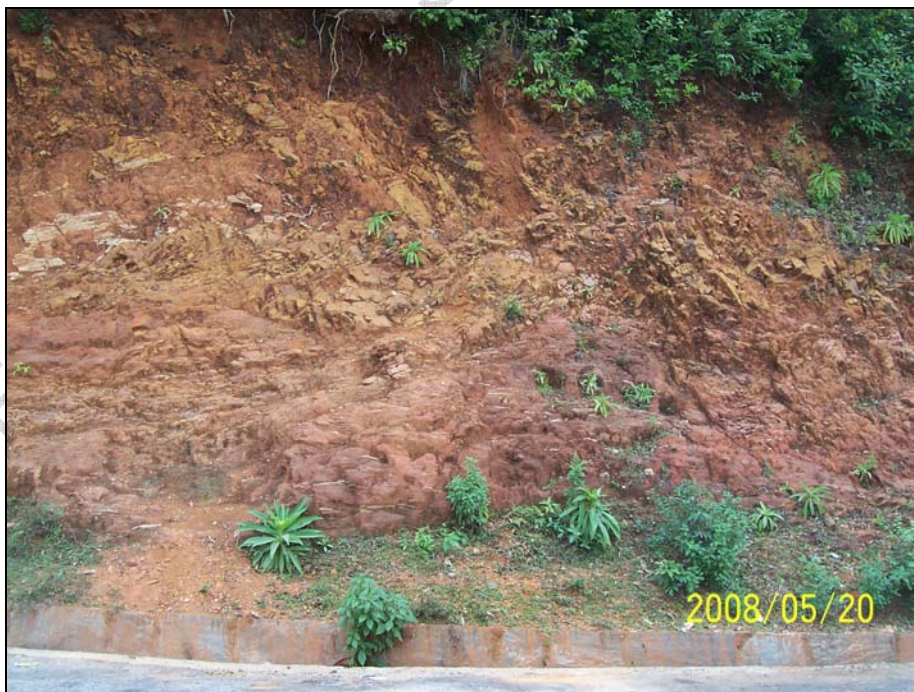
Photo 116: The plan view of the debris slump

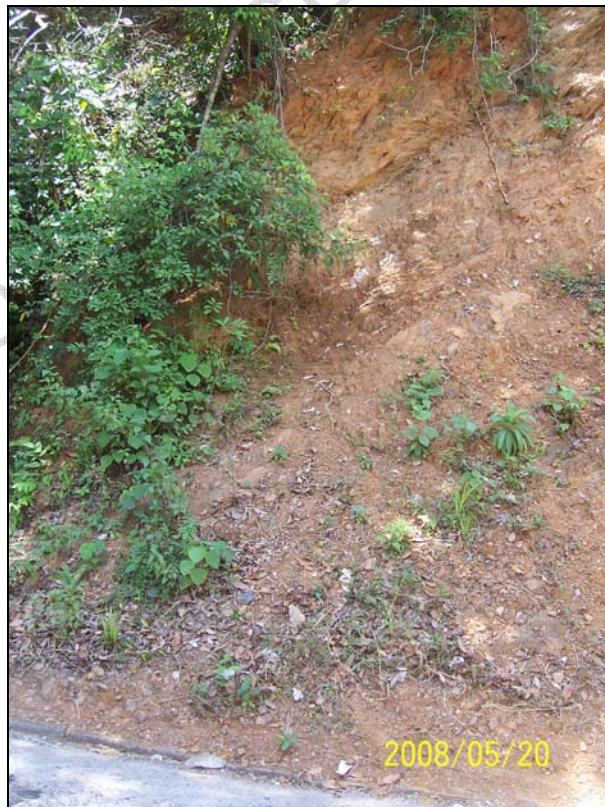
Photo 118: The side view of the debris slump

- i) Removal of unstable crown and huge trees standing on the crown to decrease the load.
- ii) The slope angle should be reduced to <40° to increase the stability.
- iii) Bio-engineering and plantation of deep rooted plant/shrub on the slope is suggested to reduce erosion and increase slope stability.
- iv) Retaining wall with weep holes is suggested to at the toe of the slide.

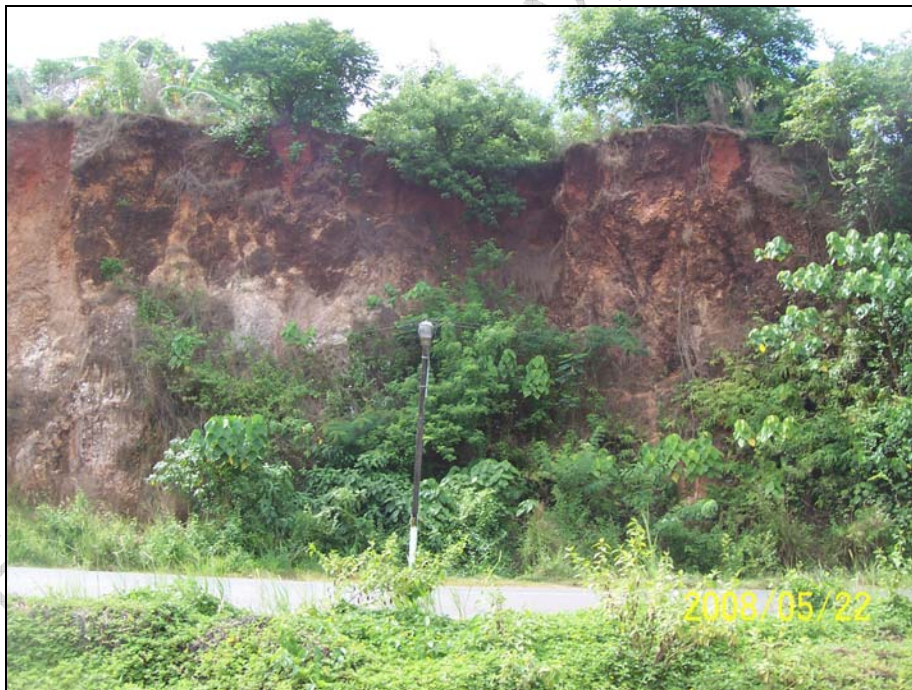
Photo 120: The plan view of the debris slump with steep slope angle

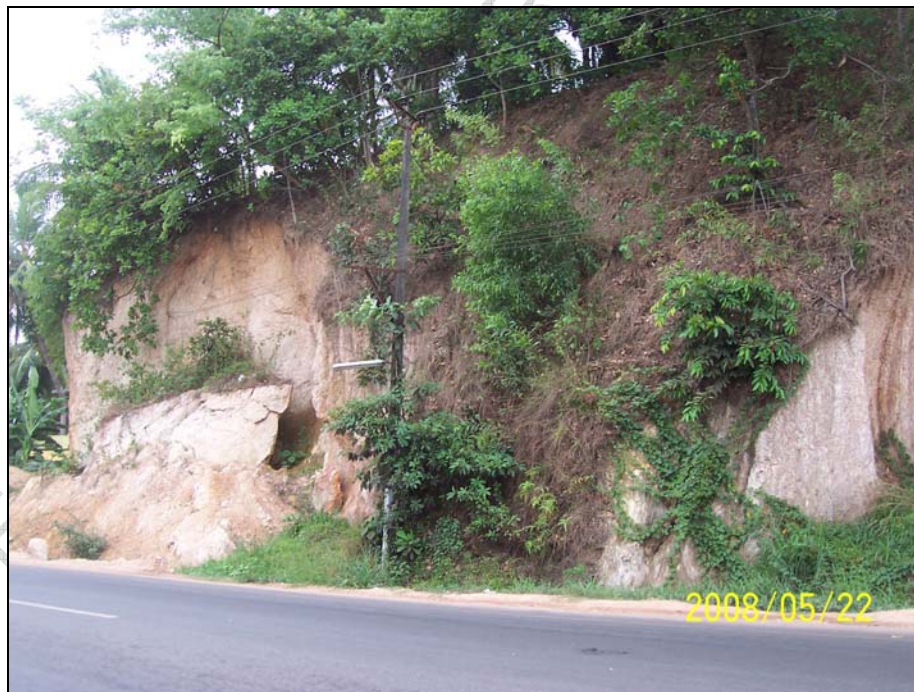
Photo 122: The side view of the debris slump with steep slope angle

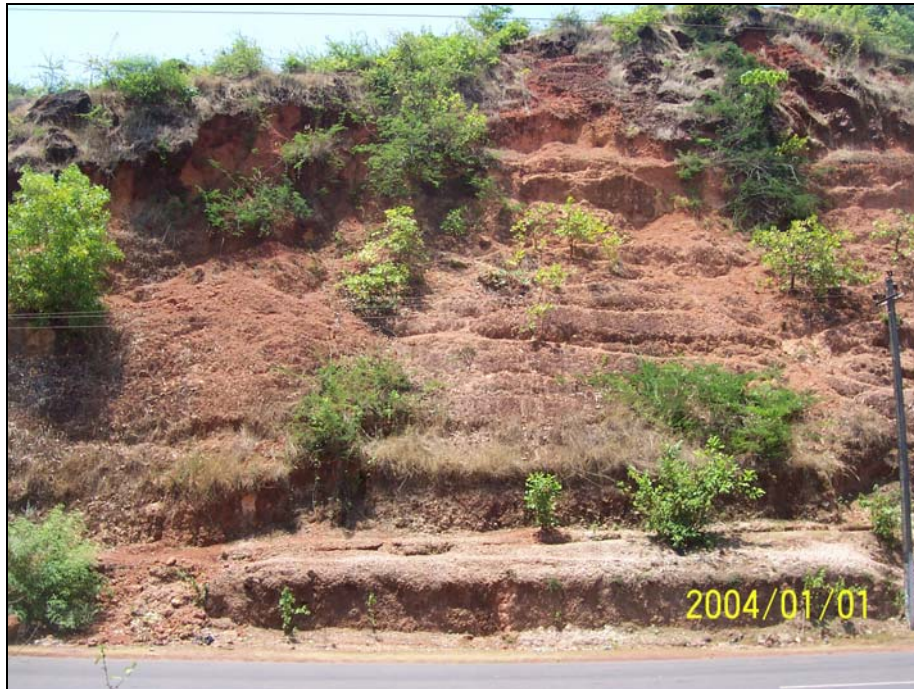
Photo 125: The plan view of the reactivated, debris slide with unstable crown
