**LANDSLIDE INVENTORY ALONG NH & SH OF GHAT ROADS IN  
COORG AND UTTAR KANNADA DISTRICTS, KARNATAKA  
(Progress Report for the Field Season 2013-14)  
Code No.: LHZ/ SR/ KG/2013/070**

**Project: ENGINEERING GEOLOGY  
State Unit: Karnataka and Goa  
BANGALORE  
2014**

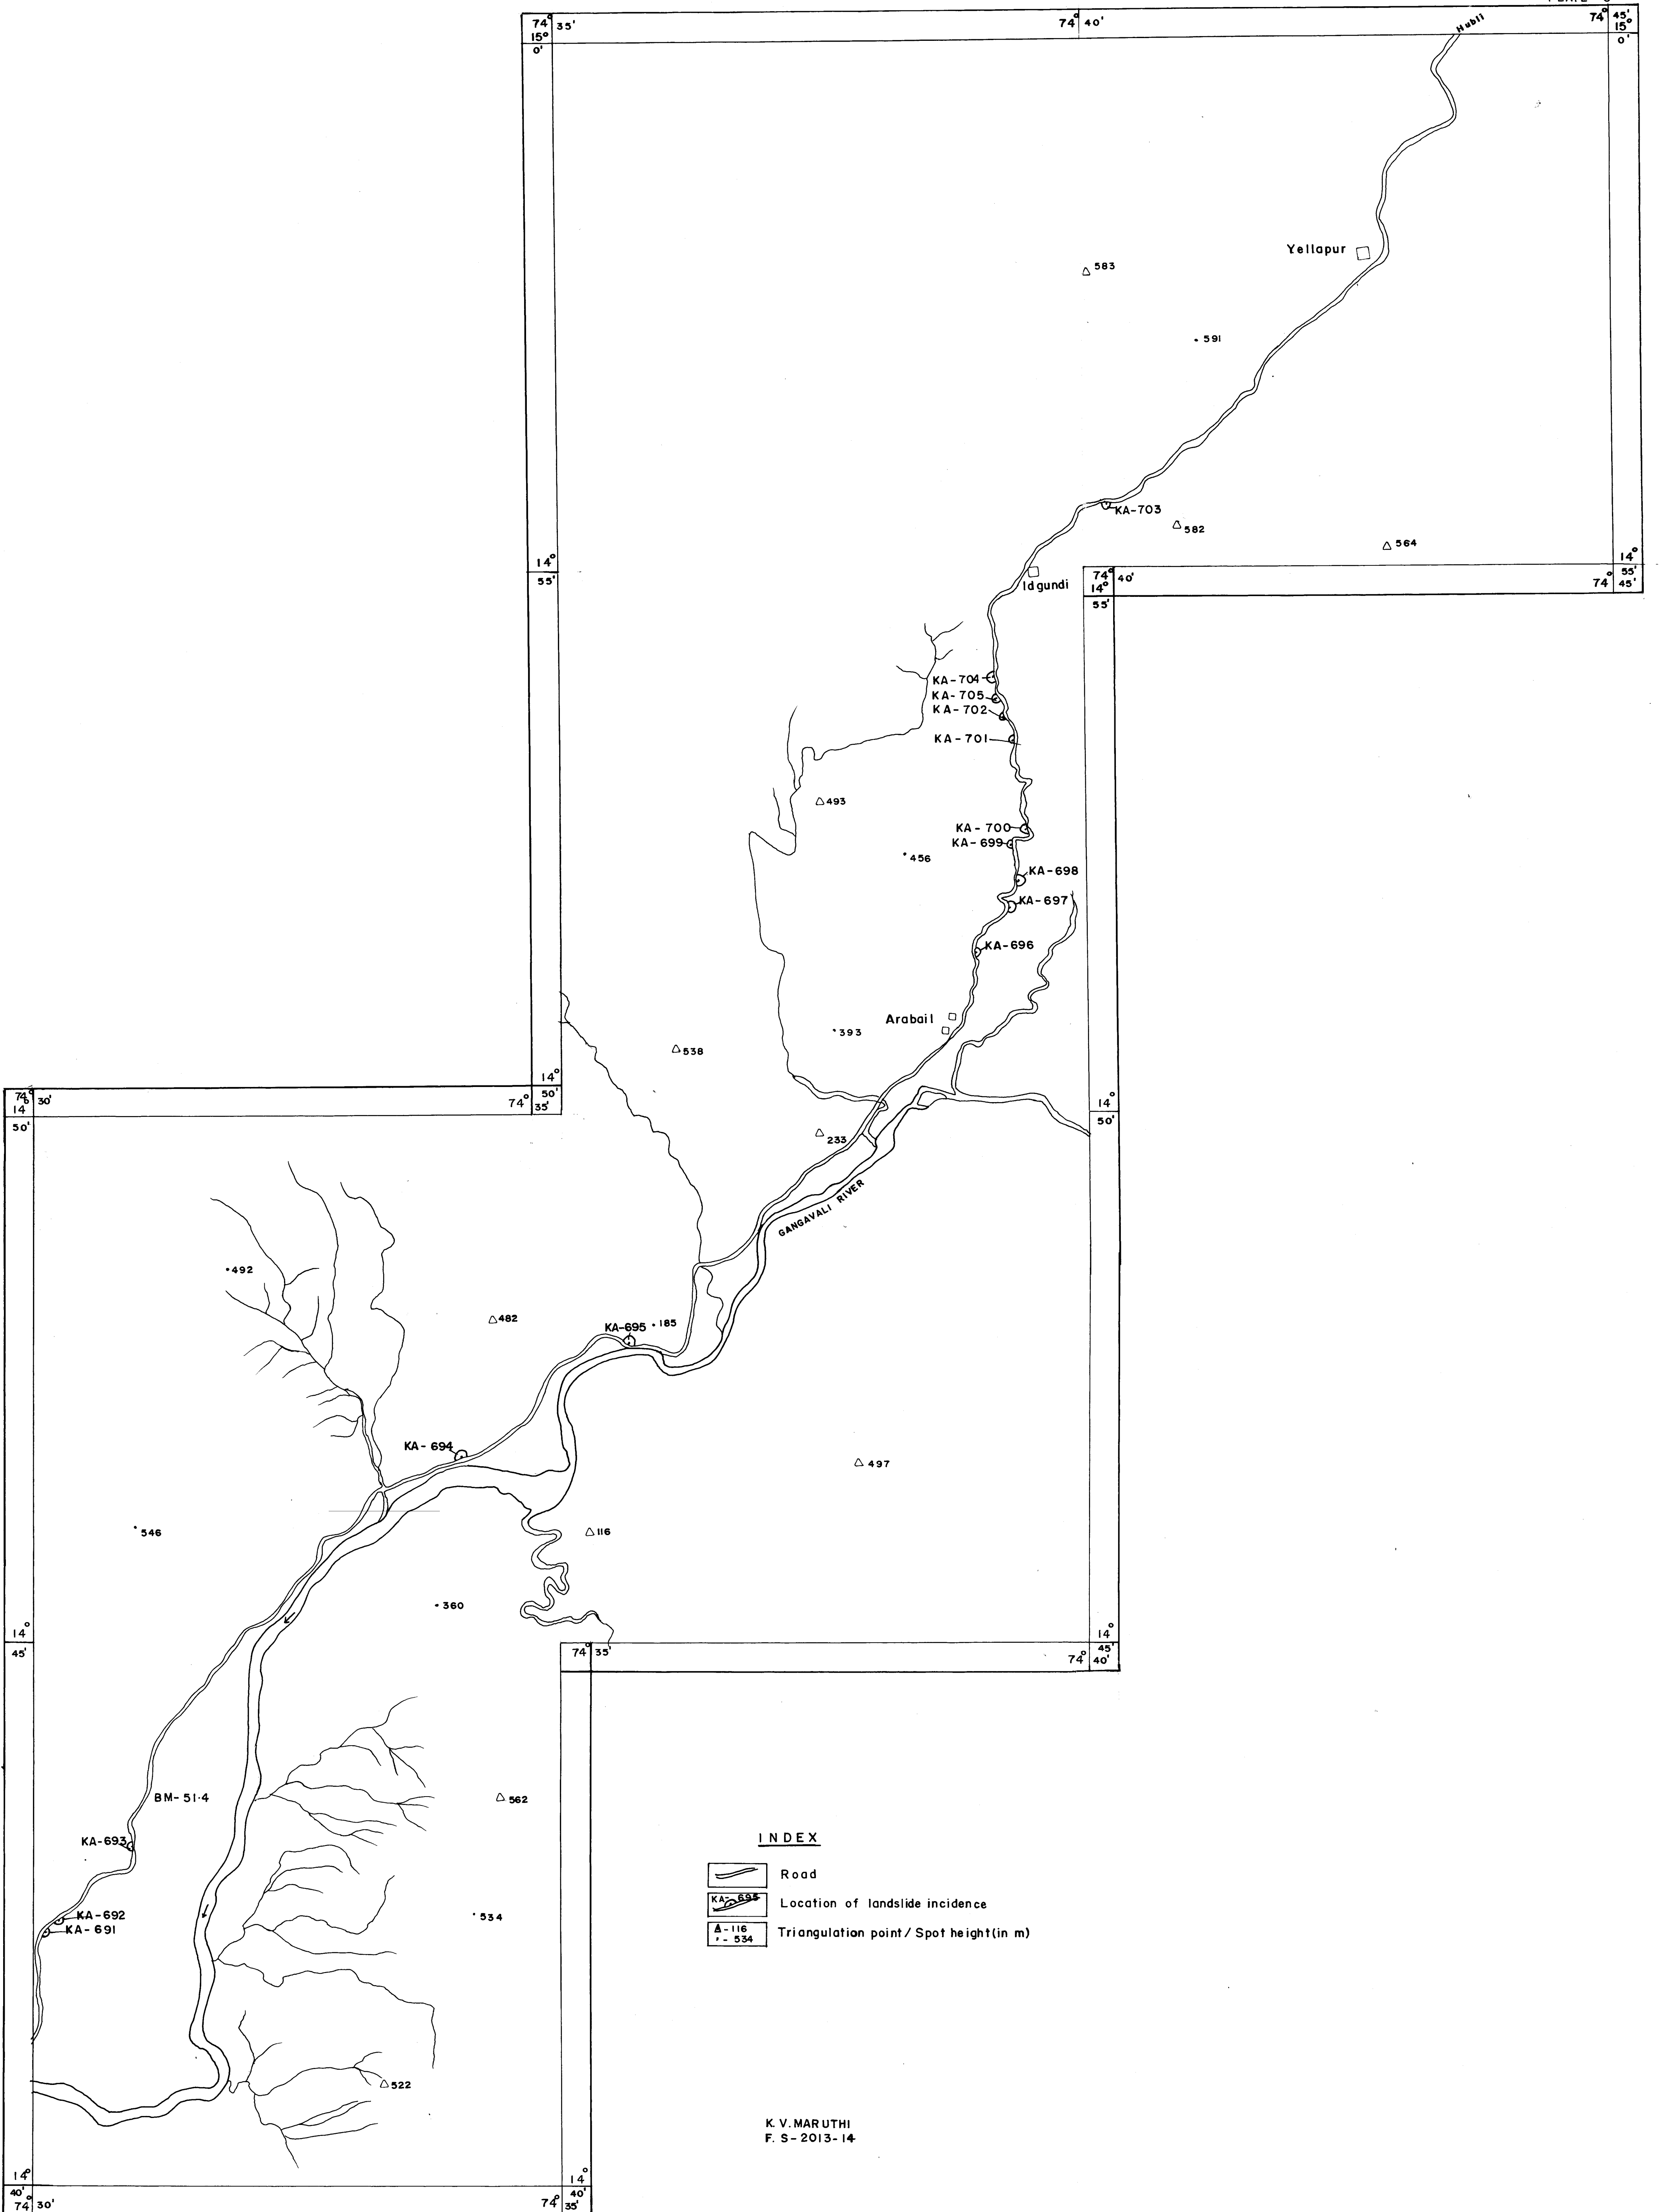
PLATE - 8

Plate 8: Landslide inventory map along NH &SH Ghat roads of Karnataka, part of toposheet no 48 J/ 9 & 48J/10

J) Ankola-Yellapur road section (NH-63): This road section was partially covered in FS 2007-08 but not completely covered so this section was again taken up for Inventory studies this year. 21 landslides were recorded section for nearly 53 km stretch (*Plate 8*).
