**A REPORT ON LANDSLIDE INVENTORY ALONG NH & SH  
OF GHAT ROADS IN KARNATAKA**

**(Progress Report for the Field Season 2007-08)**

**Code No.: LHZ/SR/KG/2007/044**

**Project: ENGINEERING GEOLOGY**

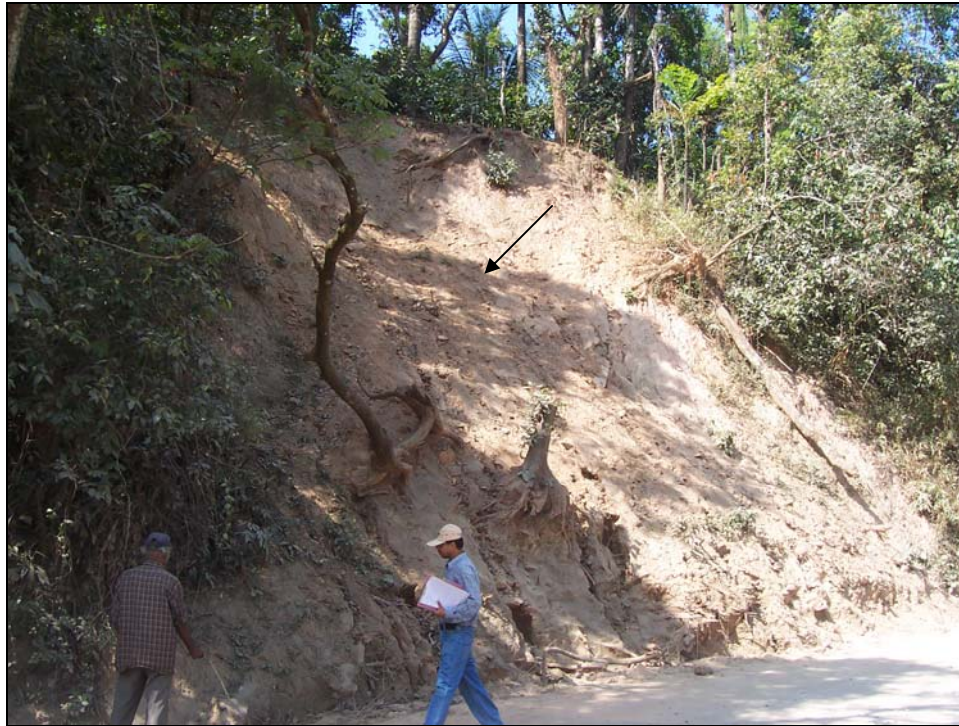
***Photo 15: Shallow debris slide with a concave sliding plane***

- i) The relative height of the slope is low hence benching of the slope with a average slope angle of 45° will ensure its stability in long run.
- ii) As the slide is a shallow slide with depth of sliding less than 2 m, deep rooted plants/shrubs with is to be planted in the benched slope to increase its stability.

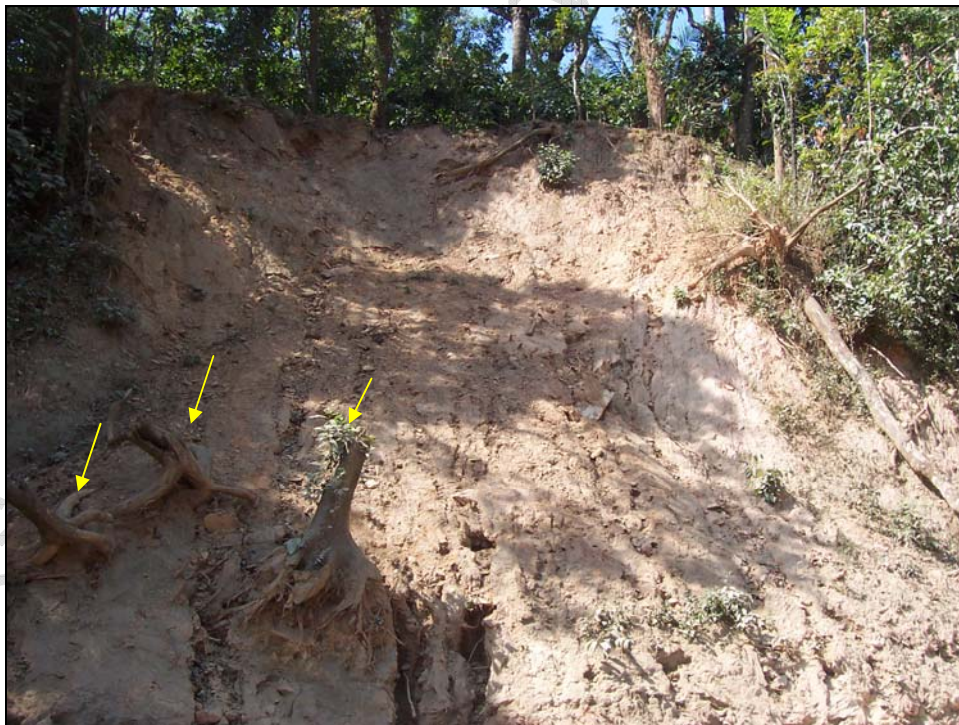
***Photo 16: View of the slide with unaffected plants near the toe of the slide***

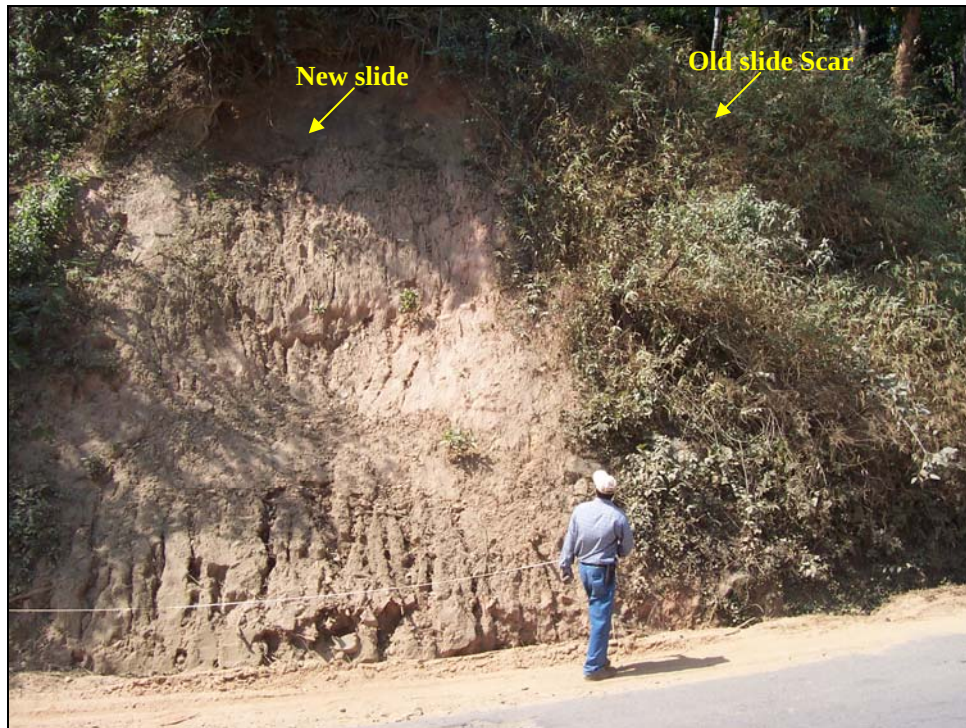
***Photo 17: An angular plan view of the Lateral progradation of the old slide in its right flank***

- i). The relative height of the slope is low hence benching of the slope with a average slope angle of  $45^{\circ}$  will ensure its stability in long run.
- ii). As the slide is shallow with depth of sliding less than 2m, deep rooted plants/shrubs with high tensile strength is to be planted in the benched slope to increase its stability.

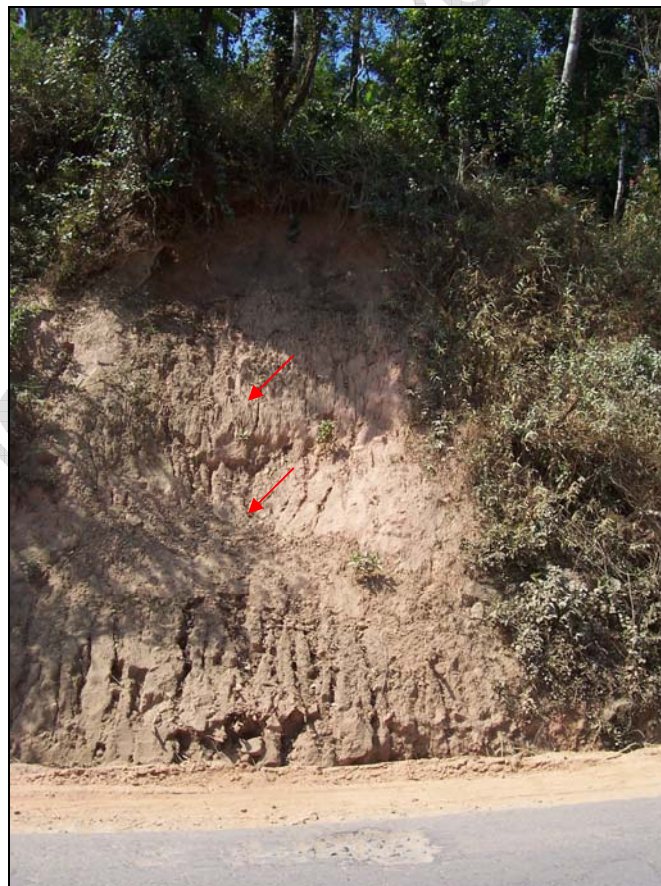
***Photo 18: The concavity and convexity of the slide plane.***

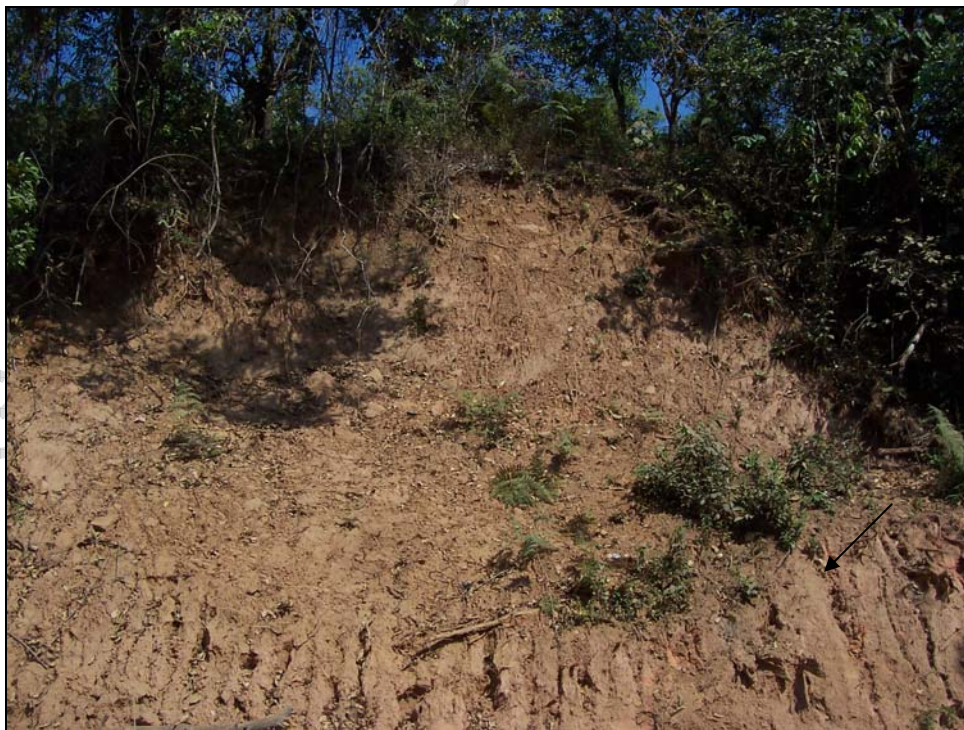
***Photo 22: Formation of striations on the slide zone***

- i) The relative height of the slope is low hence benching of the slope with an average slope angle of 45° will ensure its stability in long run.
- ii) As the slide is shallow with depth of sliding less than 2m, deep rooted plants/shrubs with high tensile strength is to be planted in the benched slope to increase its stability.

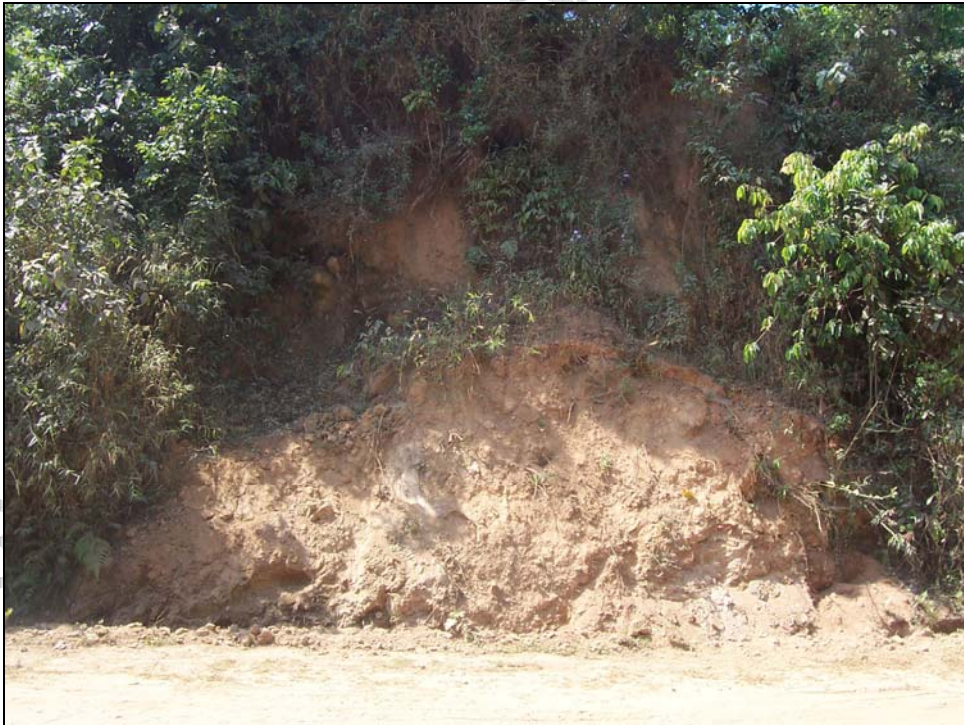
**Photo 26:** *The plan view of the debris slide*

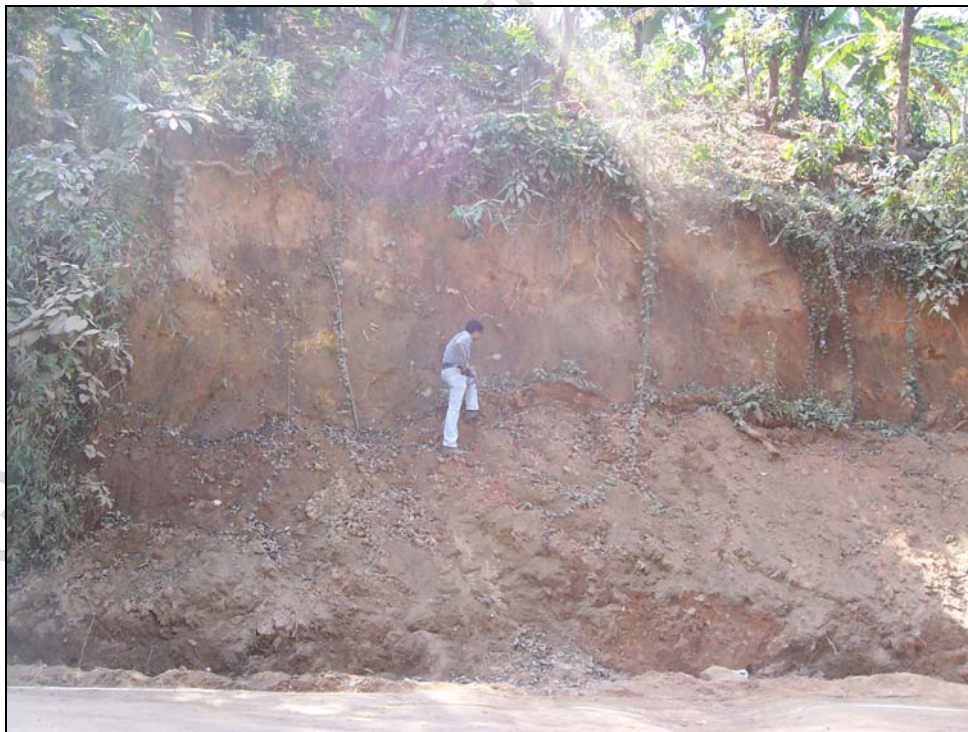
**Photo 29:** *The plan view of the debris slide with crown height of 4m.*

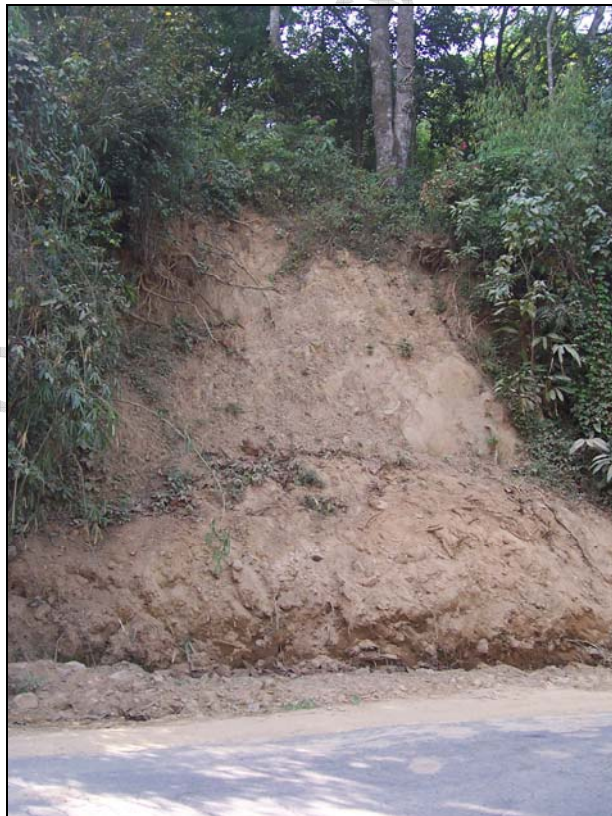
**Photo 37:** The side view of the debris slide with zone of accumulation

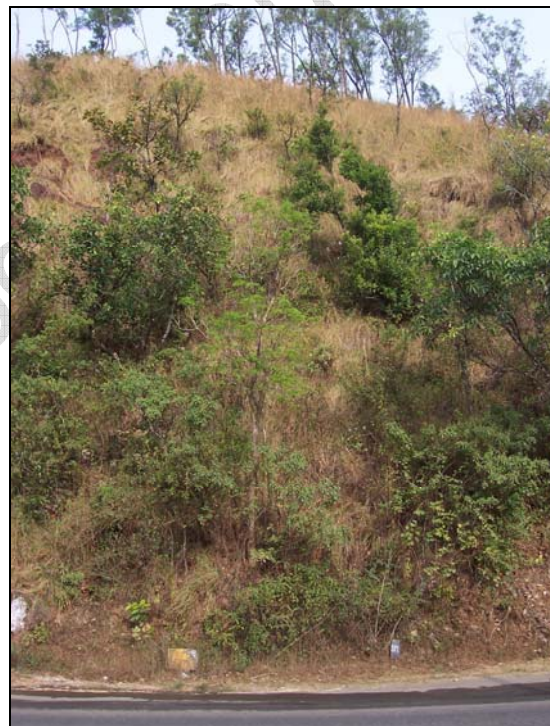
**Photo 46:** Plan view of the debris slide with huge trees standing on the crown

- i) The protective measures proposed at the site include removal of slide material and unstable from the slope
- ii) Grading of the slope with benches
- iii) Plantation on the slope to increase the soil strength.

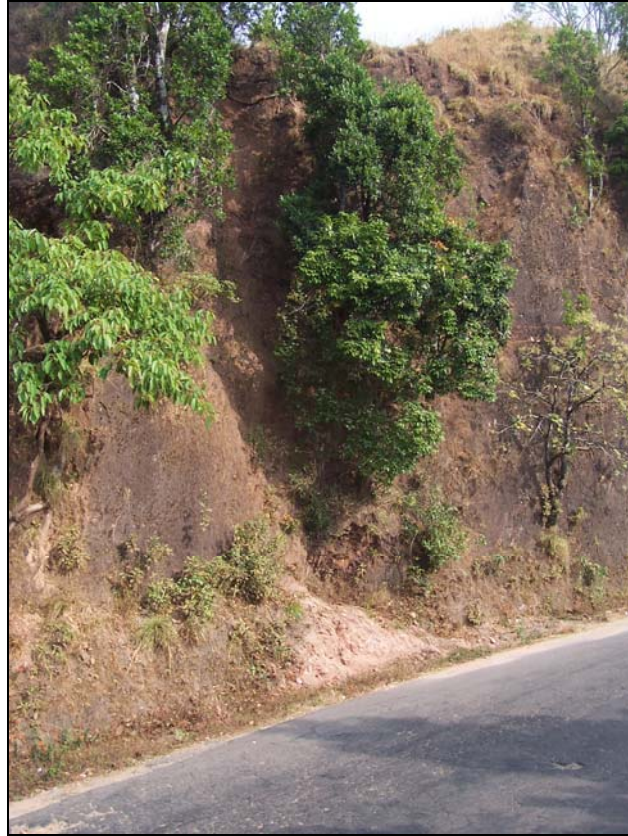
**Photo 47:** View of the rock slide with trees on the crown and slide plane

- i). The protective measures proposed at the site include removal of weathered material and big trees from the crown which are exerting pressure on the crown.
- ii). Geometrical modification of the slope by grading or making benches.

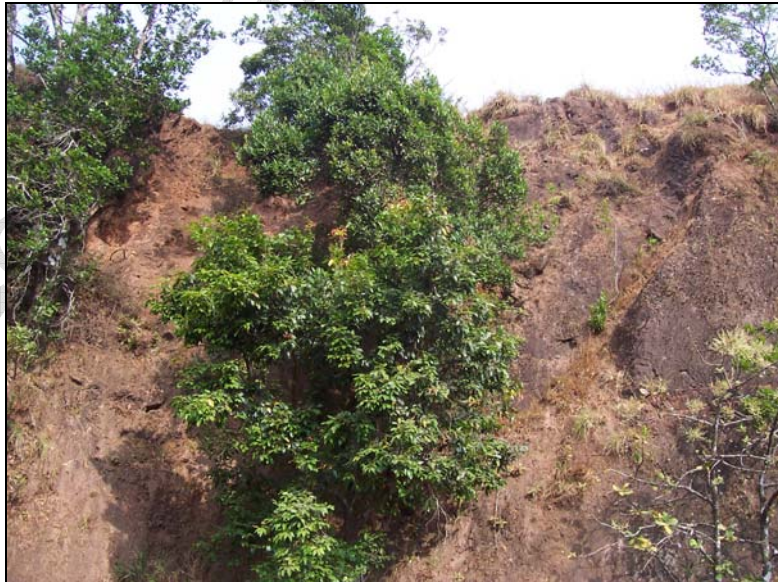
**Photo 48:** Plan view of the rock slide with trees on the crown and slide plane.

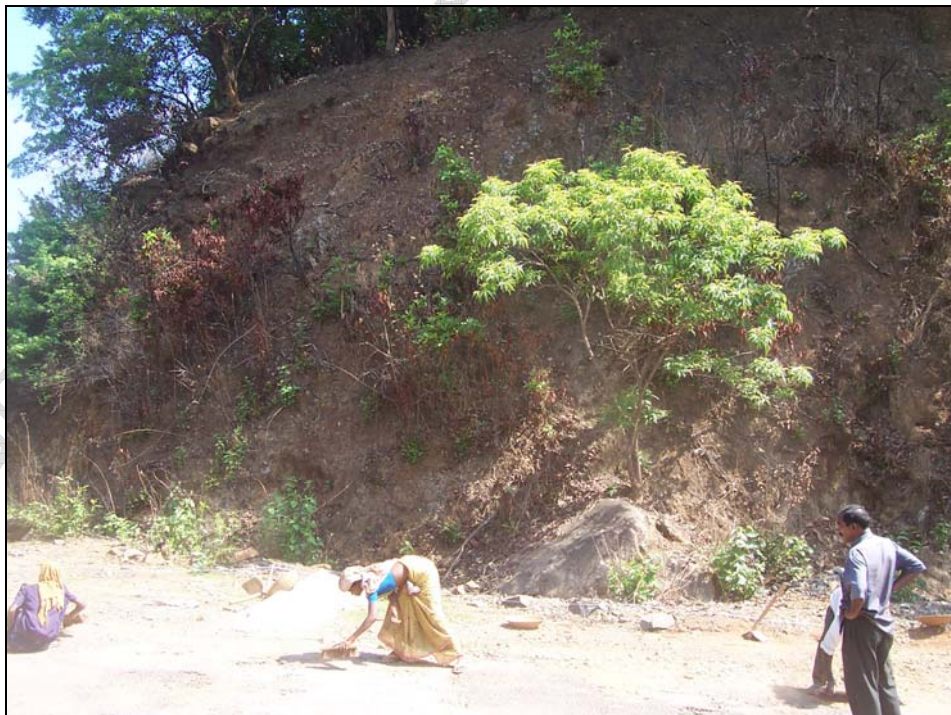
**Photo 69:** *The view of the debris slide with exposed bed rock*

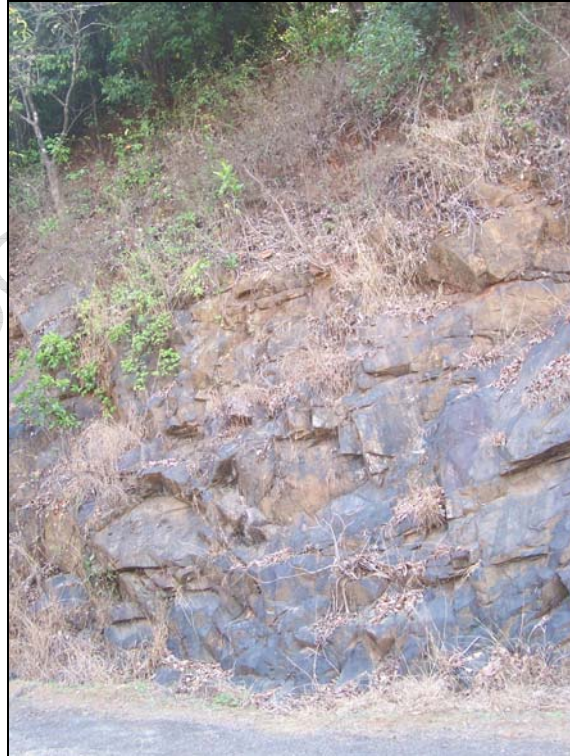
**Photo 71:** *The plan view of the rock slide with exposed bed rock*

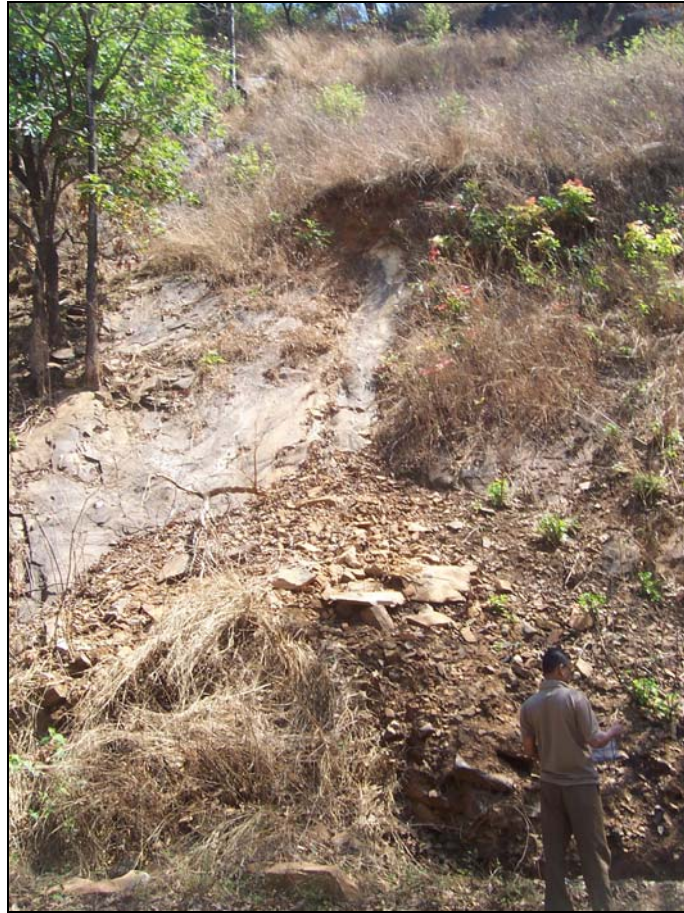
**Photo 74:** The plan view of the rock slide

- i) The protective measures proposed at the site include removal of weathered and loose material from the crown.
- ii) Soil nailing and rock bolting is suggested to protect the vulnerable planes from sliding.
- iii) Horizontal drainage is suggested to remove the infiltrated water.

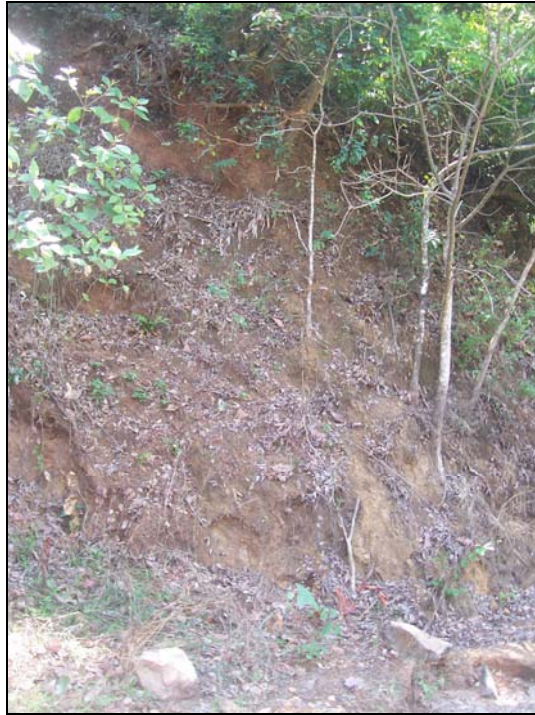
**Photo 76:** *The plan view of the debris slide*

- i) As the slide is shallow with depth of sliding less than 2m, deep rooted plants/shrubs with high tensile strength is to be planted in the benched slope to increase its stability.
- ii) Unstable loose material and trees from the crown should be removed.
- iii) Proper drainage is to be provided for discharge of water away from unstable slopes.

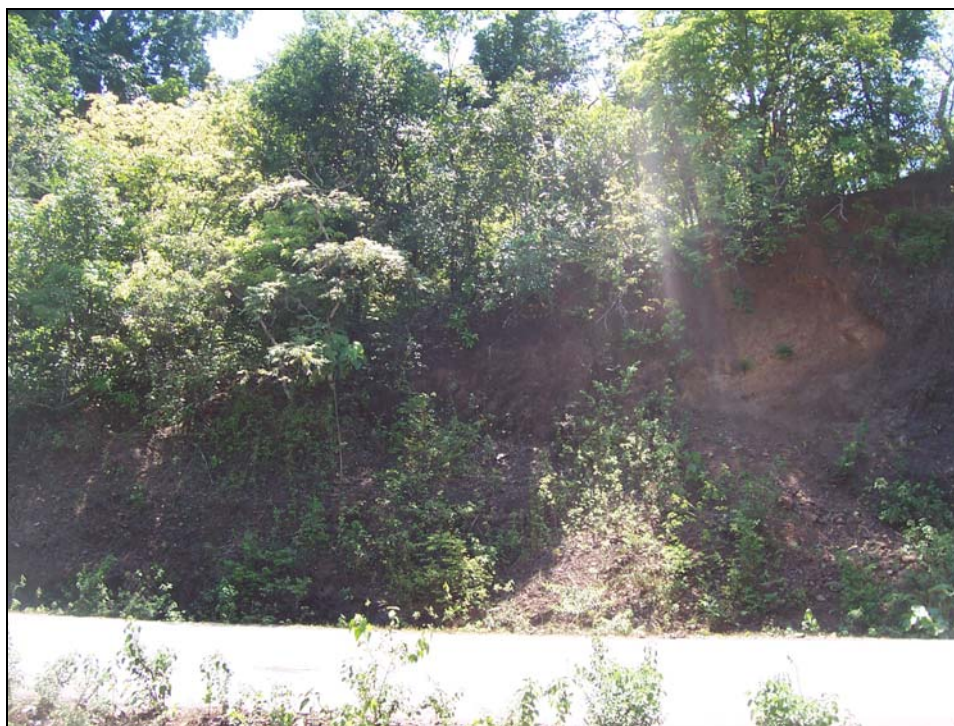
- a. Maximum length of failed mass from crown to foot : 15 m
- b. Maximum width of failed mass from the left flank to the right flank boundary : 52 m
- c. Maximum depth of the failed mass from the surface of the slide to the failure surface : 1-2 m
- d. Volume of failed mass above the failure surface : 780 m<sup>3</sup>
- e. Slope angle after failure : 90°
- f. Slope angle before failure : 90°
- g. Original slope angle : 15°
- h. Direction of slide : S80°E

**CAUSES:** Increase in the gradient of the slope due to the vertical cut slope for making road decreased the slope stability. The lack of surface drainage increased the percolation and infiltration of water into the mound. The heavy precipitation during monsoon increased the pore water pressure, the loose overburden and the laterite in the slope failed due to saturation.

**NATURE OF DAMAGE:** Yellapur –Arbail road in national highway NH-63, was blocked due to the heaped debris material on the road

Photo 88: The plan view of the complex slide

- i) The protective measures proposed at the site include removal of huge trees standing on the unstable crown part and slided material which are resting on the slided plane .
- ii) The slope angle should be reduced to <40° to increase the stability by grading of the slope.
- iii) Plantation of deep rooted vegetation on the slope is suggested to reduce erosion and increase slope stability.
- iv) Retaining wall of height about 4m should be provided.

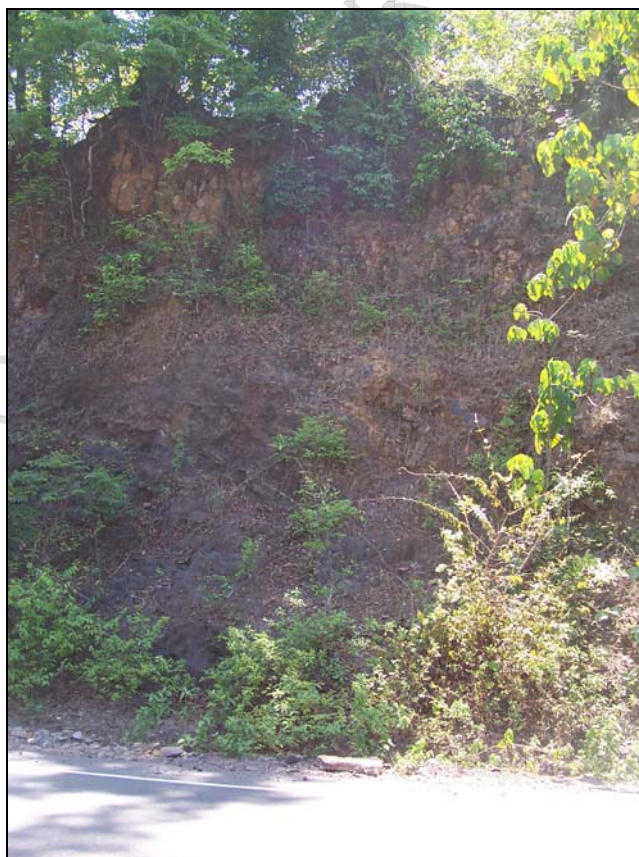
Photo 89: The plan view of the debris cum slide with accumulation at the toe.

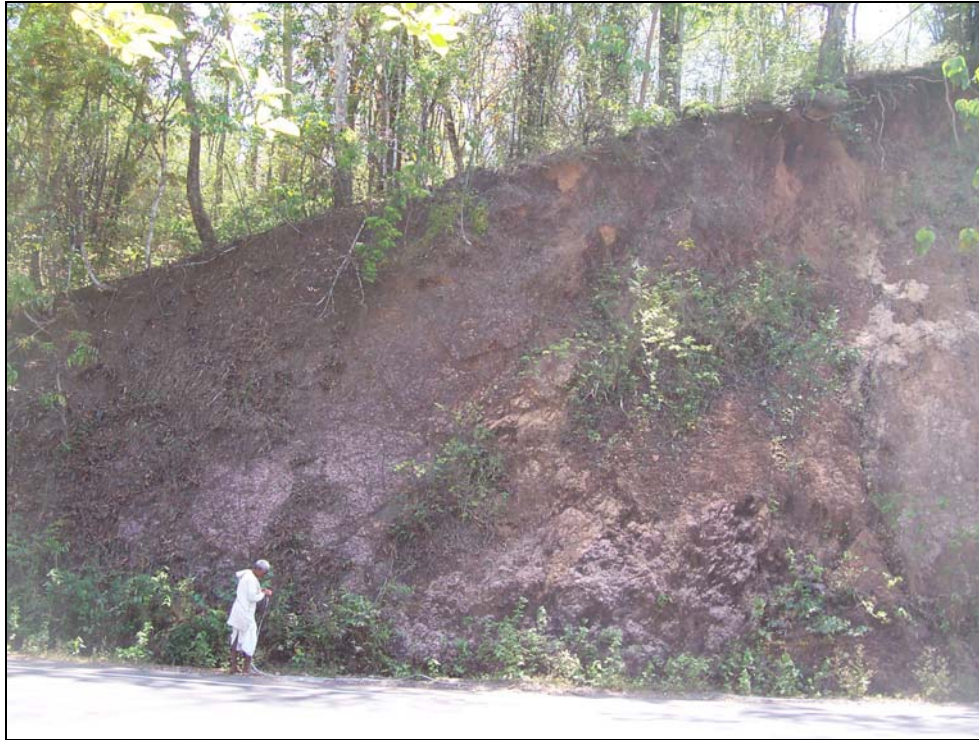
**SLIDE DESCRIPTION:** Slide is located in the eastern slope of NNW-SSE trending hillock which has a maximum height of 400 m. The relative relief of the slope is 140 m and slope angle is 15° towards NE. Highly weathered granite with kaolinisation on the slope of the slide zone is observed. The total slide zone surface is irregular and drained with small rills and gullies. The slides look to be stabilised due to the high vegetation cover in the slide slope. The present topography of the cut slopes has both concave and convex geometry. The slide is classified as multiple, reactivated debris slide.

**CAUSES:** The original slope angle of this spur is very gentle. This slope was cut vertical for construction of road which decreased the stability of the slope. The compressive strength of the weathered granite is very weak and kaolinised clay lenses in the surface exposes the weak zones and the slope failed due to increase in pore water pressure during high rainfall experienced in this area.

**NATURE OF DAMAGE:** Yellapur –Arbail road in NH-63 was blocked due to the heaped debris material on the road.

Photo 90: The side view of the debris slide

- i) The slope angle should be reduced to <40°.
- ii) Deep rooted plants/shrubs is to be planted in the graded slope to increase its stability.
- iii) The unstable crown portion should be removed.
- iv) Retaining wall of height about 4m should be provided.

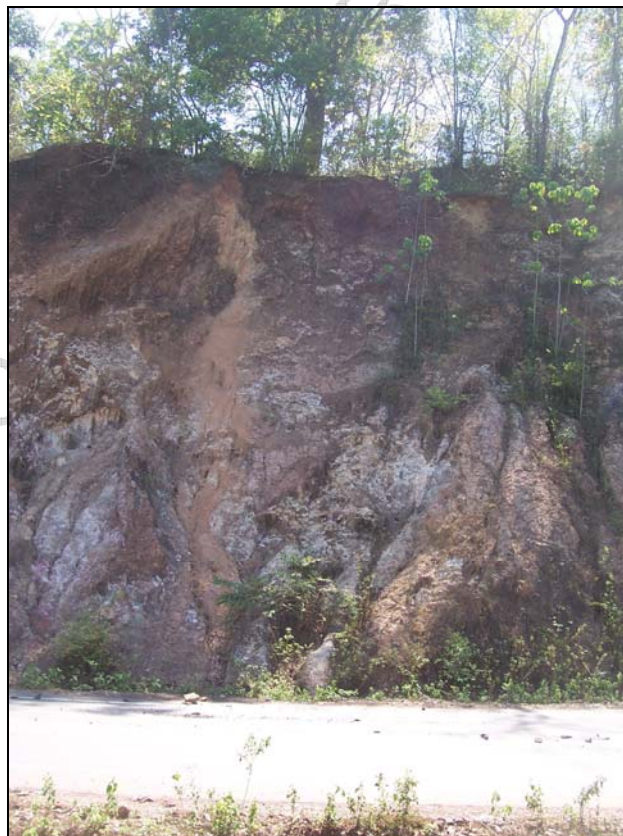
Photo 91: The plan view of the debris slide

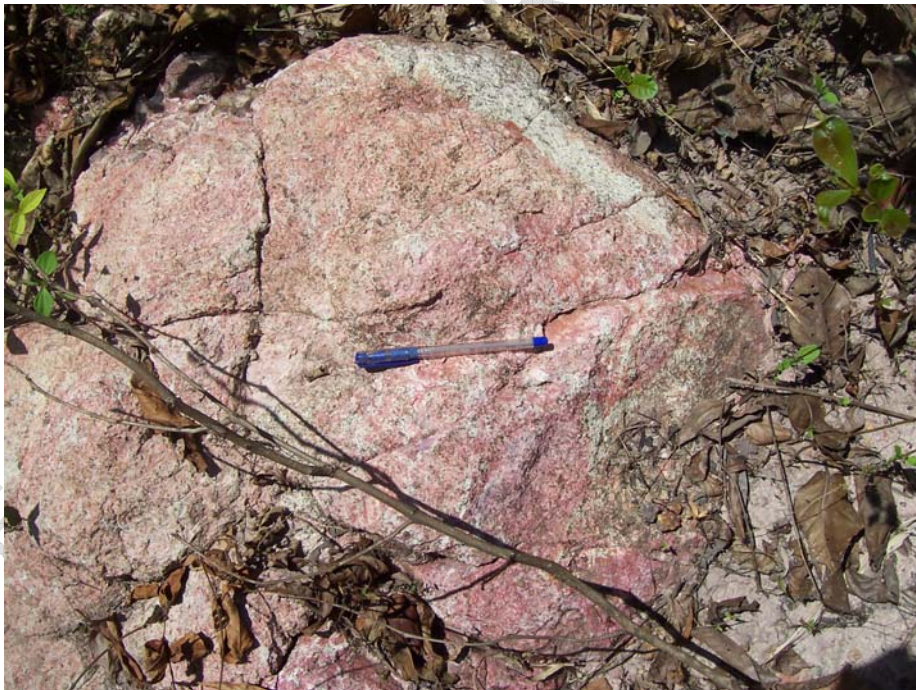
Photo 93: The kaolinised clay lenses in the surface of the debris slide

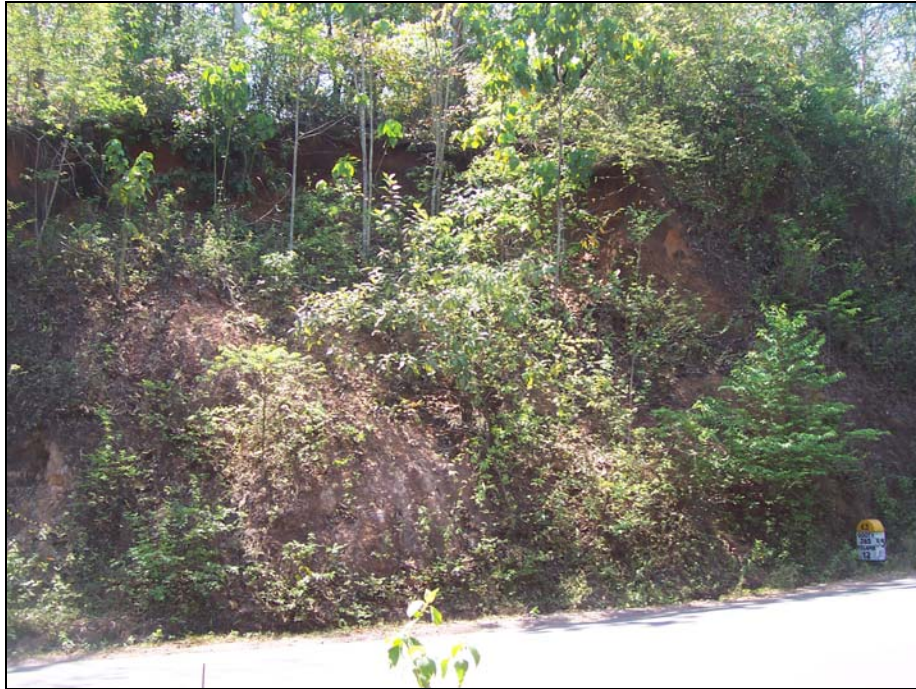
- a. Maximum length of failed mass from crown to foot : 17 m
- b. Maximum width of failed mass from the left flank to the right flank boundary : 24.7 m
- c. Maximum depth of the failed mass from the surface of the slide to the failure surface : 1-2 m
- d. Volume of failed mass above the failure surface : 420 m<sup>3</sup>
- e. Slope angle after failure : 70-80°
- f. Slope angle before failure : 90°
- g. Original slope angle : 15°
- h. Direction of slide : S84°E

**CAUSES:** The original slope angle of this spur is very gentle. This slope was cut vertical for construction of road which decreased the stability of the slope. Due to the cutting of the mound, the toe portion became vulnerable. The slope forming material became saturated due to increase in pore water pressure during high rainfall experienced in this area.

**NATURE OF DAMAGE:** Yellapur –Arbail road in NH-63 was blocked due to the heaped debris material on the road

Photo 94: The plan view of the debris slide

- i) The slope angle should be reduced to <40° by grading of the slope.
- ii) The unstable crown portion should be removed.
- iii) Proper surface drainage should be provided to minimize water infiltration.
- iv) Retaining wall of height about 3m should be provided.

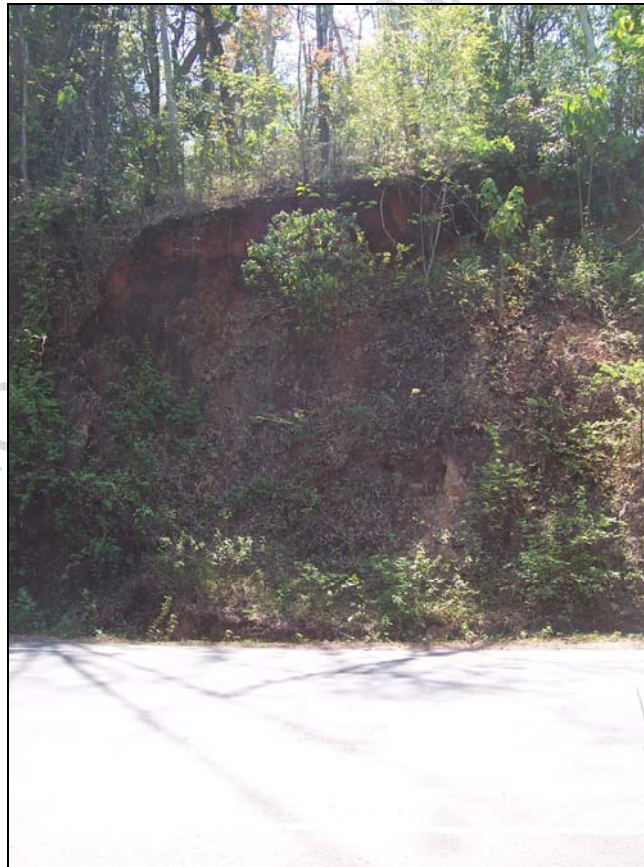
Photo 95: The plan view of the debris slide

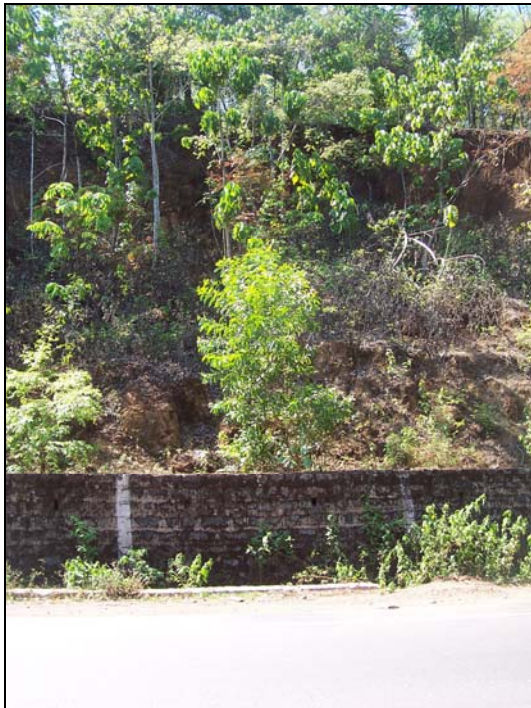
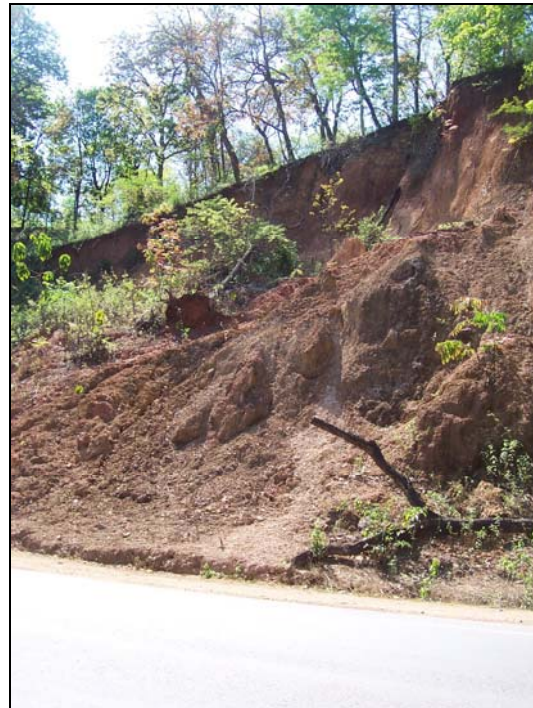
**CAUSES:** The increase in the gradient of the slope due to the vertical cut slope for making road decreased the slope stability. The lack of surface drainage increased the percolation and infiltration into the mound. The heavy precipitation during monsoon increased the pore water pressure, the loose overburden and the weathered granite in the slope failed due to saturation.

**NATURE OF DAMAGE:** Yellapur –Arbail road in NH-63 was affected due to slided material.

Photo 96: The view of the debris slide with unstable crown

- i) The protective measures proposed at the site include removal of huge trees standing on the unstable crown and slide material which are resting on the slided plane should be completely removed
- ii) The slope angle should be reduced to <40° to increase the stability by grading of the slope
- iii) Plantation of deep rooted vegetation on the slope is suggested to reduce erosion and increase slope stability.
- iv) The retaining wall has been provided for certain distance and it should be increased to for the entire width of the slide.

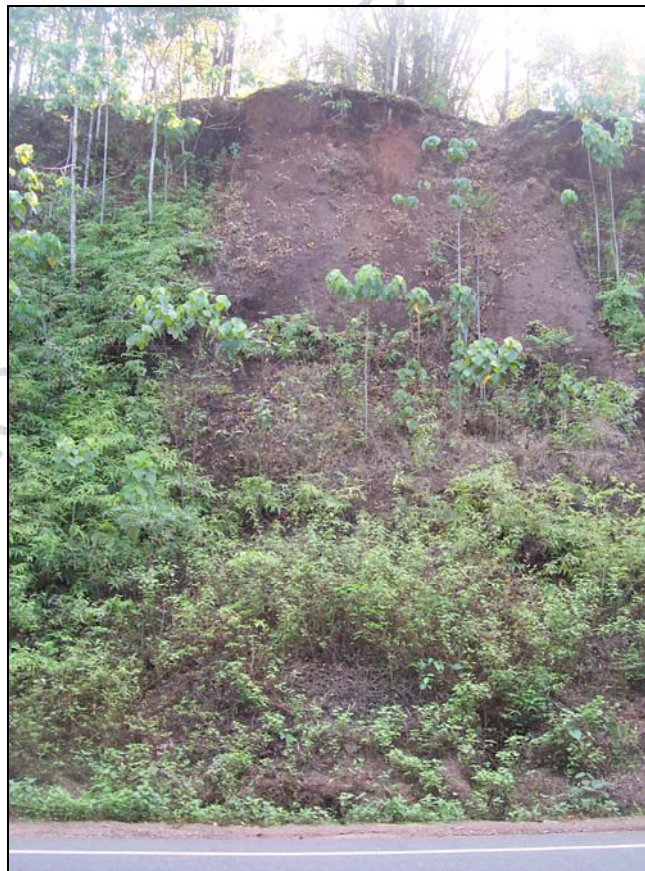
**CAUSES:** The increase in the gradient of the slope due to the vertical cut slope for making road decreased the slope stability. The remedial measures were not provided for the earlier slide, so the slide prograded laterally. The heavy precipitation during monsoon increased the pore water pressure, the loose overburden and the weather granite in the slope failed due to saturation.

**NATURE OF DAMAGE:** Yellapur –Arbail road in NH-63 was blocked due to the heaped debris material on the road

Photo 101: The plan view of the debris slide with steep slope angle.

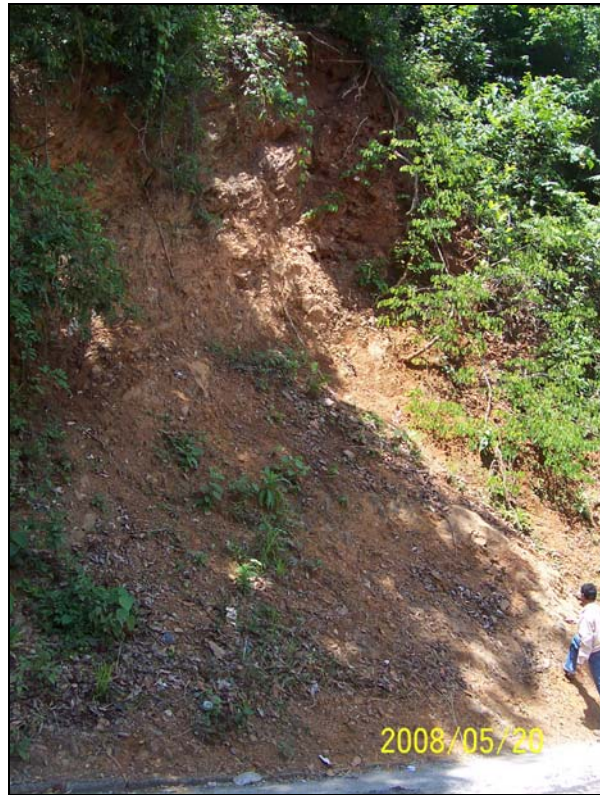
Photo 117: The plan view of the debris slide

- i) Removal of unstable crown and huge trees standing on the crown to decrease the load.
- ii) The slope angle should be reduced to <40° to increase the stability.
- iii) Bio-engineering and plantation of deep rooted plant/shrub on the slope is suggested to reduce erosion and increase slope stability.
- iv) Retaining wall with weep holes is suggested to at the toe of the slide.

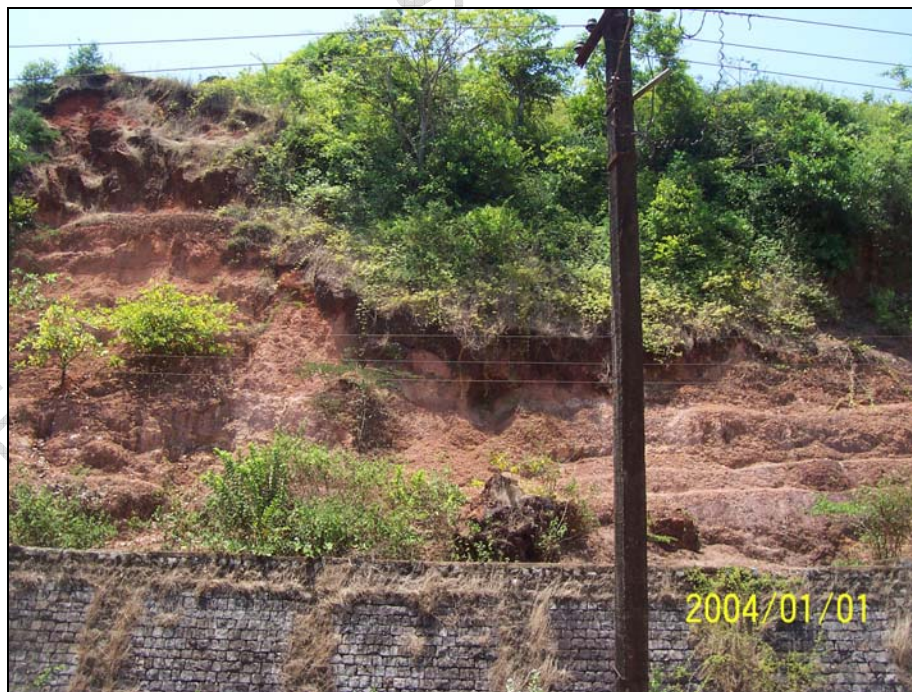
Photo 124: The plan view of the reactivated, debris slide with no protection at  
the mid slope and is likely to slide again

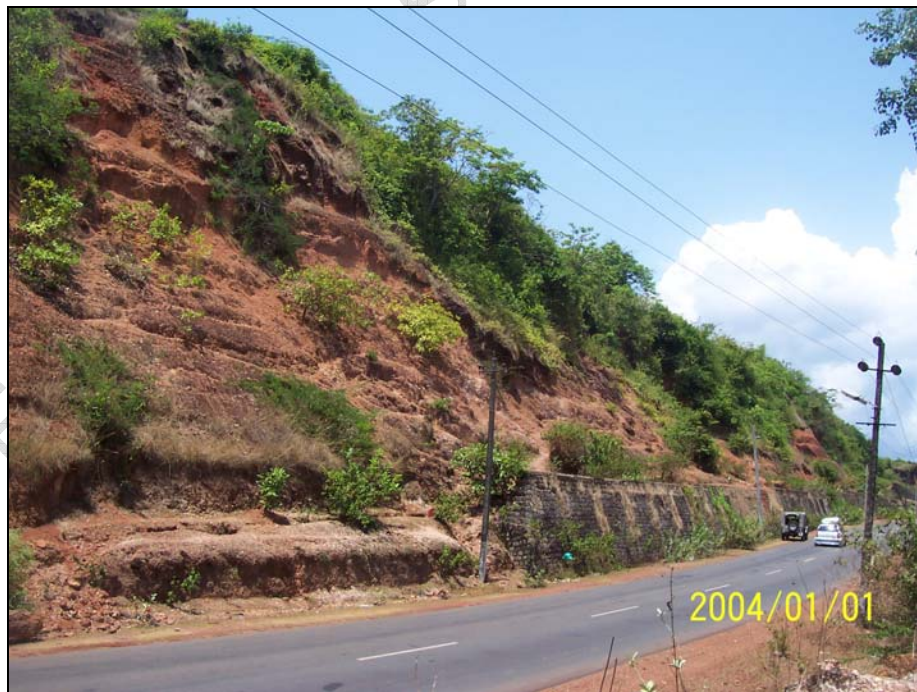
Photo 126: The side view of the reactivated, debris slide with steep slope angle

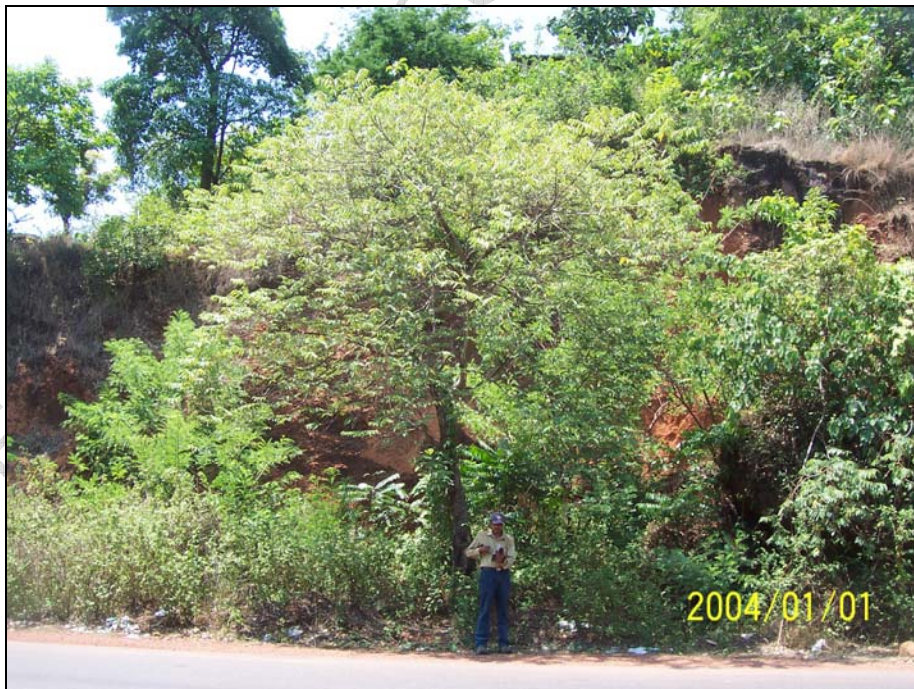
Photo 128: The side view of the reactivated, debris slide with steep slope angle
